SERVICE BULLETIN

NO. SB-1

Model: A2

Subject: C-90-16F Continental Engine Breather Fitting

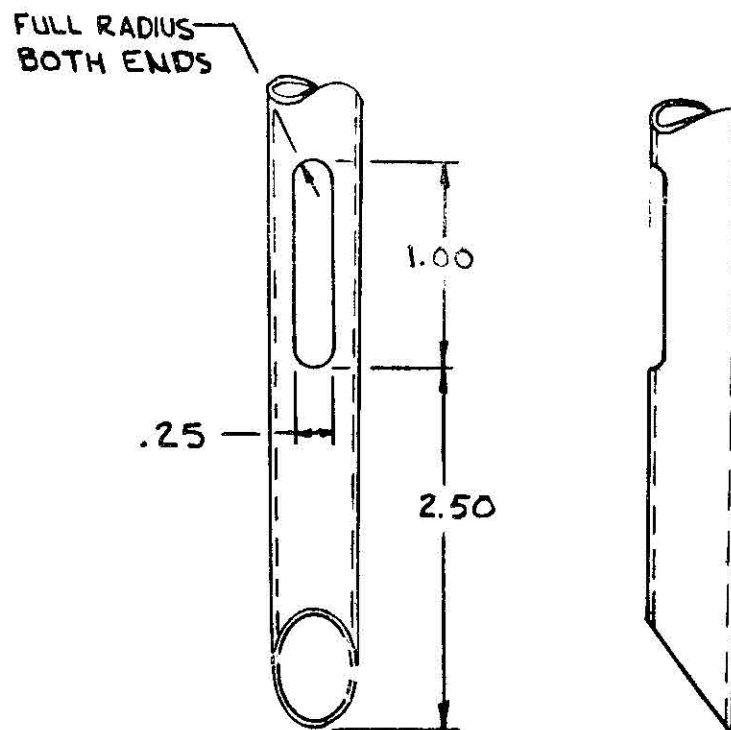
In order to supply an alternate source of breather air to eliminate the possibility of pressurizing the engine case in the event that icing occurs at the breather tube end, a slot has been added to the lower portion of the breather tube, per the sketch below.

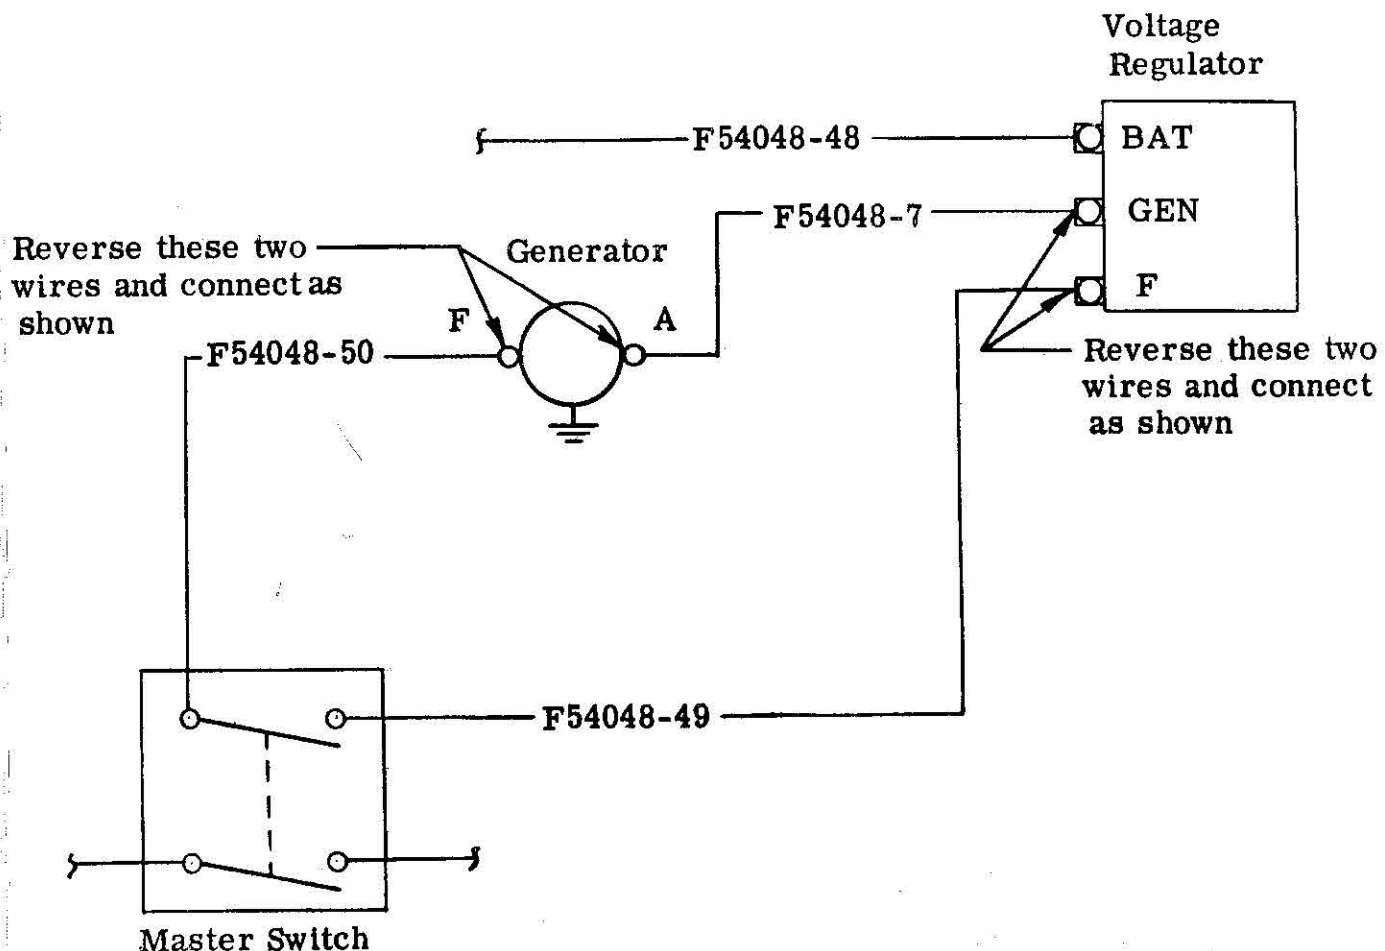
A correction in the wiring on current models coming off the line has been incorporated to completely eliminate the remote possibility of overheating the generator if for some reason the master switch is turned off in flight for a prolonged period of time. The change consists of merely reversing the two wire connections on the generator and two of the wires on the voltage regulator. The final configuration should be as shown below.

NOTE: The final dash number of the wire part number will be found on the wires in the airplane to aid in tracing connections.

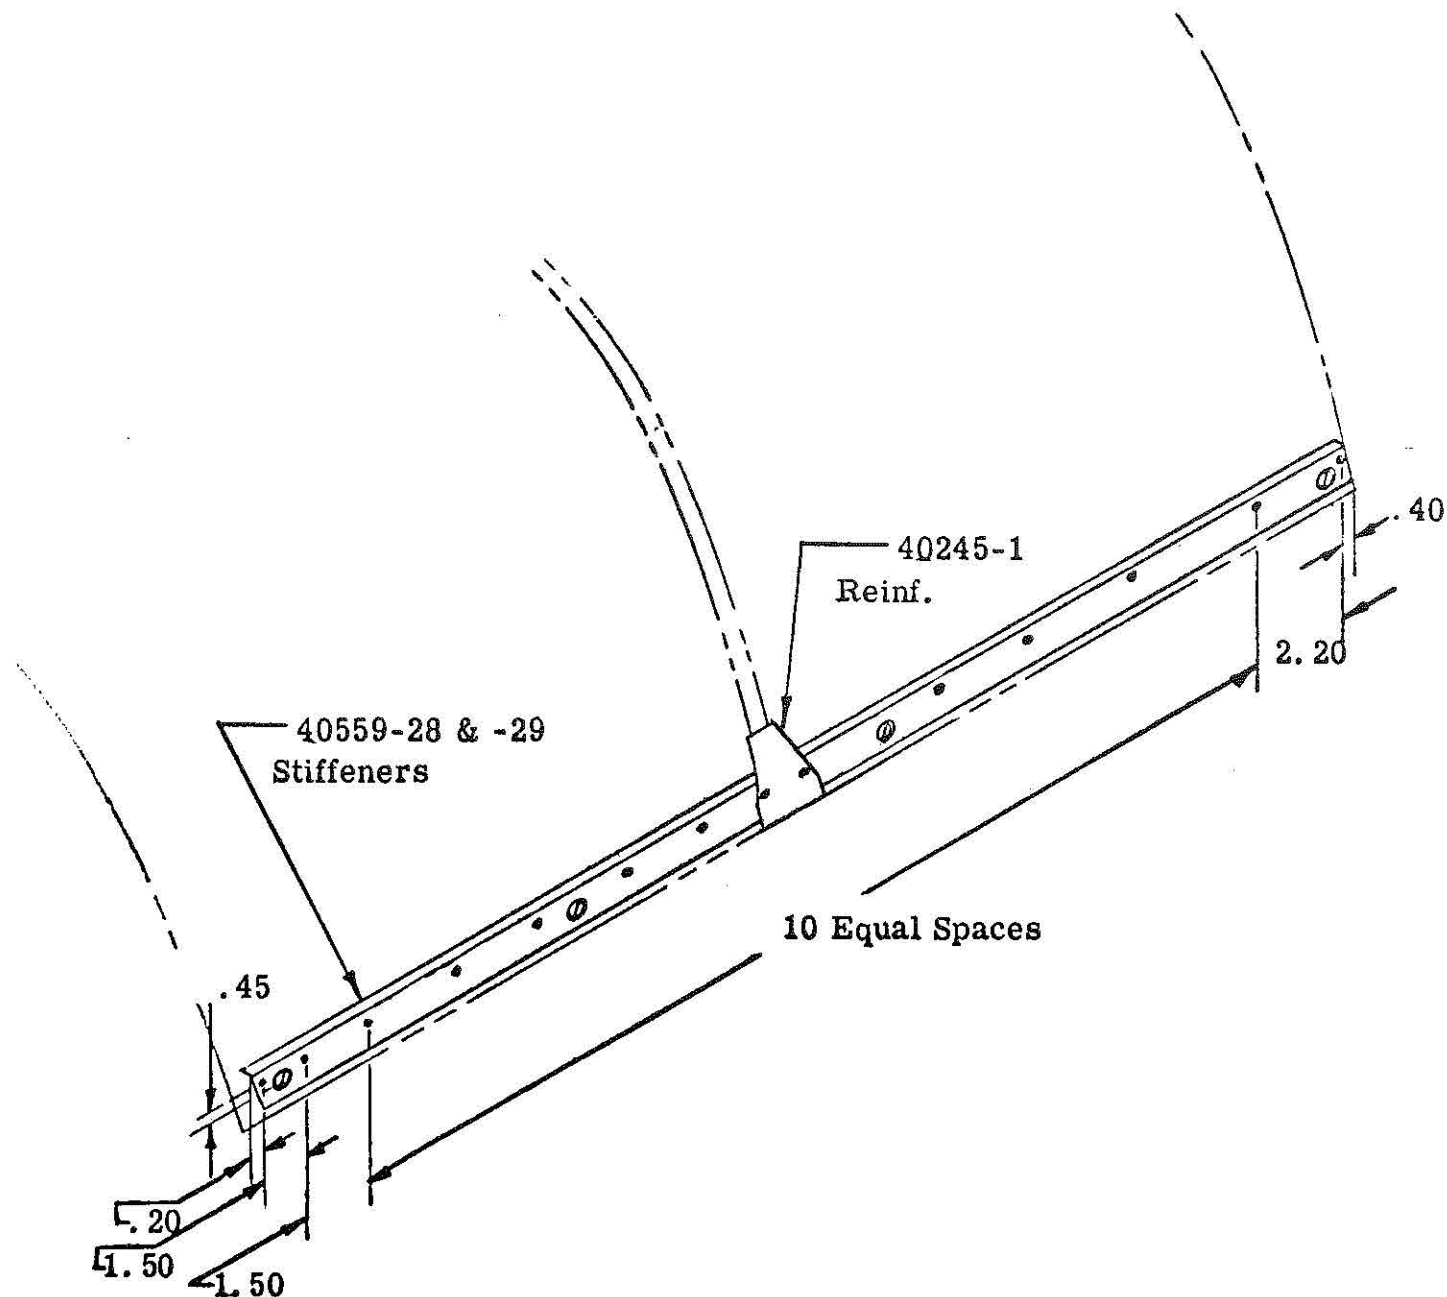
Figure 1

To preclude the possibility of skin cracking around the Camloc fasteners and reinforcement on the engine cowling doors, Alon recommends the following stiffener and reinforcement be added on each door:

1. Remove the four (4) Camloc fasteners on each door.
2. Drill out the two (2) rivets which secure the 40245 reinforcement to each door, and remove the reinforcement.
3. Install the 40245-1 reinforcement in same location and secure with two (2) MS20470AD3-4 rivets.
4. Install 40559-28 stiffener on the LH door, and 40559-29 stiffener on the RH door, aligning Camloc fastener holes in each stiffener with the holes in the door.
5. Per figure 1, drill fourteen (14) No. 40 (.098) holes through door and stiffener and secure each stiffener with MS20470AD3-4 rivets.
6. Reinstall the four (4) Camloc fasteners on each door.
7. Trim stiffeners, as required, to achieve a flush fit. Note: Do not crimp 40559-28 and -29 over the 40245-1 reinforcements.

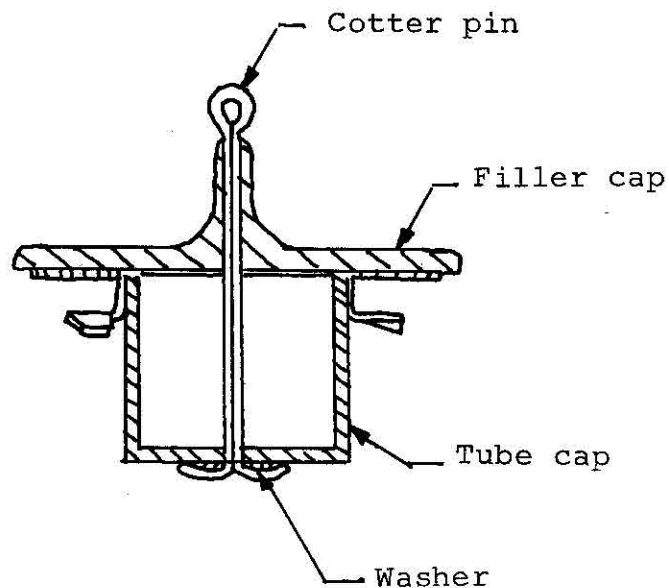
Figure 1.

The following rework may be accomplished to eliminate the possibility of fuel overflow and in-flight siphoning:
(Refer to Figure 1)

- (1) Drill # 30 (.128) diameter hole through center of filler cap.
- (2) Install AN380C3-8 cotter pin downward through hole in filler cap.
- (3) Install 224 tube cap with open end against filler cap and cotter pin extended through the hole in the opposite end.
- (4) Install AN960C6 washer and bend tabs of the cotter pin flatly against washer and bottom of cap.

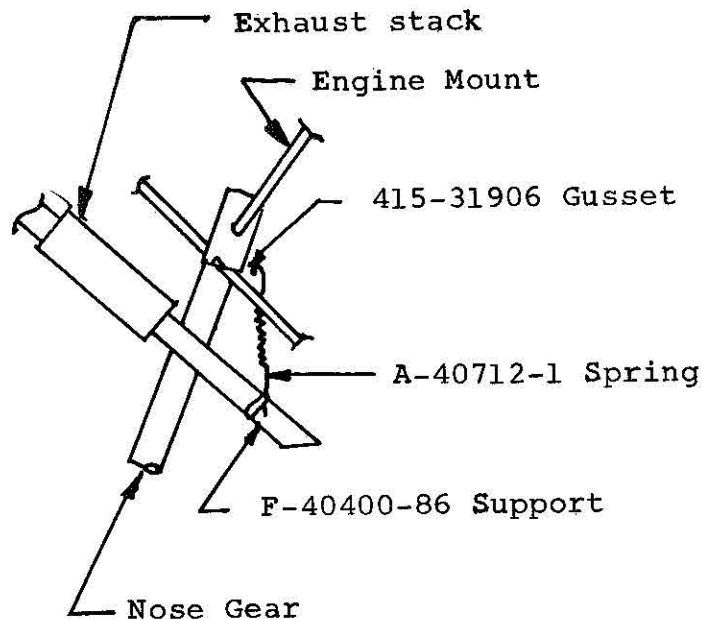
Figure I

Model: A2**Serials:** A-90 through A-159**Subject:** Provide vertical support for exhaust stacks by adding an exhaust stack support spring.

To provide a vertical support which will function in conjunction with the F-40400-86 horizontal support angle, install A40712-1 support spring as shown in Figure 1. Attach one end of the spring to the aft lip of the 415-31906 gusset portion of the mount assembly, and the other end of the spring under the lower flange of the F-40400-86 support.

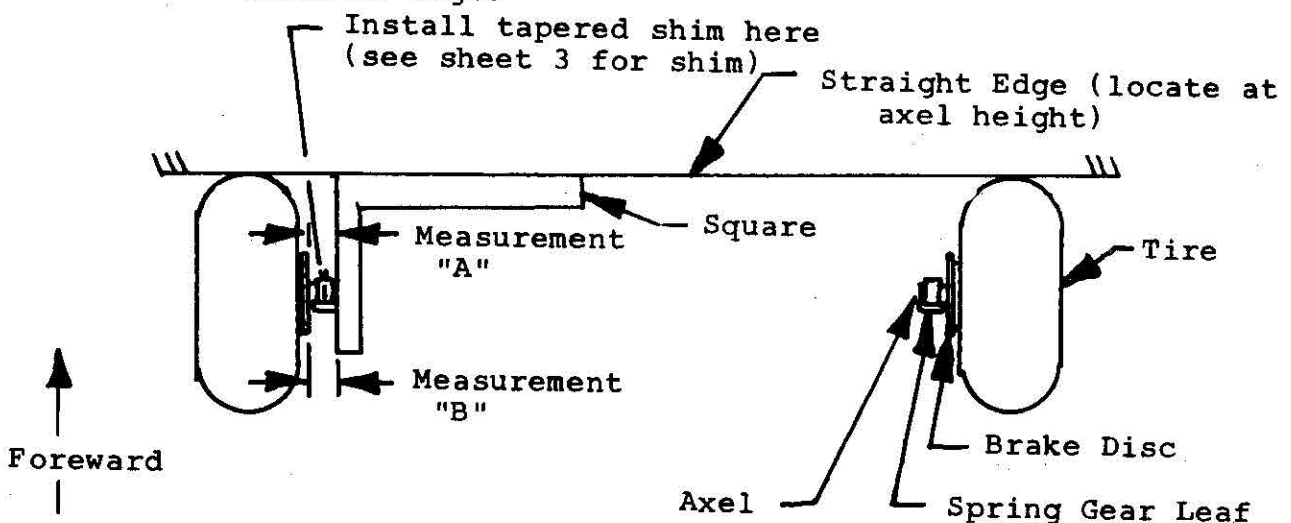
Figure 1 VIEW LOOKING DOWN

To eliminate the possibilities of main gear tire wear due to misalignment, the following methods may be used for checking and correction*:

1. As shown in Figure 1, check alignment by placing a straight edge across the front of both main gear tires at axel height (both tire air pressures to be equal). See "Note" on page 2.
2. Hold a square against this straight edge and against the inboard end of the axel, measure the distance between the square and the inboard surface of the brake disc at (2) places (the extreme forward and aft edges) on both gear.
3. Subtract the smaller measured distance from the larger to determine the net misalignment dimension.
4. Locate this value on Line "C" of the chart (Figure II) and find its intersection with Line "A", drop straight down to Line "B" and at its intersection read the value on Line "C". This will establish the taper or amount to be added to the .003 to .010 basic thickness of the tapered shim at its thickest edge.

Measurement "A" - "B" or "B" - "A" = Net Misalignment Dimension

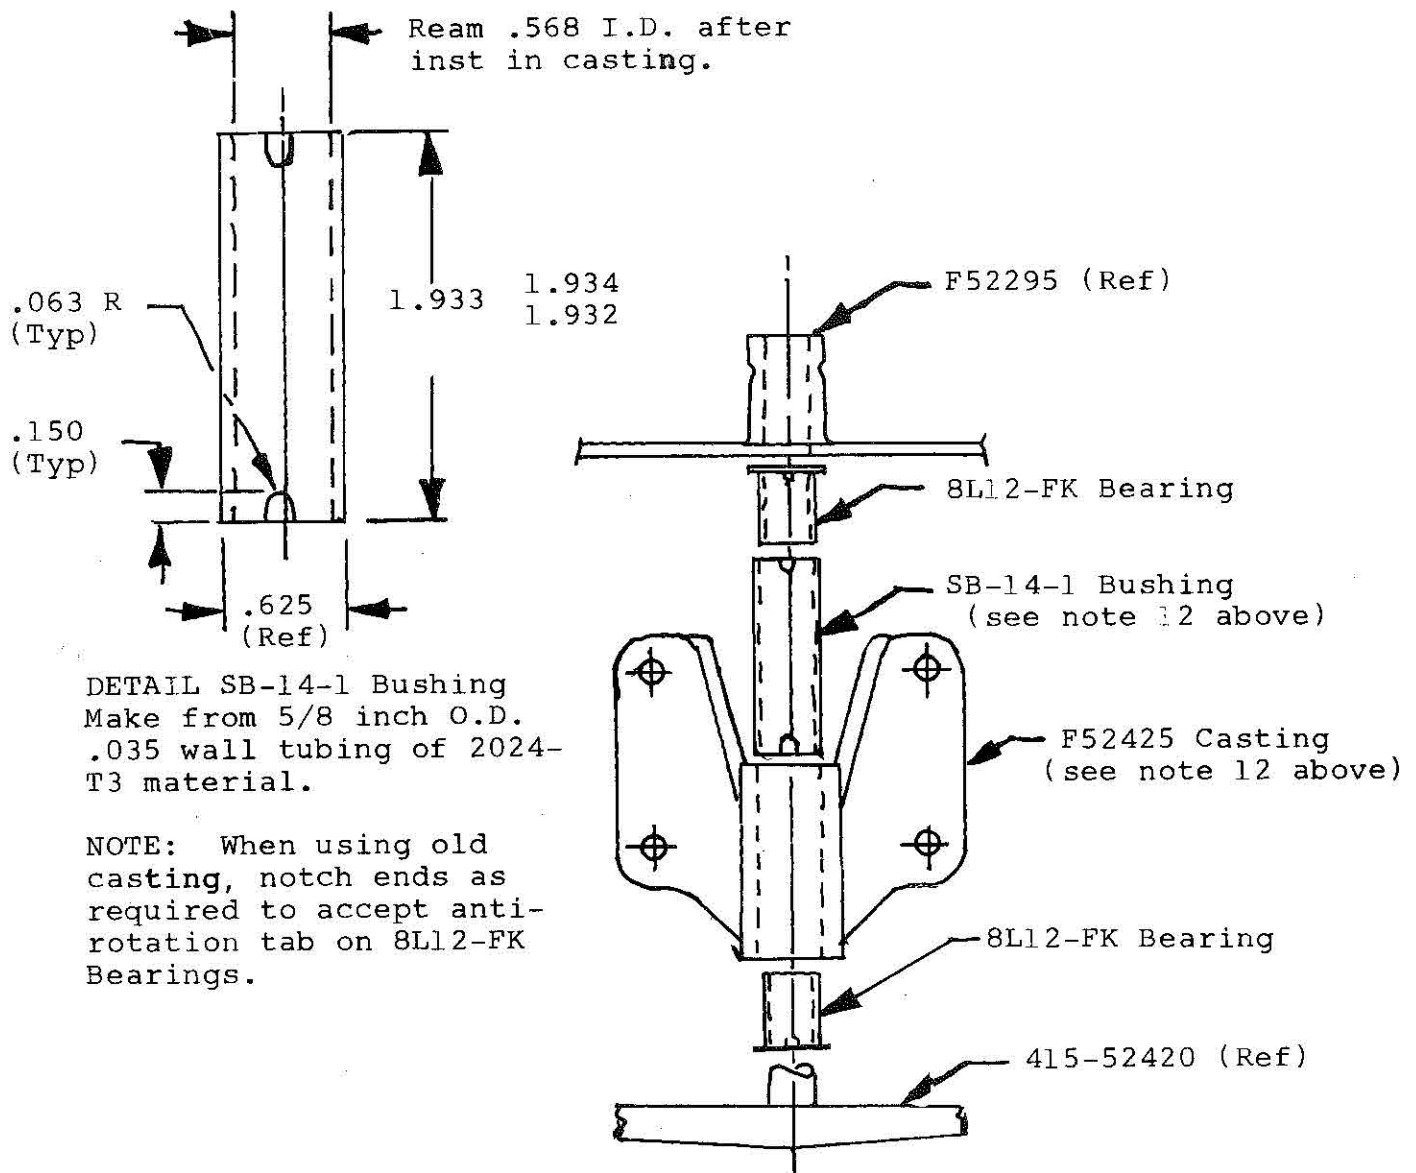
The purpose of this bulletin is to eliminate the possibilities of a rudder bellcrank seizure caused by the bakelite bushing that has expanded due to moisture within the bushing.

The above may be accomplished by replacing the bakelite bushing with the nylon bearings and by either installing the SB-14-1 bushing in the existing bellcrank casting or by replacement of the existing bellcrank casting with a new part which will eliminate the requirement for the SB-14-1 bushing.

11. Dismantle the bellcrank assembly and re-assemble using:
 - (a) the new nylon bearings with a new bellcrank casting, or
 - (b) the new nylon bearings with the SB-14-1 bushing and the existing bellcrank casting.
12. Having re-assembled the bellcrank, install it in the reverse order of the preceding instructions. When re-rigging, cable tension to be 60 to 70 inch-pounds by tensiometer.

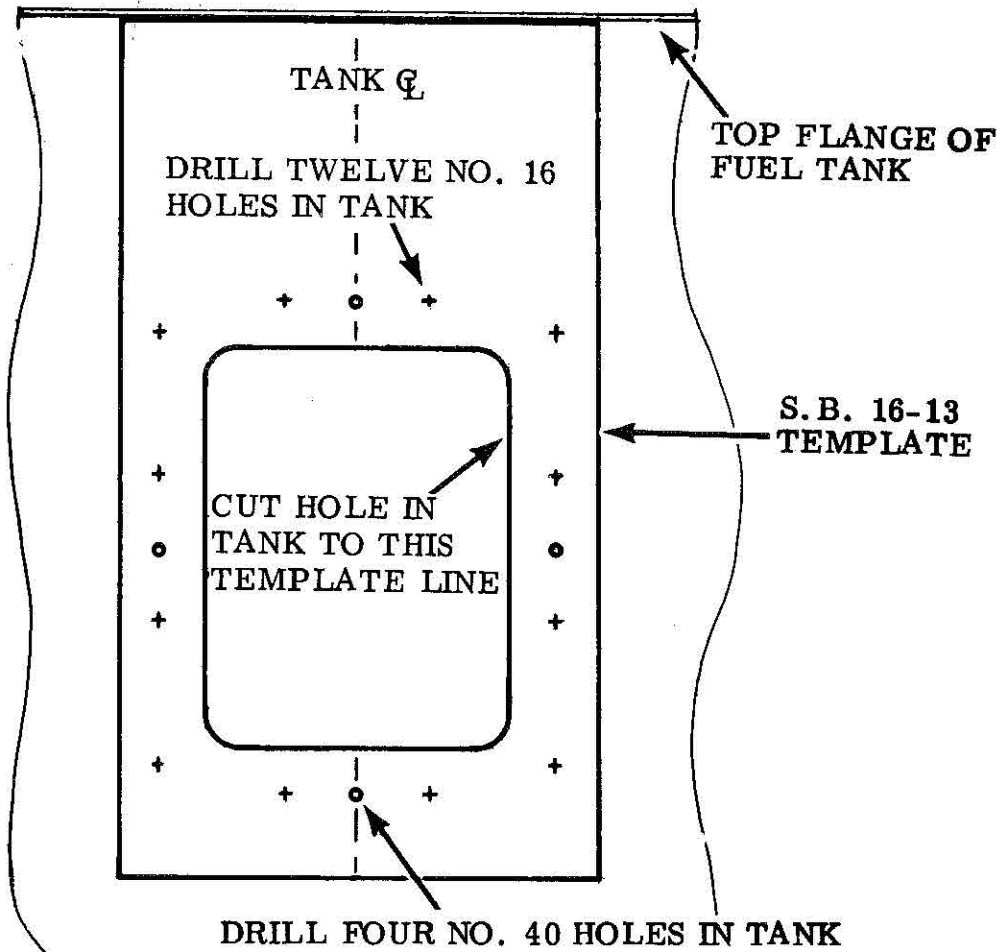
FIGURE 1

INTRODUCTION: In some instances, fuel has been observed flowing during flight from the vented fuel-filler caps. To preclude this condition, accomplish Instruction I and II. Accomplish Instruction III to help prevent the possibility of fuel seeping into the air-frame during ground servicing.

- a. Install AN913-2 plug in overflow return line fitting from which T-fitting has been removed.
- b. Locate template on center line of aft side of fuselage tank using top of tank as locating reference (See Figure 1).

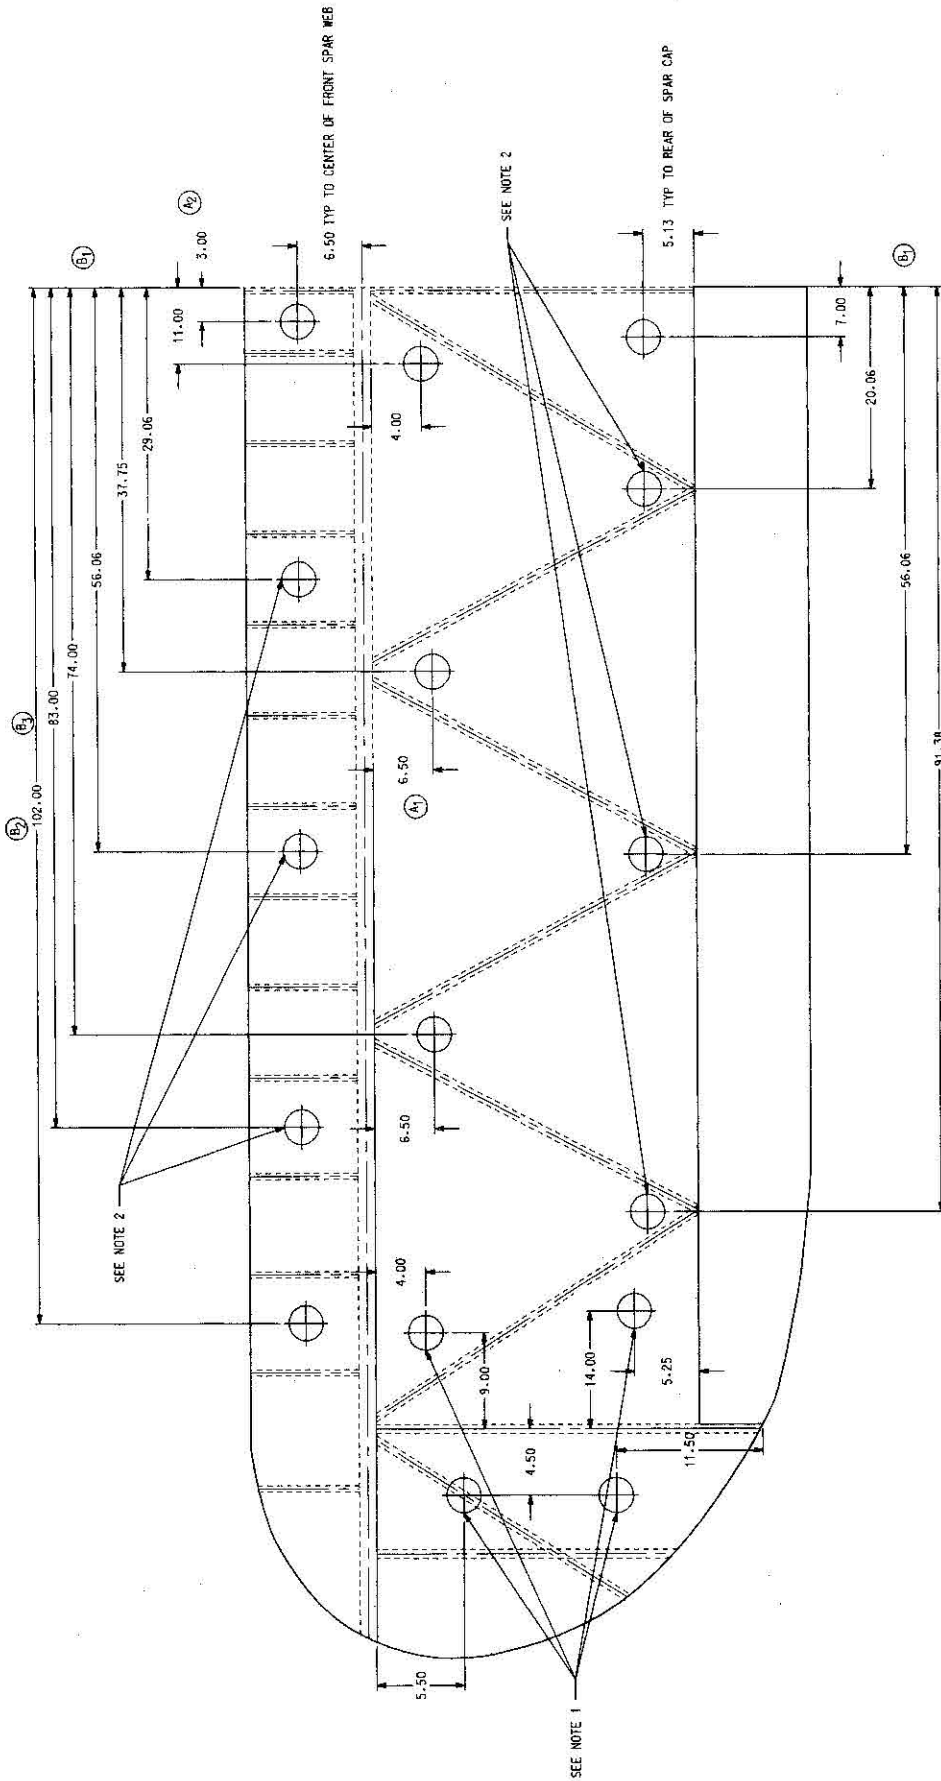
BOTTOM VIEW

There have been field reports of severe corrosion in the outer wing panel structure of several aircraft. The most effective means of preventing corrosion damage is early identification and correction. However, the original design configuration does not provide adequate means for routine visual examination of the wing panels during periodic inspections. Consequently, this Service Bulletin provides for the installation of strategically placed inspection openings to allow for complete visual access to the wing panel structure, and calls for an inspection to establish the current condition of the structure. The inspection openings will then allow routine inspections to be accomplished as required under FAR Part 43, Appendix D, (f).

If equipment is available, cut borescope hole in center of inspection opening locations as shown on diagram SB-29, Rev. B. Inspect wing interior and make preliminary assessment of wing condition. FAA Advisory Circular AC 43-4A, "Corrosion Control for Aircraft", dated 7/25/91 or later, should be used to identify and treat corroded areas. Service Memos 45, 58, 58A, 64 and Service Bulletin No. 27 concern outer wing panel structure and should be reviewed at this time. If preliminary examination reveals conditions that are not repairable through an inspection opening, remove wing covering as required and repair or replace unairworthy parts prior to further operation. Replace covering. Install inspection openings and covers per Steps 2, 3, and 5. If borescope equipment is not available, proceed to Step 2.
