ERCOUPE SERVICE BULLETIN NO. 34

ELEVATOR CONTROL HORN INSPECTION

DATE: January 4, 2013 Revision None

MODELS AFFECTED: Ercoupe 415-C, 415-CD, 415-D or other Ercoupe models with a continuous trailing edge elevator.

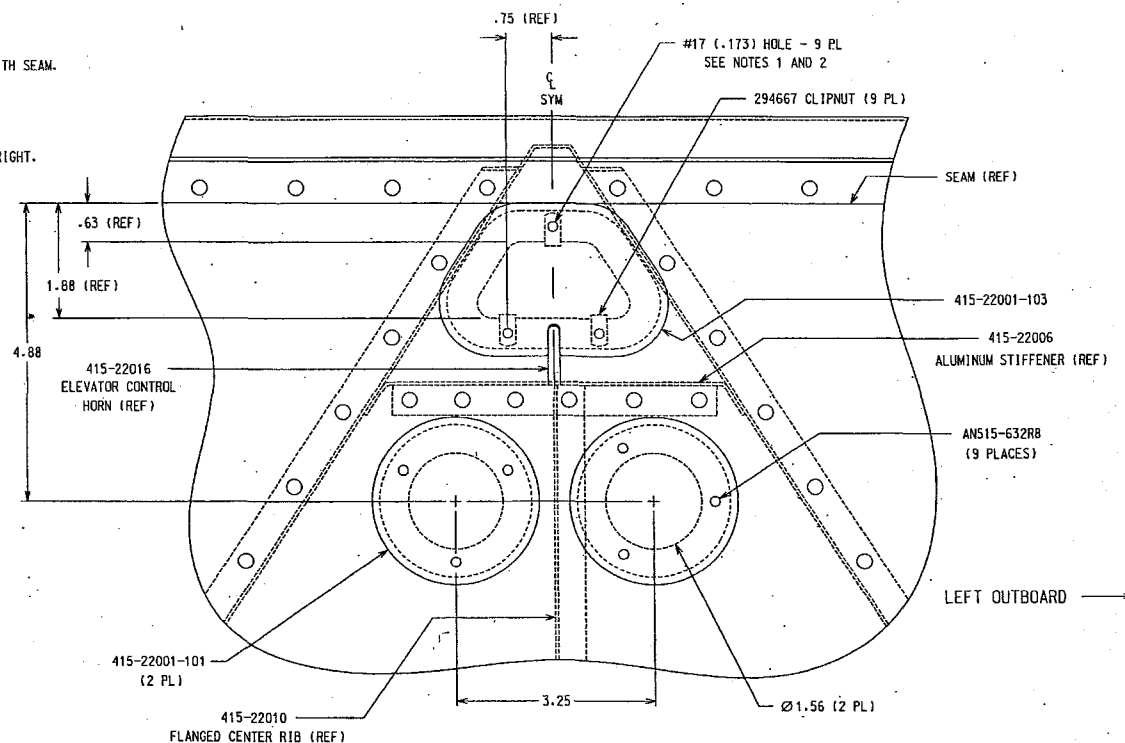
There was a field report of dissimilar metal corrosion found on an Ercoupe 415-C. The area of corrosion occurred where the steel elevator control horn attaches to the

aluminum lateral stiffener located within the elevator assembly. Dissimilar metal corrosion is a concern of aircraft designed and manufactured during this era.

As originally designed, this area of the elevator has no adequate means of internal inspection. Any compromise in the steel or aluminum can only be detected by removing the aluminum elevator skins. However, the addition of several small inspection covers, specifically designed for this situation, provides for any necessary inspection of this area.

Univair has determined that two 1.56 diameter holes and one trapezoidal shaped hole located at the center of the bottom elevator skin will provide adequate inspection coverage of the attachment area of the steel elevator control horn. See Univair drawing 415-22013 INSP for layout dimensions of inspection holes.

4. Cut two 1.56 diameter holes in lower elevator skin aft of the aluminum stiffener per drawing 415-22013 INSP. Locate the inspection hole forward of the aluminum stiffener using template 415-22001-105, per drawing 415-22013 INSP. Locate and drill #17 holes as required.

5. Apply corrosion protection to the newly exposed edges of the cutouts and holes to prevent corrosion, per AC43.13-1B, Chapter 6, Section 3, "Corrosion Protection Measures for Basic Materials".

6. Inspect 415-22016 elevator control horn and the area where it attaches to the 415-22006 aluminum stiffener. Inspect both the forward and aft sides of the aluminum stiffener. See FAA Advisory Circular AC43.13-1B for guidelines concerning dissimilar metal corrosion.

7. If corrosion is found, repair and/or replace parts as necessary. Replacement parts are available for purchase from Univair.
8. When inspection is complete, install 294667 clipnuts and 415-22001-101 and 415-22001-103 plates over their respective openings and secure with MS35206-230 screws.
