ERCOUPE
SERVICE
MEMORANDUM

No. **31**

SUBJECT: Fuel System Operation

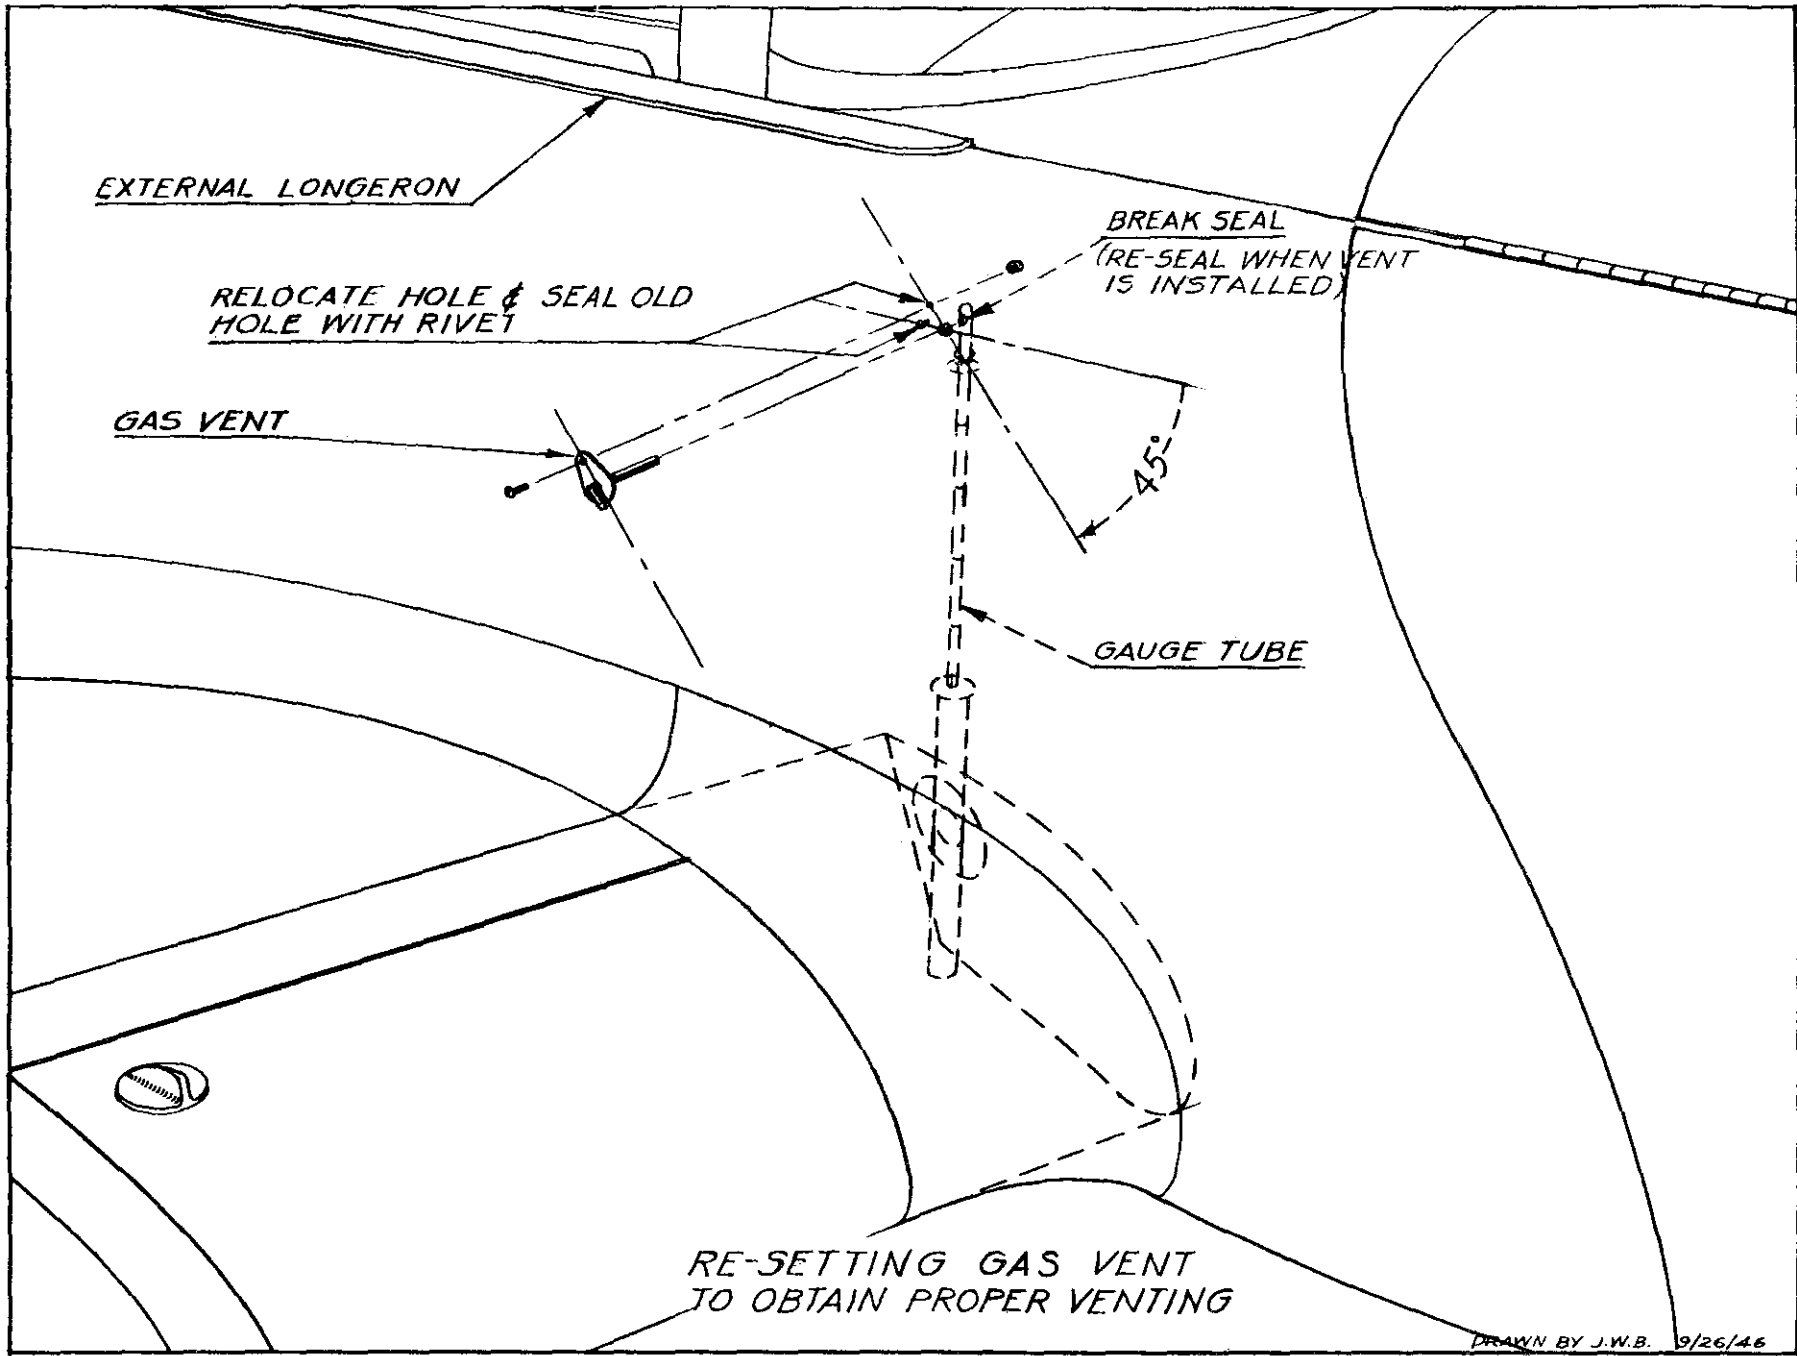
FIG. #1

it consists of a float type indicator, encased in a plastic tube. It is marked full, half full, and empty. This gage may give false readings due to improper venting, chiefly the error is reading half full in flight when more than half full of gas. This can be remedied on Ercoupes Serial Numbers 513 to 2623, by complying with the following procedure:

1. Remove 6 x 32 screw and nut which attaches vent to the right side of the fuselage.
2. Break the vent loose from the gage tube by turning the vent.
3. Realign the vent, by lowering the forward end, until it lies in a position from 40° to 45° with relation to the external longeron.
4. Drill a No. 28 hole through the fuselage skin, using the vent plate as a guide.
5. Insert the same 6 x 32 screw that was removed in operation No. 1.
6. Reseal vent to plastic gage tube by using clear nitrate dope, or any suitable cellulose cement. (See illustration No. 1.)
7. Close the original hole with a rivet.

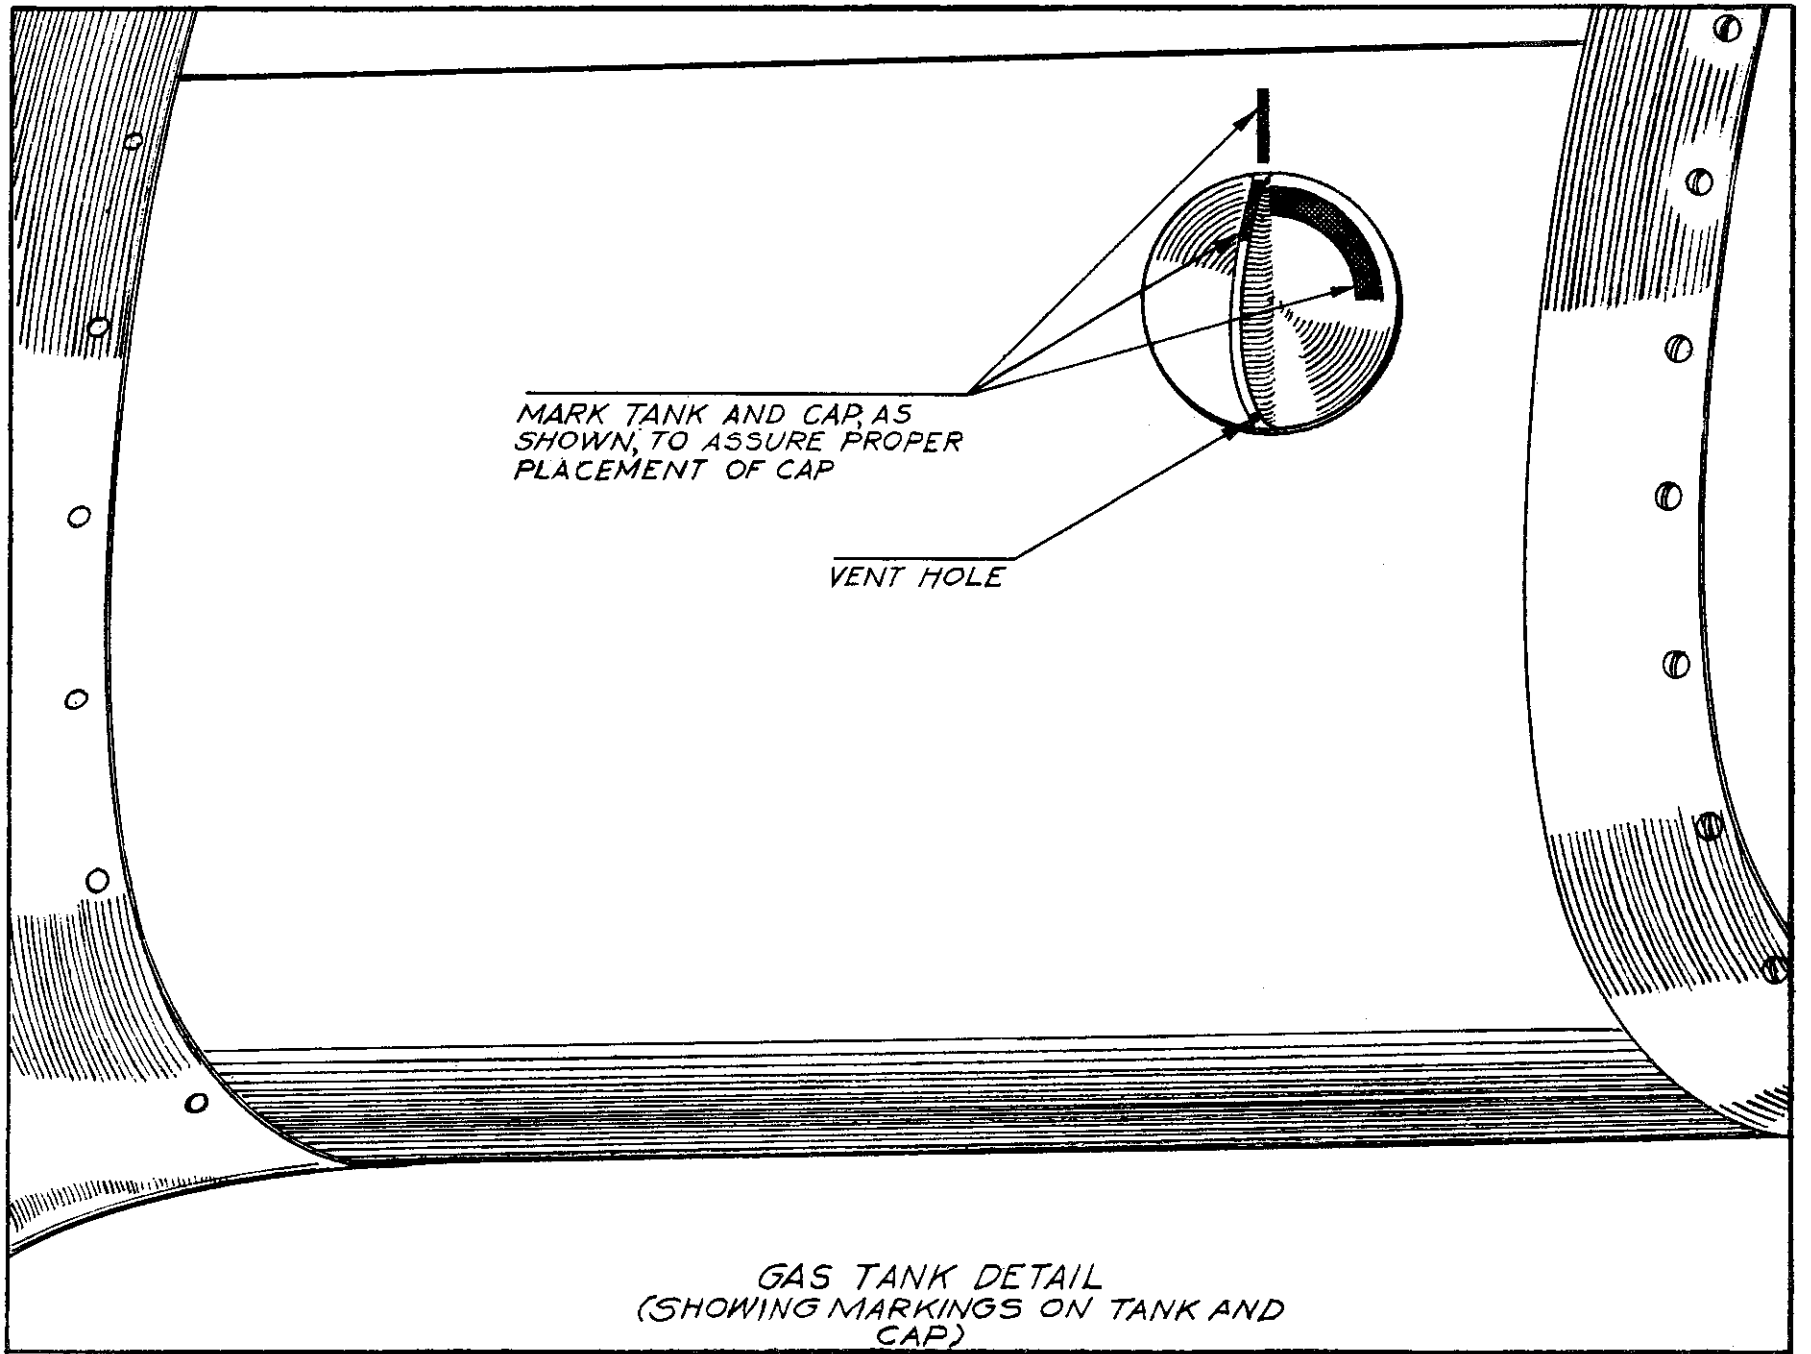
FIG. # 2

9. It has been the experience of some Ercoupe owners and operators that line mechanics put the wing tank caps on backwards. To prevent malfunctioning of the fuel system, it is imperative that the caps be put on the tanks with the vent hole to the front. This provides venting of each wing tank and will prevent syphoning or unequal flow of the fuel. Unequal flow may result in the fuel pump being unable to transfer all of the fuel from the wing tanks to the fuselage tank.

MARK TANK AND CAP, AS SHOWN, TO ASSURE PROPER PLACEMENT OF CAP

10. It is recommended that the wing tank cap be marked in a manner to indicate proper positioning. A painted red line on the wing behind the cap to match a painted sector on the cap should be used. The painted sector on the cap should extend from the point of engagement to the locked position, as indicated on accompanying sketch No. 2.
