SERVICE

NUMBER 42

BULLETIN

SUBJECT: Elevator Bungee Installation

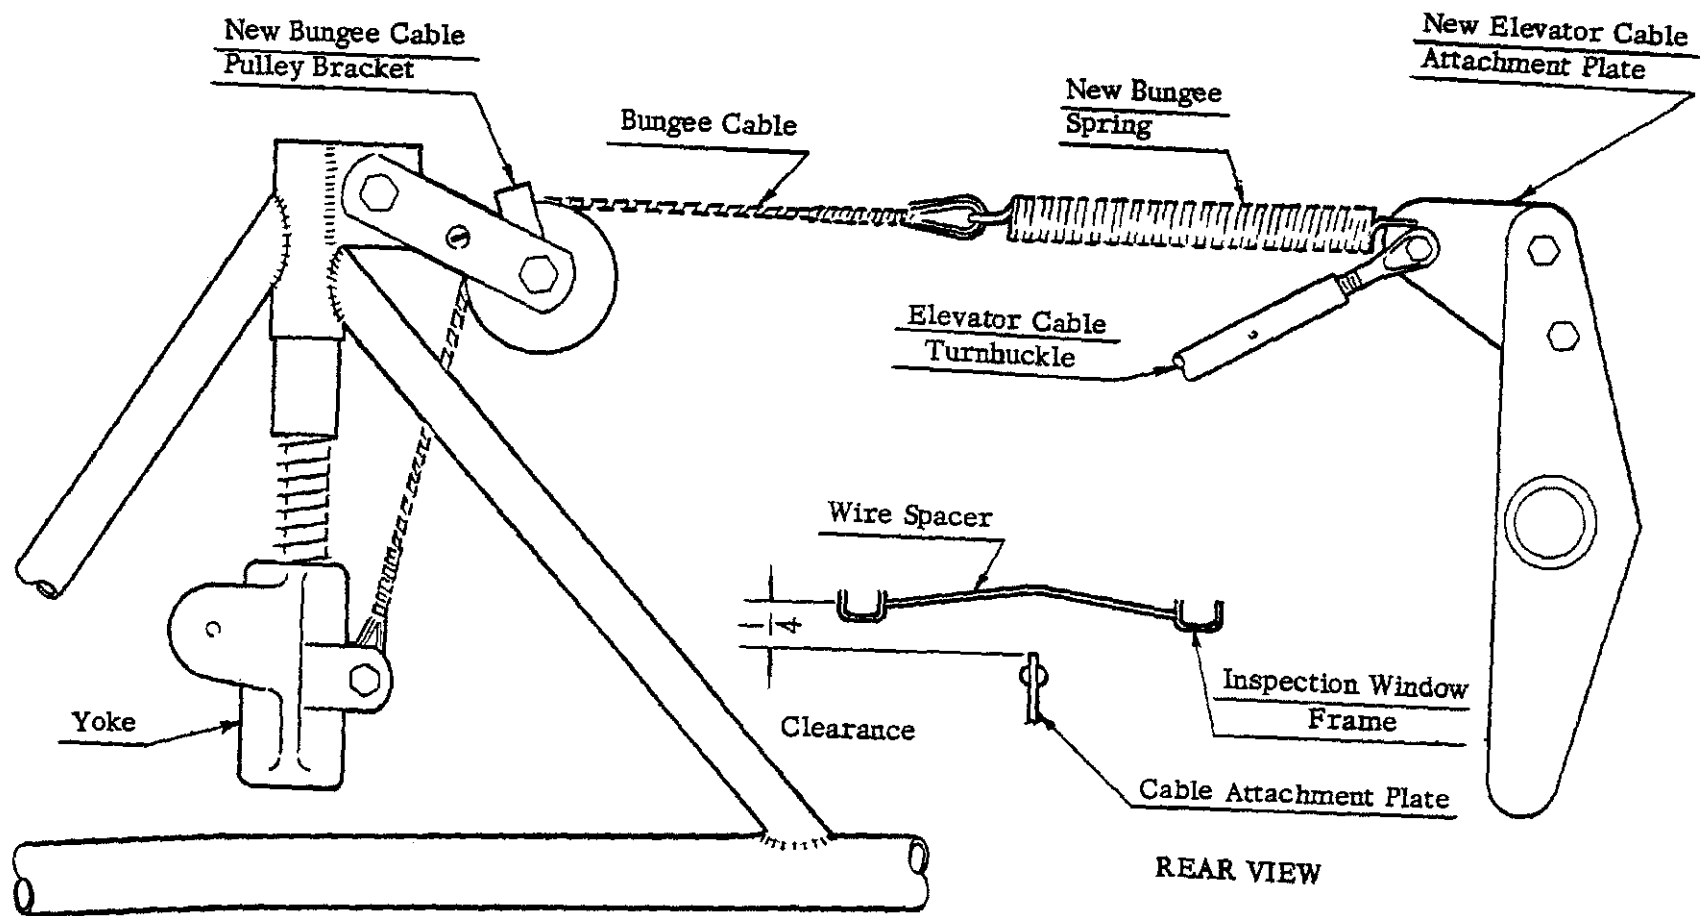
NEW BUNGEE INSTALLATION

2. From the accompanying sketch it will be noted that the revised installation is similar to the original one with the exception of the above mentioned parts and the fact that the spring now attaches directly to a small hole in the elevator cable attachment plate. The small plate, washer and No. 4 screw and nut, that were used to attach the original spring, may be discarded. In dis-assembling the installation, it will not be necessary to disconnect the forward end of the Bungee cable from the stabilizer yoke and in reassembling the installation, the new spring and elevator cable link should be attached to the Bungee cable, then the new pulley bracket and pulley should be installed. The elevator cable plate should then be bolted between the elevator horns and lastly the elevator cable turnbuckle attached to this plate, making certain the turnbuckle is free to swivel.

1. The Bungee cable pulley bracket, elevator cable to horn attachment plate and Bungee spring must be replaced by the parts accompanying this bulletin.

In the fuselage structure, directly above the elevator horn, there is a wire spacer between the inspection window channels. This should be bent up in the center, if necessary, to prevent interference with the enlarged cable attachment plate. A 1/4" clearance at this point, when the elevator horn is in the most critical position, is considered satisfactory.
