SERVICE

NUMBER 55

SUBJECT: Fuel Tank Vents

MODELS AFFECTED: J4E, Serial Nos. 4 1378, 4-1385 and up. J5, Serial Nos. 5-784 and up.

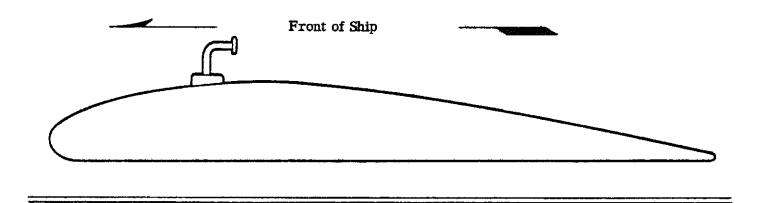
FIGURE 1 - Install Cap As Shown

It has been reported by a few owners of the above model airplanes that the engine will not operate properly with low fuel in the 7 gallon header tank.

This condition is attributed to the present wing tank filler cap vent creating a high negative pressure on the surface of the fuel with a resulting loss of effective fuel head.

Therefore, it will be necessary to exchange your present wing tank filler cap vent for a new cap of a different design which will eliminate this trouble.

- 1. This new type vent must always be installed so that the end with the disk faces to the rear of the airplane as shown on the attached sketch. (See Fig. 1).
- 2. At the time this cap is to be used on your airplane, the words "FACE VENT TO REAR" must be painted on the wing tank beside the tank filler neck. (See Fig. 2).
- 3. Upon installation of the new type filler cap, an appropriate entry should be made in the aircraft log book.
