SERVICE

NUMBER 72

SUBJECT: Rudder Pedal and Floorboard Attachment Lugs

MODELS AFFECTED: J3 and J5 Series

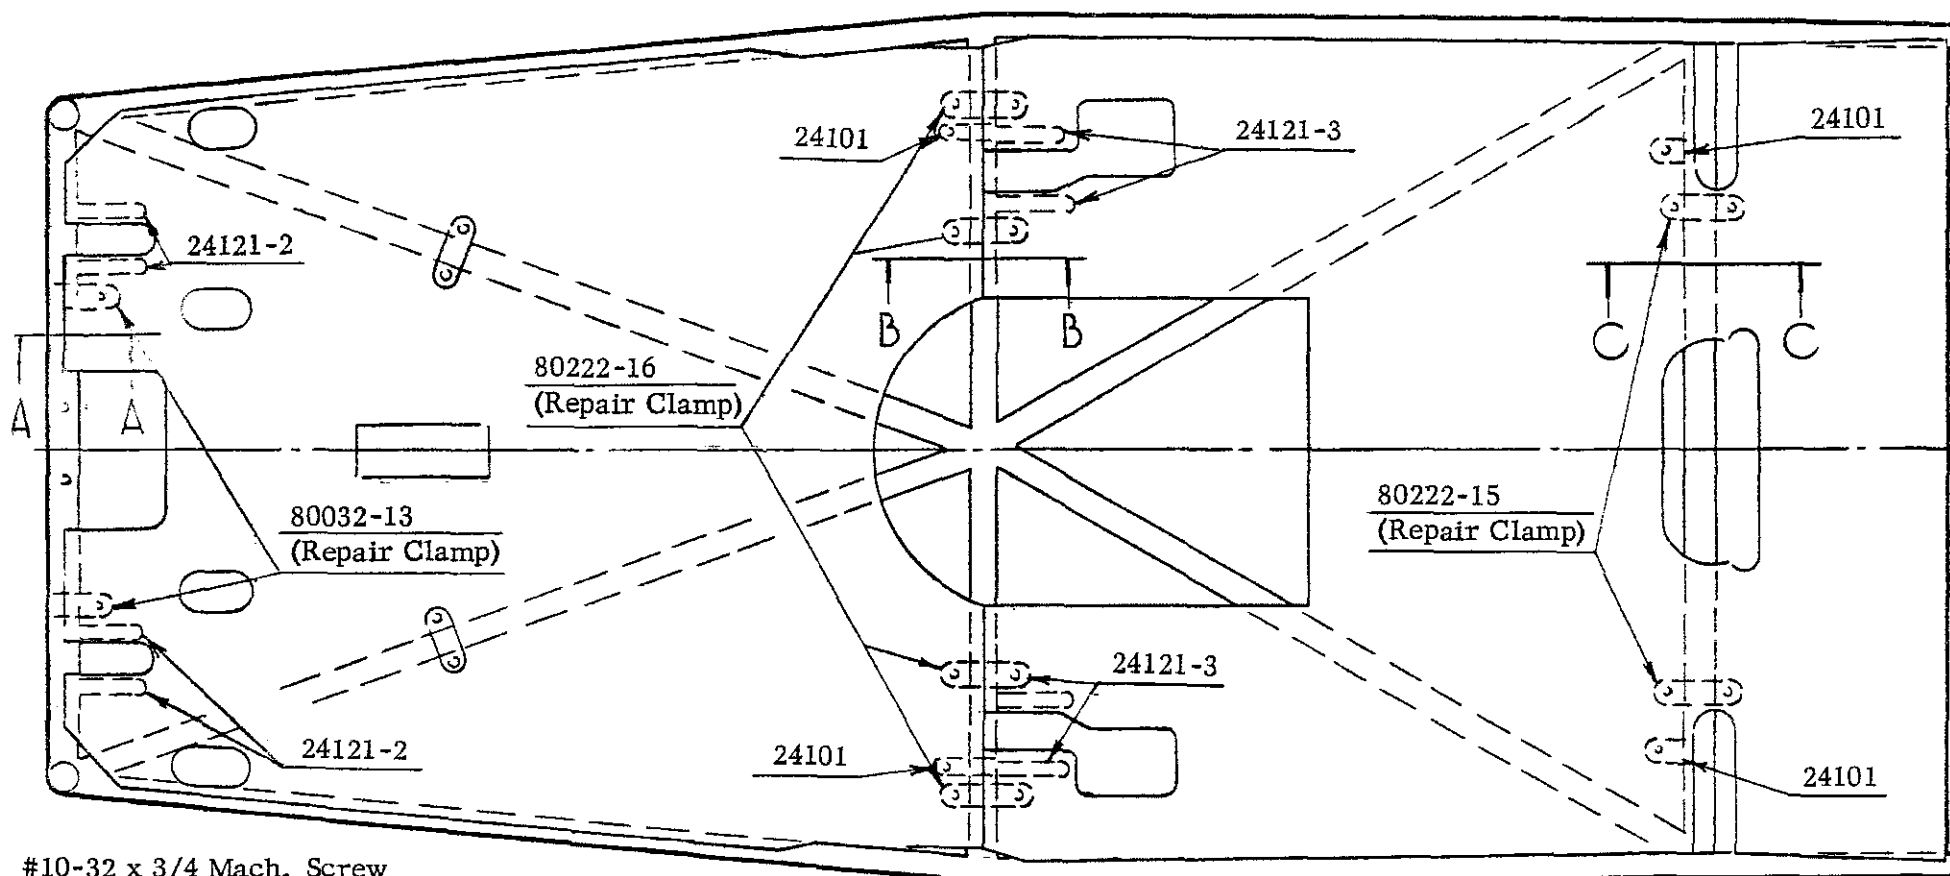
FLOORBOARD FITTING REPAIR

A number of reports have recently been received regarding failure of the floorboard and rudder pedal lug attachment to the tubular structure. This is apparently due to continued flexing of these parts during operation. As it may be possible to foul the controls as a result of such failures, we recommend that an immediate check be made to determine whether or not these fittings are intact on your airplane.

In the event that such failures are discovered, a temporary repair may be effected by attaching the floorboard with a clamp fastened about the tubular structure immediately adjacent to the failed part. (See attached sketches.) SAE No. 1025 steel strip .045" thick by 3/4" wide is recommended for such clamps. The original fittings should then be re-welded or replaced when convenient; in which case the repair clamps may be reinstalled for additional strength.
