SUBJECT: Tailskid Spring Attachment Reinforcement

MODELS AFFECTED: E2 and J2

PIPER AIRCRAFT CORPORATION, LOCK HAVEN, PA., U. S. A.

SERVICE BULLETIN NO. 83

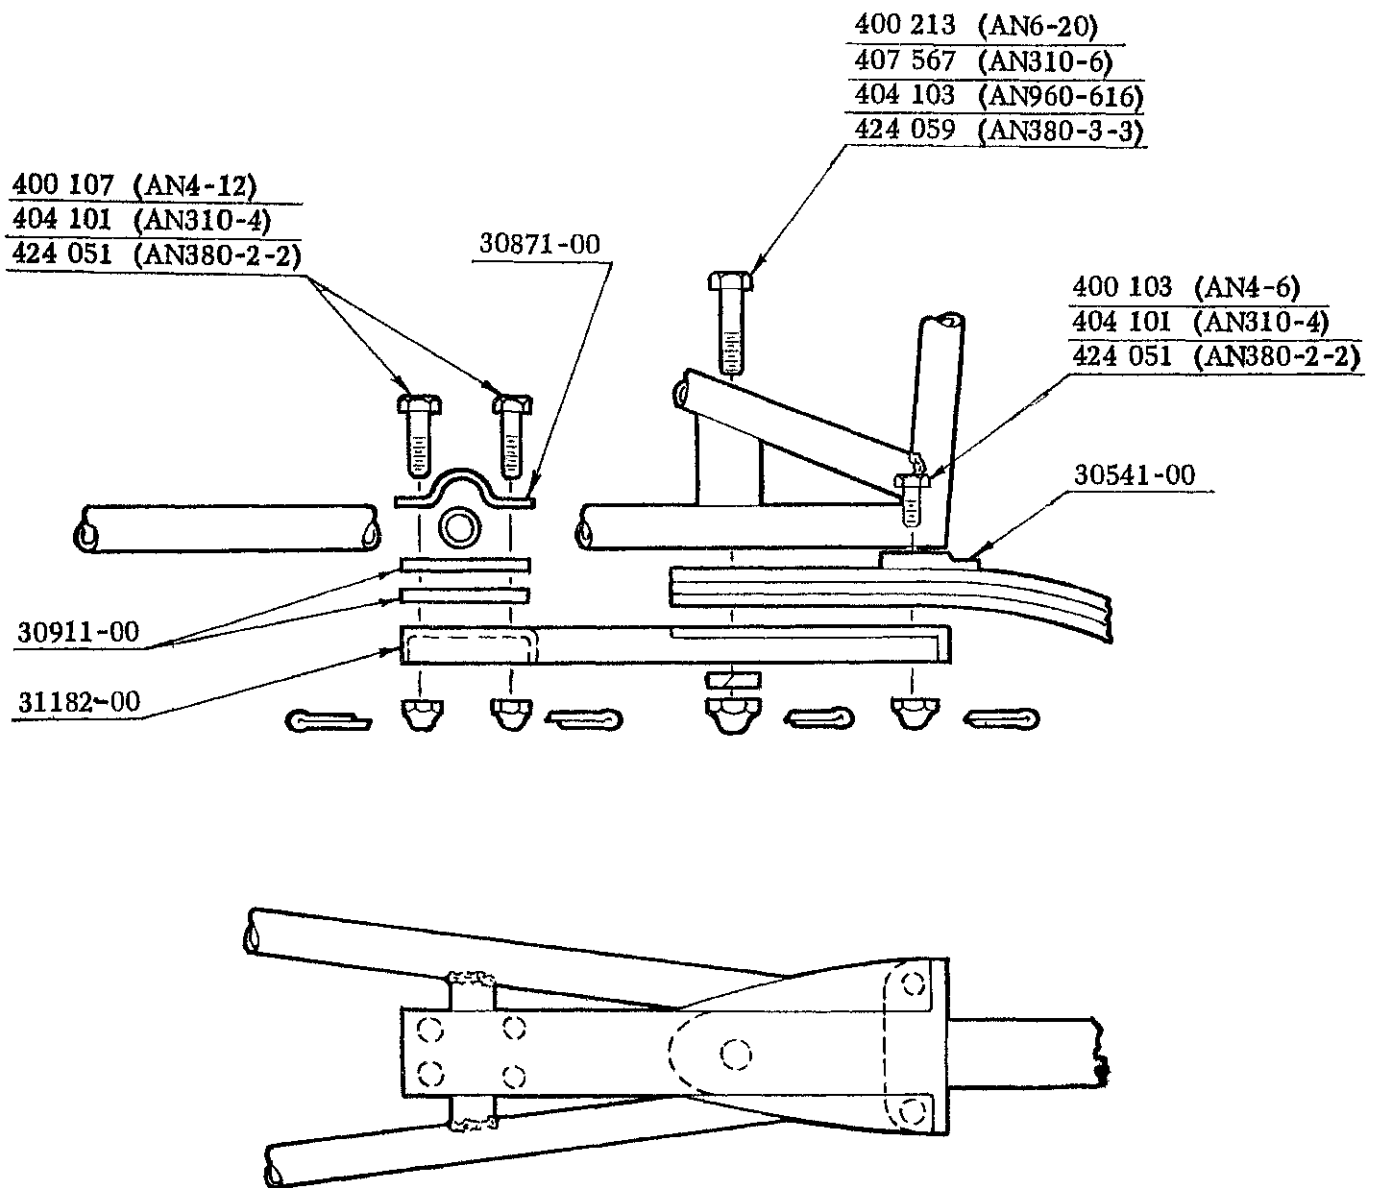
We have received a number of reports of failure of the tailspring attachment on the subject model airplanes, and at the suggestion of the Civil Aeronautics Administration, we have developed a reinforcing unit, part numbers 30882 and 30871, which may be bolted to the tailspring and fuselage structure. (See Sketch).

If your airplane is subject to hard landings, incident to student training, or if you are operating from a rough field, we recommend that this reinforcement be installed to prevent any possible failure of the tailspring attachment.

These parts may be obtained through your local dealer or distributor and, when installed, should be covered by an appropriate entry in the aircraft log book.
