SERVICE No. 174B BULLETIN

Piper Aircraft Corporation

Service Bulletin No. 174B (Supersedes S. B. #174A)

SUBJECT: Inspection and Maintenance of Fuselage Fabric in Area of Windshield Top Attachment Channel

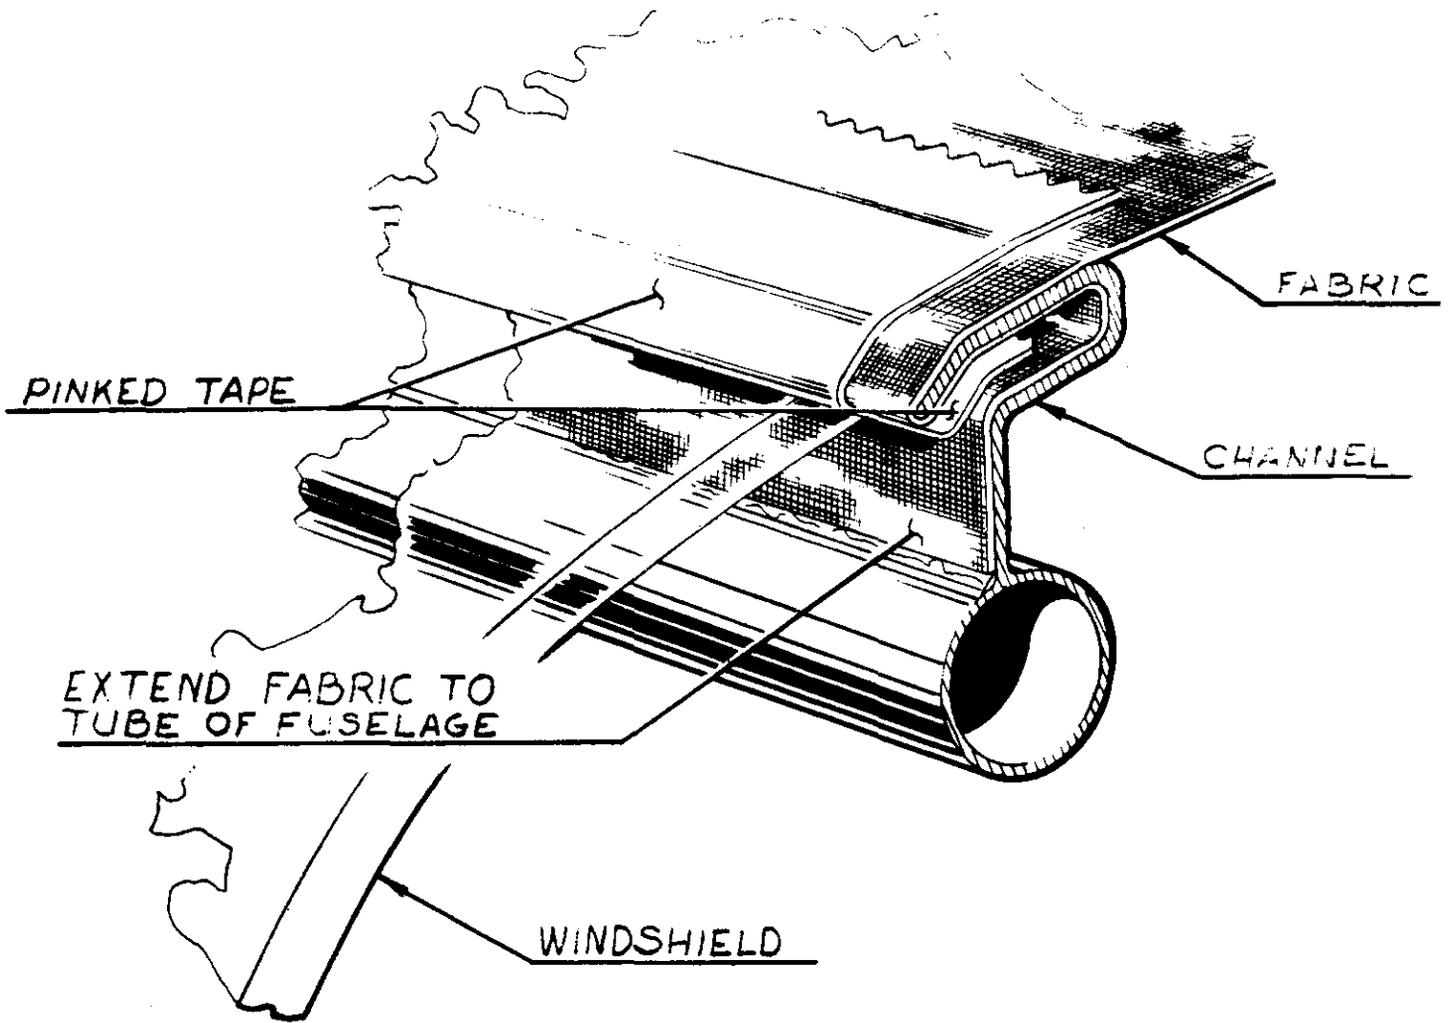
Service experience indicates that, in a few cases, the above mentioned airplanes have had difficulties with the fabric where it attaches to the fuselage under the windshield top and/or directly over the rear edge of the windshield top attachment channel.

During the service life of these airplanes it has been brought to our attention that, during the recovering operation, the fabric at the windshield channel was attached in a very careless manner, resulting in an unsafe condition.

All the above mentioned airplanes shall be carefully inspected at this point and any sign of deterioration of the fabric shall require that a strip of 2-1/2 inch pinked reinforcement tape be added per sketch shown on the reverse side of this bulletin.
