VENDOR SERVICE PUBLICATION

SUBJECT: Oil Pump Impeller and Drive Replacement; AVCO Lycoming Service Bulletin No. 385C dated October 3, 1975 (attached).

Service Bulletin No. 385C
(Supersedes Service Bulletin No. 385B)
Engineering Aspects are
FAA (DEER) Approved

SUBJECT: Oil Pump Impeller and Drive Replacement

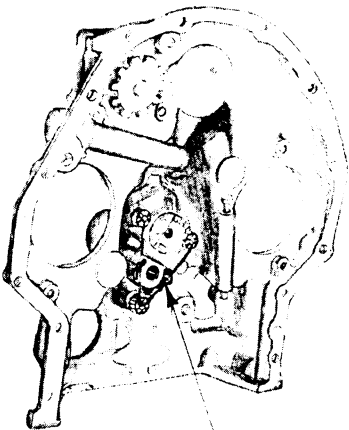
Figure 1. Interior View of Accessory Housing Showing Location of Cotter Pin in Oil Pump Idler Shaft

INSPECTION: Applicable remanufactured engines shipped after December 21, 1972 should be inspected to determine if this modification is required: first of all, if the engine log book indicates the engine has not been modified in accordance with Service Instruction No. 1230 or No. 1272, proceed to remove the accessory drive cover from the mounting pad at the lower right side of the accessory housing to obtain access to the area between the crankcase and the accessory housing. On some engines this accessory drive pad is not machined, in this event it will be necessary to remove either the left magneto or the *fuel pump to obtain access to the area between the crankcase and the accessory housing. Regardless of which accessory pad is used, determine if the oil pump idler gear is secured with a cotter pin at the location shown in figure 1. This can be accomplished using an inspection mirror, preferably an illuminated one. If the cotter pin is visible, it is unnecessary to perform the modification required by this bulletin.

IF IDLER SHAFT IS SECURED WITH A COTTER PIN AT THIS LOCATION MODIFICATION IS NOT REQUIRED

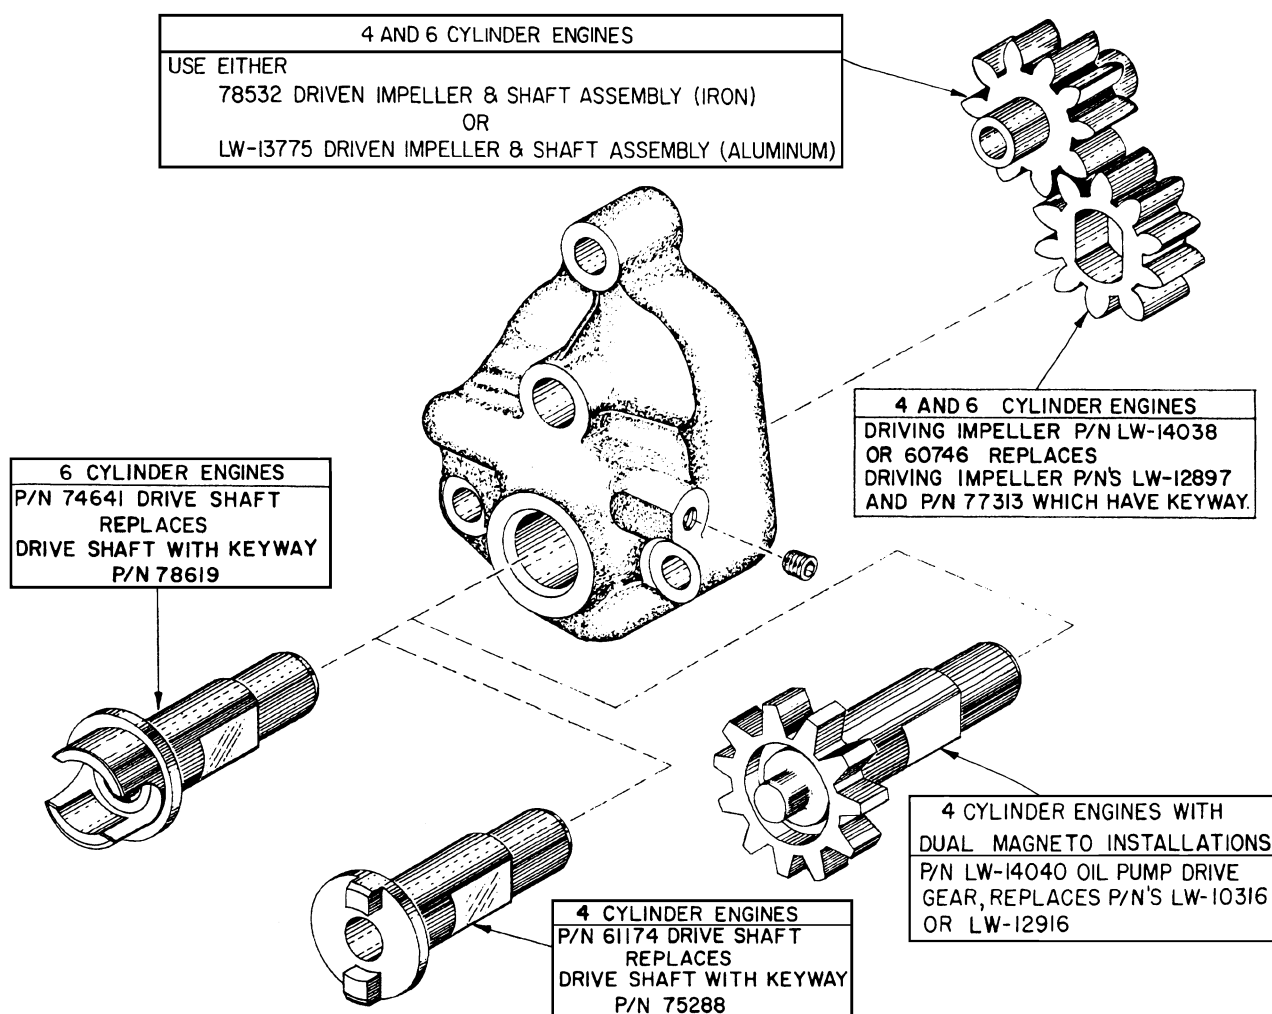
Figure 2. Oil Pump Drive Assembly

This modification consists of replacing the oil pump drive shaft and drive impeller to eliminate the Woodruff key drive which has proven to be the cause of excessive wear in the keyway of the hardened drive impeller. Therefore, it is recommended that all of the applicable engines listed in the chart, as well as any others that may have been modified in accordance with Service Instruction No. 1272, use the following procedure for parts replacement.

3. Reassemble the oil pump using the new drive shaft and drive impeller supplied with the kits shown in the following "Parts Data" section. See figure 2. Be sure all of the parts are lubricated thoroughly during assembly.
