Model: 415-C, 415-D, E, G and F-1**Serials:** 1 through 5714 inclusive**Subject:** Rudder Bellcrank Seizures

Alon Service Bulletin
February 3, 1967
Page Two

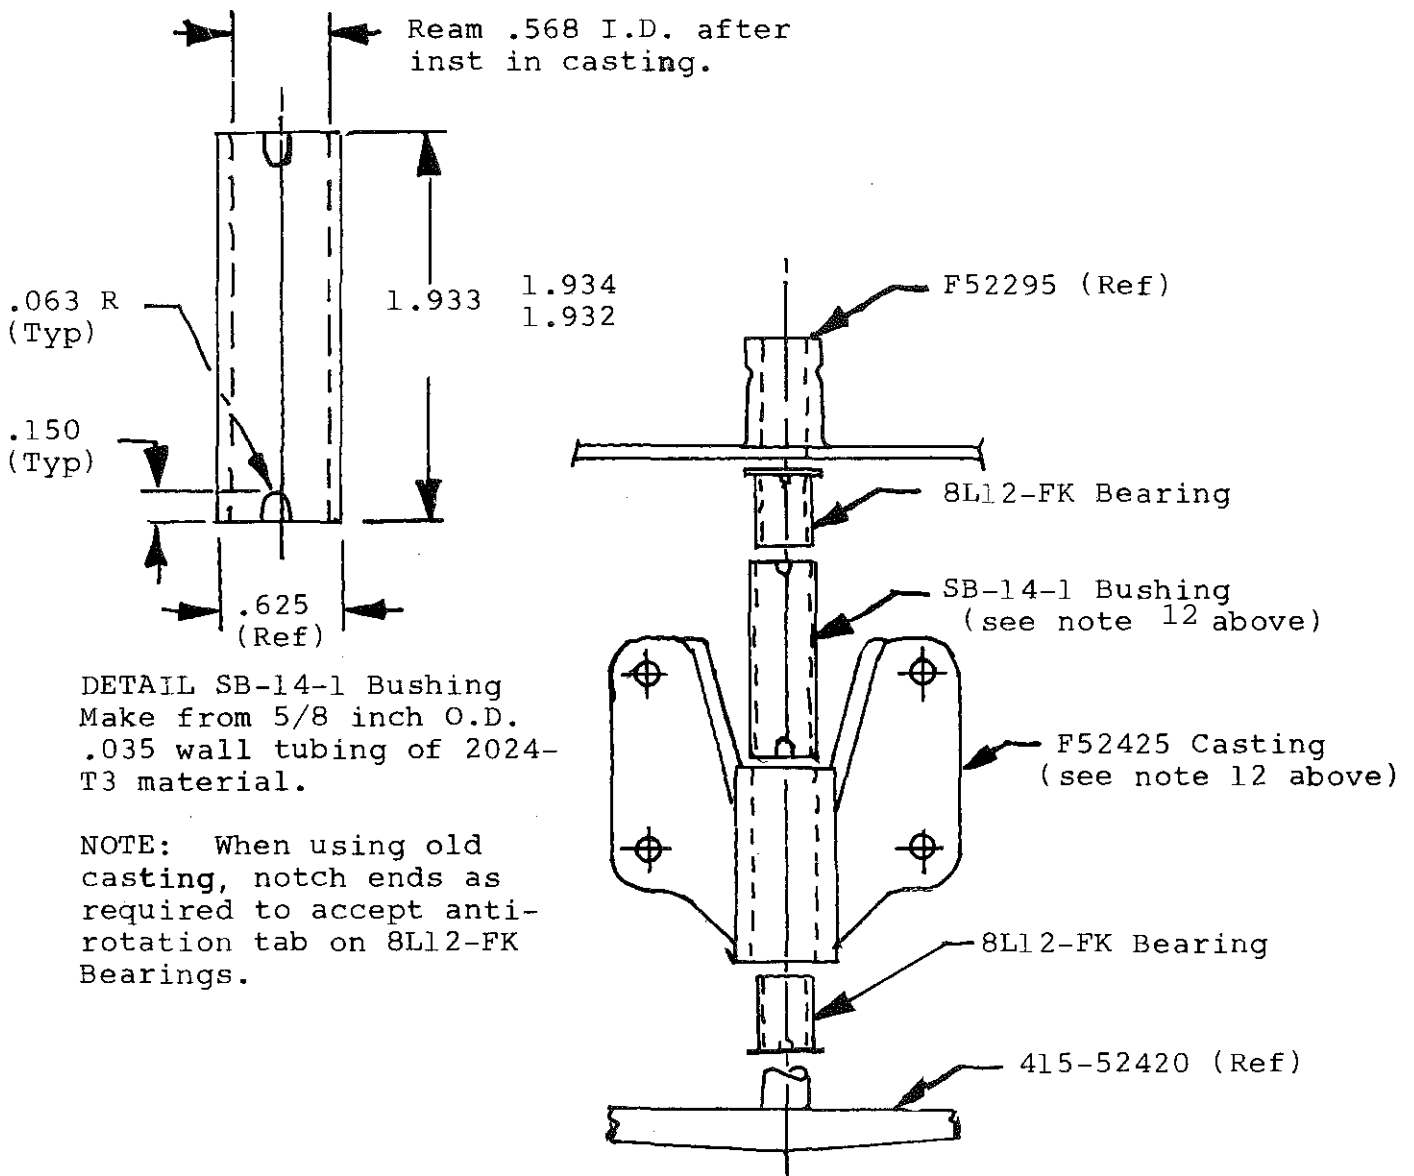
The purpose of this bulletin is to eliminate the possibilities of a rudder bellcrank seizure caused by the bakelite bushing that has expanded due to moisture within the bushing.

The above may be accomplished by replacing the bakelite bushing with the nylon bearings and by either installing the SB-14-1 bushing in the existing bellcrank casting or by replacement of the existing bellcrank casting with a new part which will eliminate the requirement for the SB-14-1 bushing.

11. Dismantle the bellcrank assembly and re-assemble using:
 - (a) the new nylon bearings with a new bellcrank casting, or
 - (b) the new nylon bearings with the SB-14-1 bushing and the existing bellcrank casting.

12. Having re-assembled the bellcrank, install it in the reverse order of the preceding instructions. When re-rigging, cable tension to be 60 to 70 inch-pounds by tensiometer.
