ERCOUPE  
SERVICE  
BULLETIN

No. **31**  
**Revision 1**

**SUBJECT: Wing Center Section Inspection**

June 14, 2002

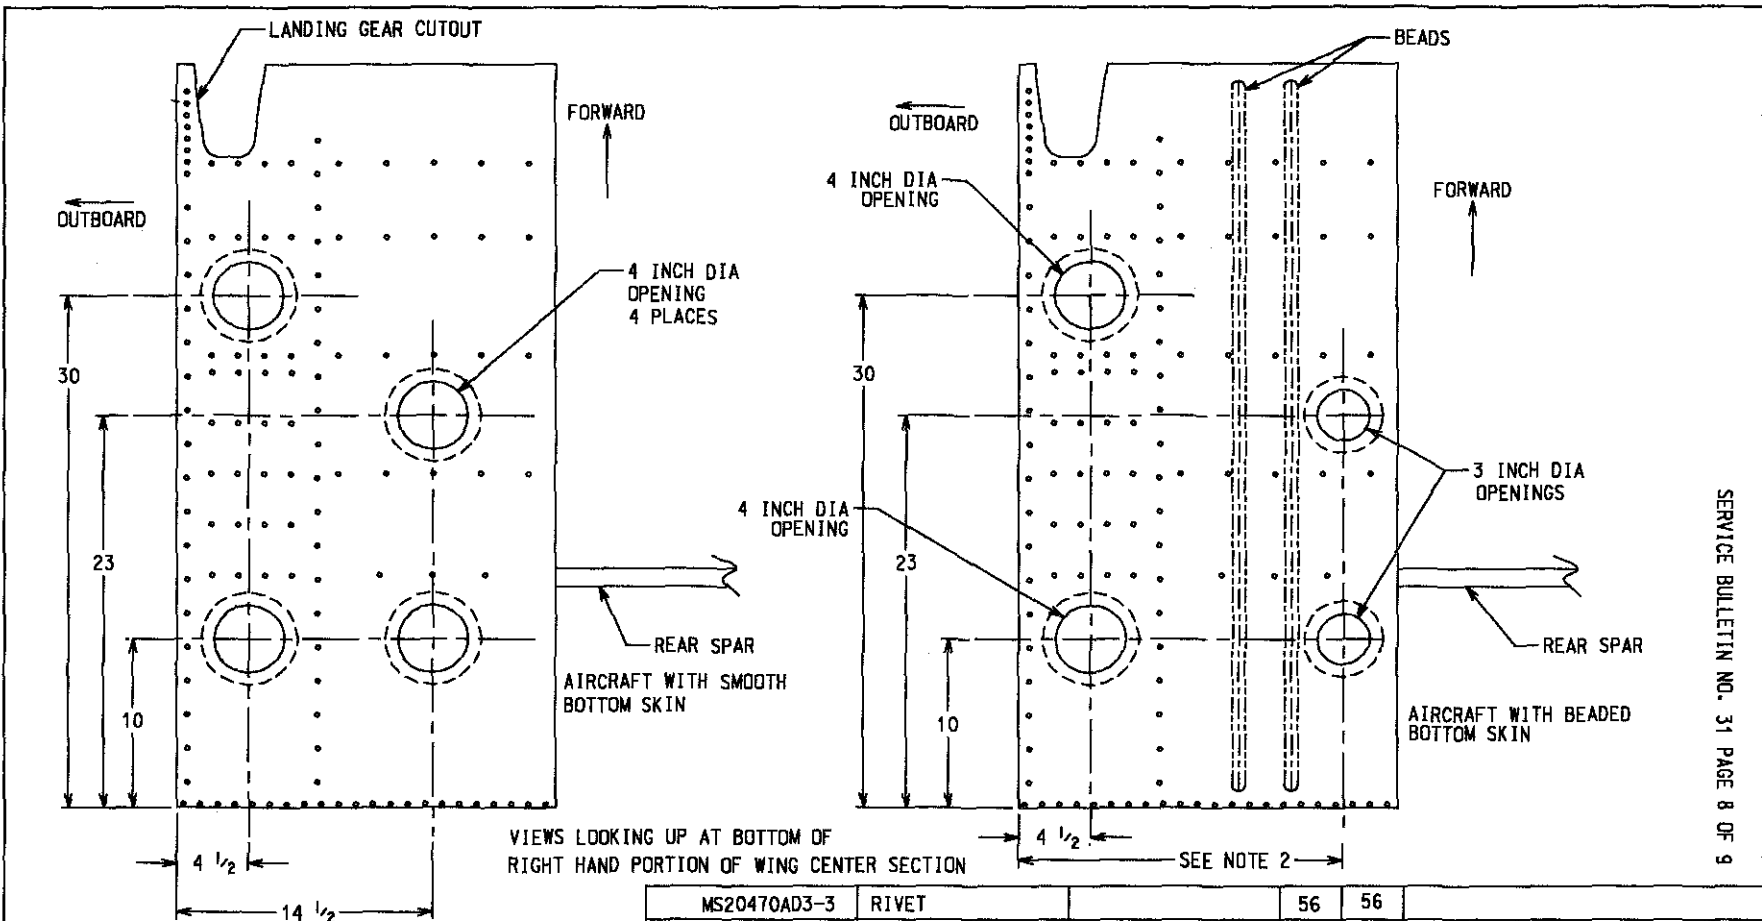
VIEWS LOOKING UP AT BOTTOM OF  
RIGHT HAND PORTION OF WING CENTER SECTION

For Method 1: Locate eight inspection openings on the lower wing surface per the enclosed drawing, SB-31, Sheet 1, Revision None, dated 01-29-02. For aircraft with smooth bottom skins, all openings should be 4 inches in diameter. For aircraft with beaded bottom skins, four of the openings should be 4 inches in diameter and four of the openings should be 3 inches in diameter as shown on drawing SB-31.

**CAUTION:** If the opening locations specified by the diagram interfere with any skin stiffeners, alter the opening location to clear the stiffener. Be sure also to provide clearance for installation of reinforcement rings to be installed in Step 11.

Cut inspection openings at the locations noted above and deburr.
