# UNIVAIR AIRCRAFT CORPORATION

ERCOUPE  
SERVICE  
BULLETIN  
No. 32

**SUBJECT:** Mandatory Wing Center Section  
Inspection

## MANDATORY SERVICE BULLETIN NO. 32 WING CENTER SECTION INSPECTION

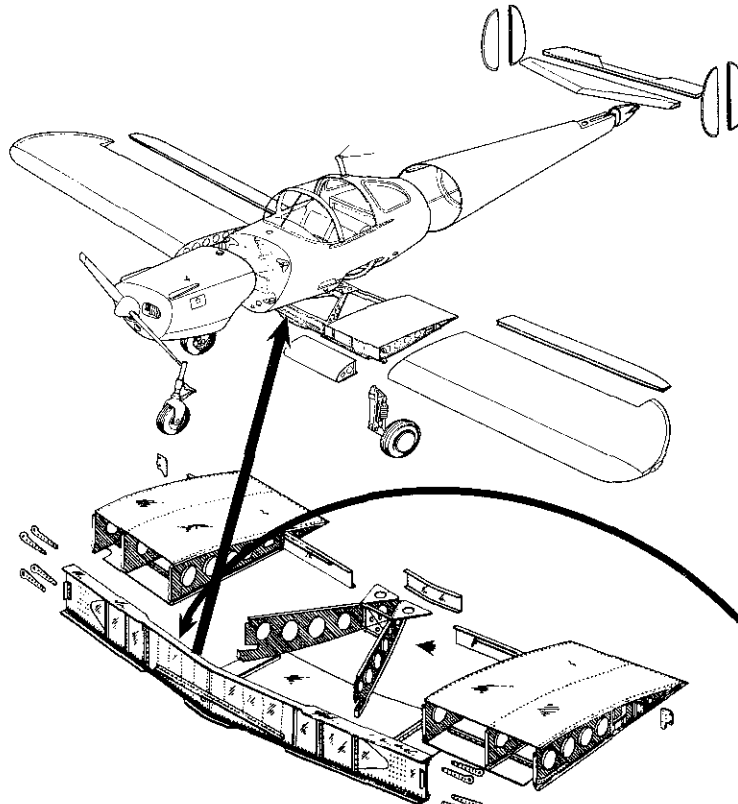
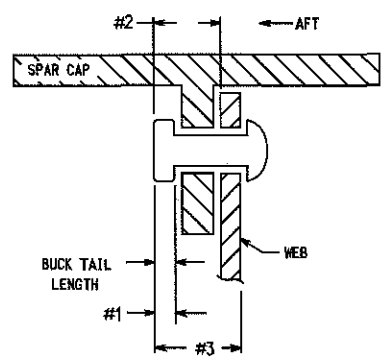
EXAMPLE FOR AREA "A"  
TABLE 1: CRITICAL FASTENER DIMENSIONS

- 3.1 The critical area of inspection for each fastener is where the fastener shank meets the bucked tail, where the fastener shank meets the head of the fastener and the shear plane between the spar web and the spar cap. These dimensions can be found in Table 1.

- 3.2 The inspection shall be performed from the bucked (flat) end of the fastener accessed from the aft side of the forward main spar web.
- 3.2.1 With the transducer diameter (.250") being larger than the fastener shank on the 5/32" (.156") fasteners, there will be an indication at .080" from the flattened sides of the bucked fastener. These indications are normal, but should be observed for consistency.

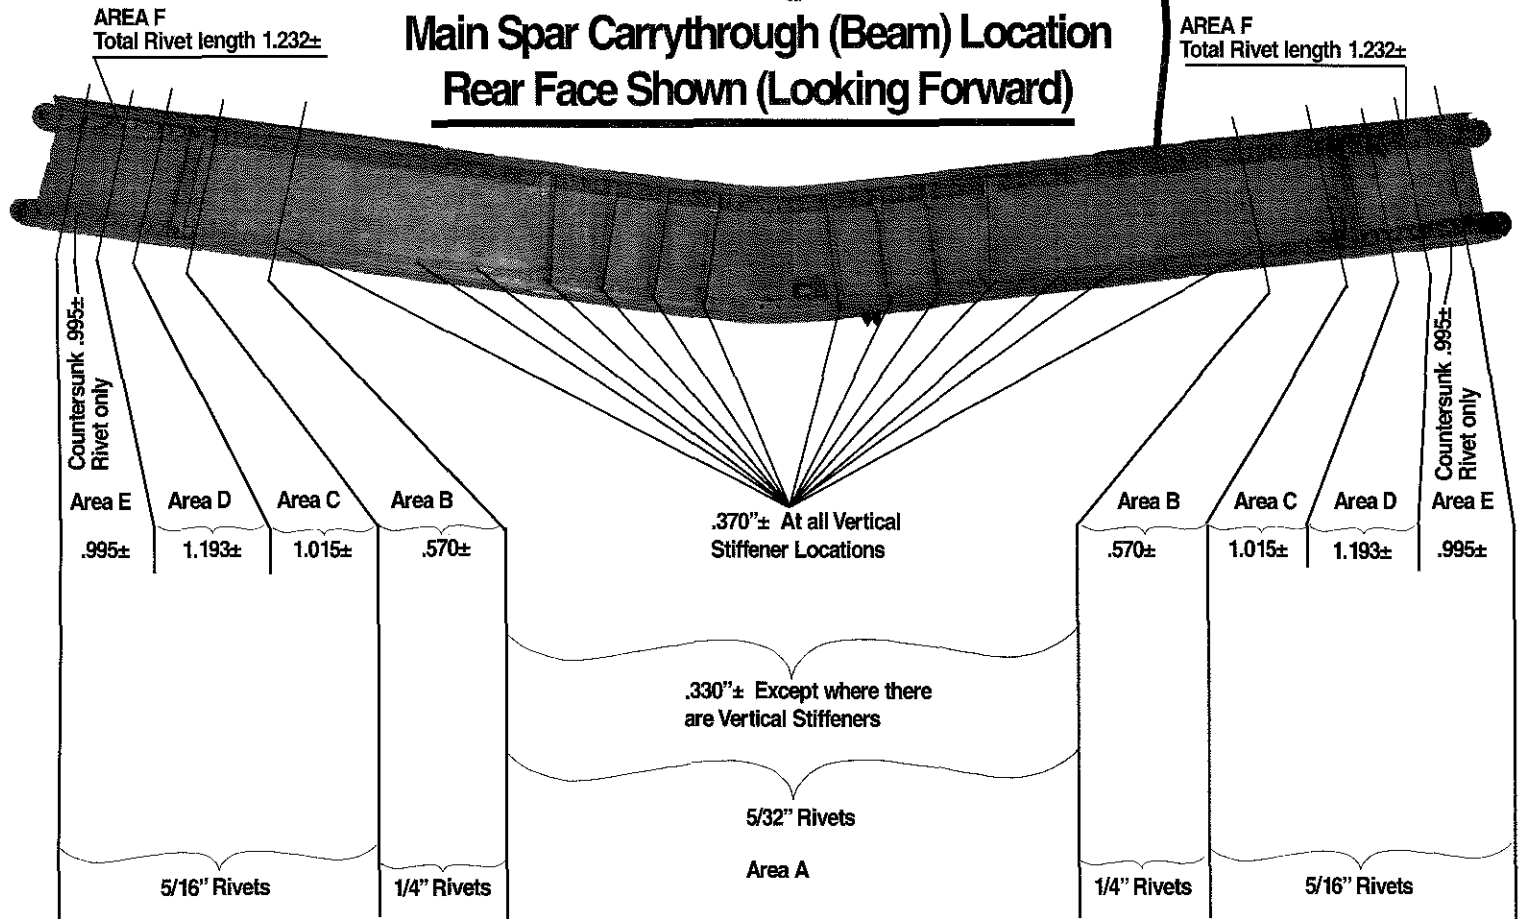
## Main Spar Carrythrough (Beam) Location Rear Face Shown (Looking Forward)

**SUBJECT:** Mandatory ultrasonic examination of all the upper and lower spar cap 5/32-inch, 1/4-inch and 5/16-inch fasteners (rivets) in the Main Spar Center Section carry through structure. See Figure 1.

Based upon inspections in accordance with Service Bulletin 31, there have been reports of light to severe corrosion and/or damage, (broken rivets attaching center section shear web to the upper and lower spar caps), in the wing center section structures of several aircraft. If corrosion has been detected anywhere in the wing center section additional hidden corrosion may be present in the main center section spar cap rivets. This corrosion cannot be seen by the visual inspection methods outlined in Service Bulletin 31. If the aircraft has experienced hard landings the main spar rivets may be damaged. Internal corrosion or internal damage of the rivets in the spar caps, if severe enough, could lead to structural failure of the wing center section, which could result in loss of control of the airplane. Consequently, this Service Bulletin provides for the ultrasonic inspection of the wing front spar carry through beam assembly rivets to establish the airworthiness of the center section structure.

Carefully drill out each rivet that shows signs of corrosion or damage, **NOTE:** *Caution following this section.* Inspect the holes where the rivets have been drilled out. If there are no signs of corrosion or damage in the holes, the rivets may be replaced with the same size and type of rivets after corrosion prevention measures are taken (see instructions below). If there are signs of corrosion or damage in the holes, carefully inspect the holes to determine if the corrosion or damage extends to the interfaces between the spar caps, spacers, and web.
