SERVICE BULLETIN

No. 109

Date February 4, 1960

Subject: Addition Of Drain Holes, Concerning All Ercoupes, Aircoupes, and Fornaires Up To Serial #5714

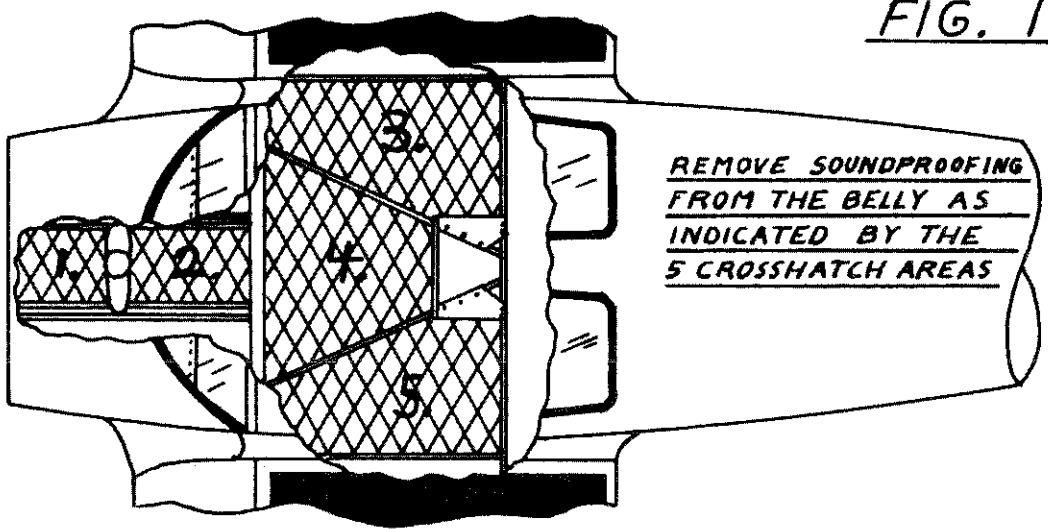
FIG. 1.

It has been noticed that water can collect in the forward belly regions of the airplane, and that there is no provision for expelling the water to the outside. The trapped water (if acidic) can cause decay and corrosion to the belly structure. Trapped gasoline is another dangerous possibility. Tests have been made to find drain hole locations which will completely drain the problem area for all normal parking attitudes.

1. Forney modification kit (FMK) #27 is available which consists of four (4) clam shell cover plates to be used in conjunction with the added drain holes.
2. The procedure for modification is as follows:
 - a. Remove the forward floor board from the airplane.
 - b. Remove the seat cushion and unscrew the seat bucket from the front beam (two screws in the center top) and two screws attaching the bucket bottom to the diagonal ribs of the center section. The bucket can now be lifted up, rotating on the rearward hinge.
 - c. Remove (if present) all soundproofing in the lowest belly regions as shown in Fig. 1.

Note: Tests have been conducted and the result of increase noise upon removal of soundproofing in these areas is negligible. Therefore, do not replace the soundproofing. This will enable unobstructed drainage and prevent water from being held by absorption into the soundproofing.
