BULLETIN

NUMBER 9

SUBJECT: Tail Surface Bracing

MODELS AFFECTED: E2, F2 and J2 "Cubs" up to Serial No. 1500

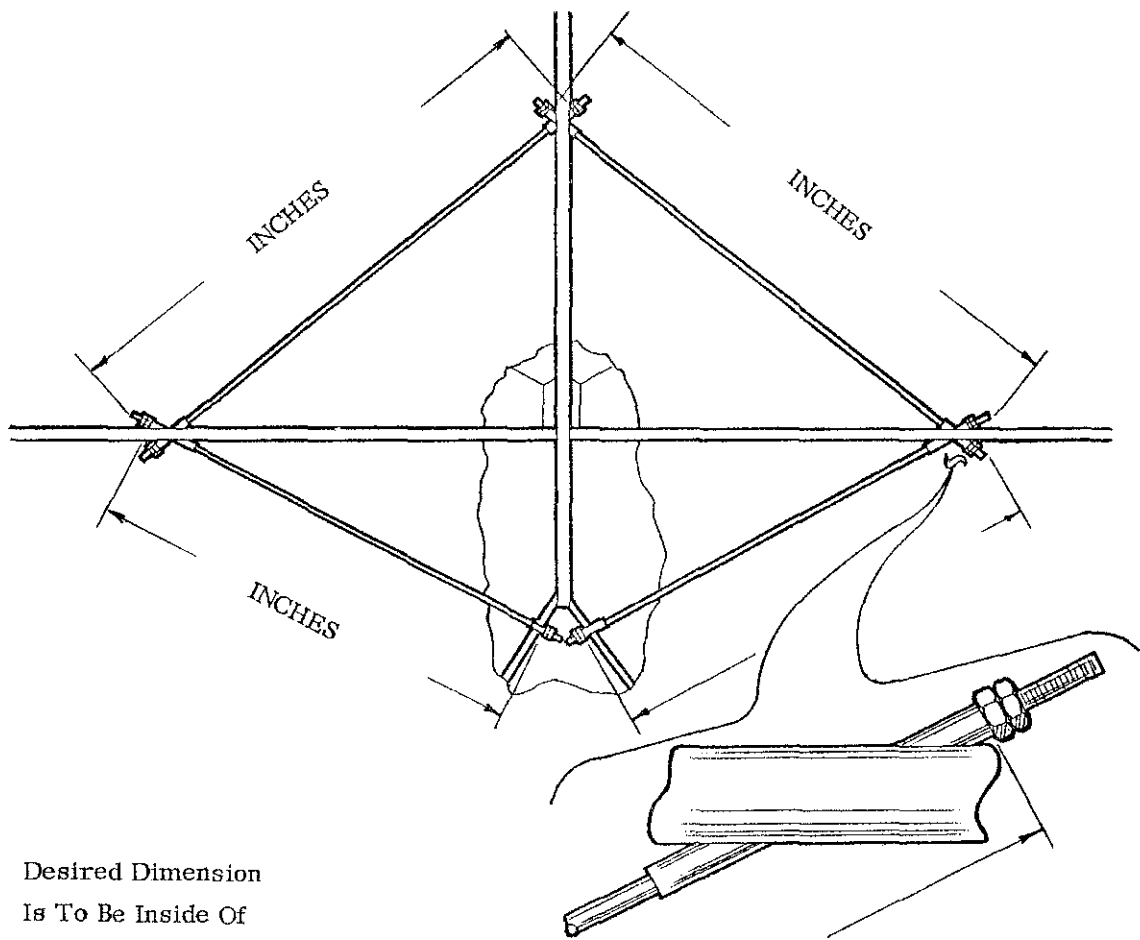
SERVICE BULLETIN NO. 9

Note: Desired Dimension
Is To Be Inside Of
First Nut As Shown At
Right

"Cubs" of Serial No. 1500 and up have this same size wire, but the end fittings are of a different design, making the bracing system more flexible and better able to absorb vibration. In order to accomplish the same purpose where the older type of fitting has been used, which carries the wires clear through the fin and stabilizer spars in bushing tubes, it will be necessary to replace the solid tie rods with a standard cable.

To facilitate this replacement in the field, fittings for the stranded cable are being made up at the factory such that the new flexible wires may be readily installed in the same fittings as used for the solid wires.
