SERVICE

NUMBER 18

SUBJECT: Replacement Tail Brace Wire Nipples

MODELS AFFECTED: J2 Cubs, Serial Nos. 1500 to 1999 and
J3 Cubs, Serial Nos. 2000 to 2609

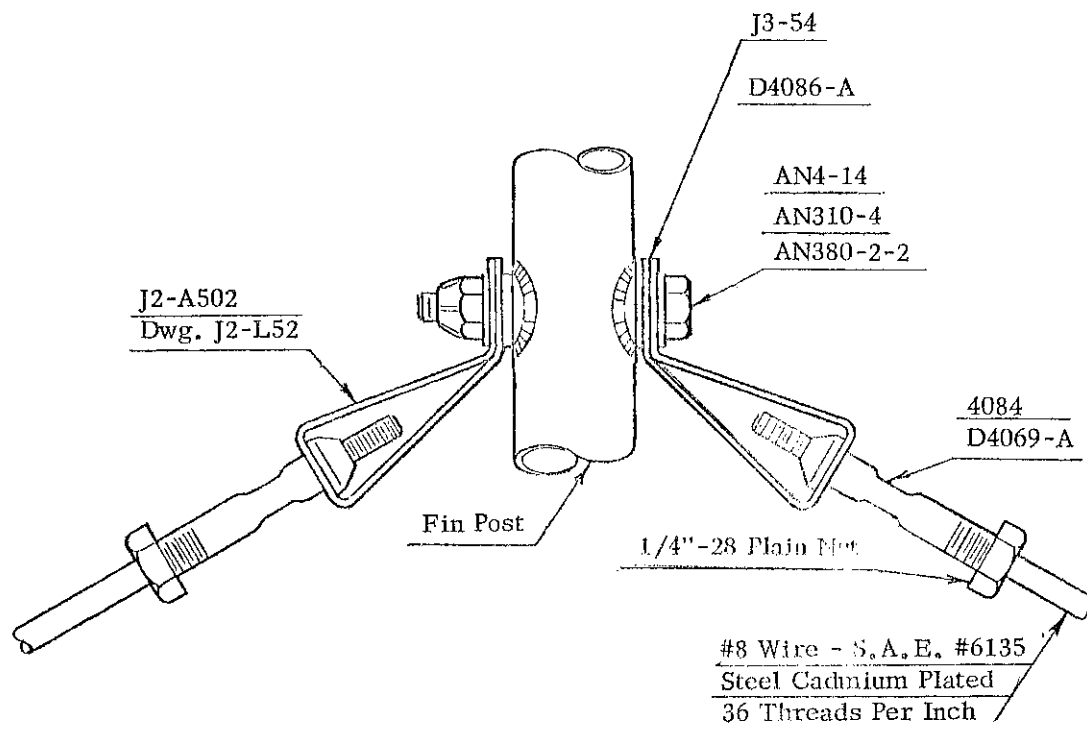
FIN TIE ATTACHMENT

A considerable number of fatigue failures of the tail brace wires at the threaded section have been reported to this office. These failures have in most instances been caused either by ground handling or vibration.

This new nipple is long enough to completely cover the threaded section of the wire and has a lock nut on one end which clamps the body of the nipple to the solid section of the wire.

In order to afford a greater margin of safety in the operation of our Cubs, we have designed a new type of tail brace wire nipple which we are recommending that you install at once, in order to avoid a similar failure in your installation.
