SERVICE

NUMBER 35

SUBJECT: Reinforcement of Windshield Attachment

MODELS AFFECTED: J3 Cubs, Serial Nos. 1999 to 6270 inclusive

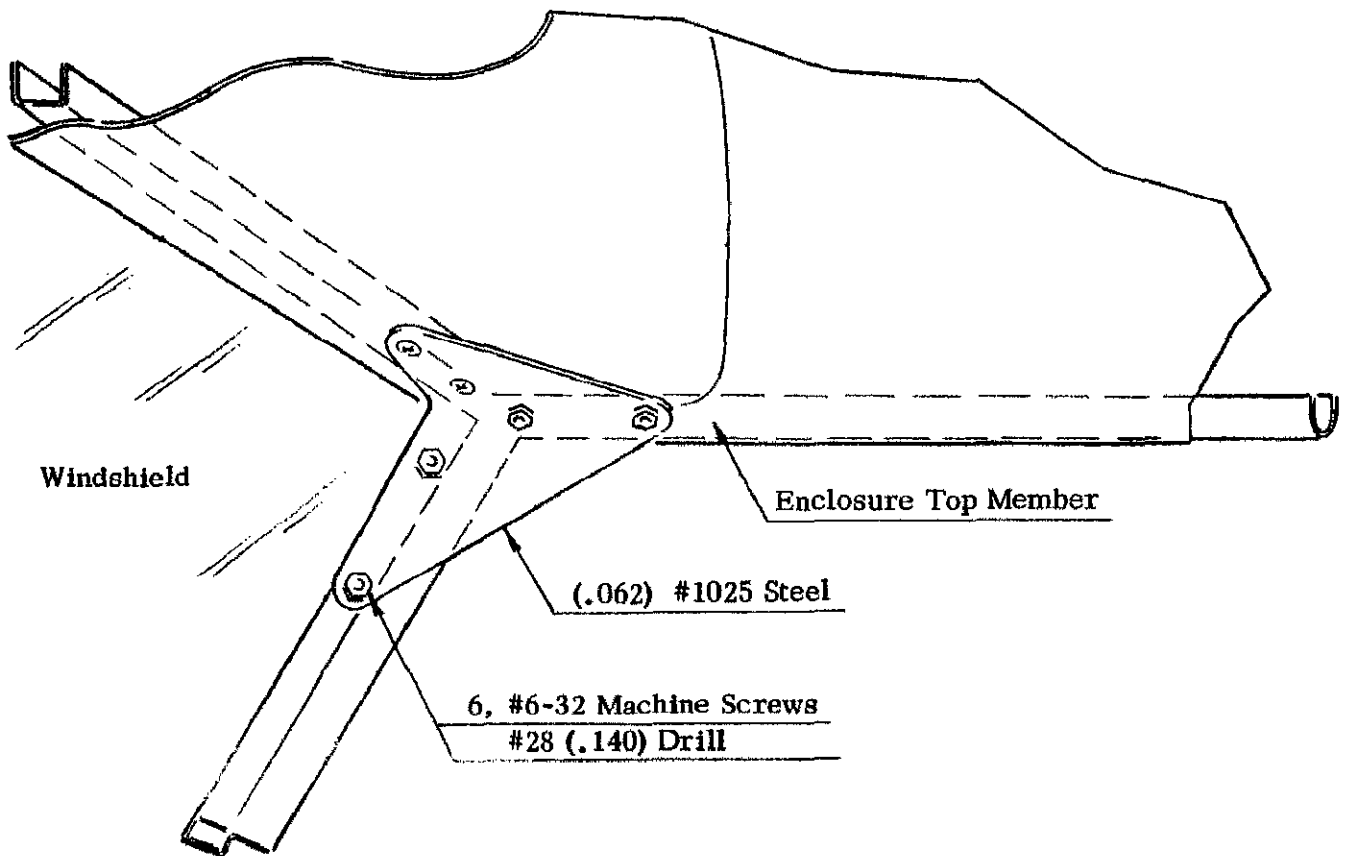
ENCLOSURE FRAME REINFORCEMENT

It has come to our attention that a number of cases of breakage have occurred in the welded joint at the intersection of the steel channels, to which the right rear edge of the windshield attaches, and the steel channel to which the hinges of the upper section of the cockpit enclosure attach. This junction is at the point where the upper edge of the windshield meets the lower surface of the wing.

These failures are due to buffetting of the enclosure during maneuvers and may also result from flying with the upper enclosure section opened against the lower surface of the wing.

While this failure will not necessarily result in an accident as the channels are installed only to supply support for the windshield and enclosure, continued operation with this joint broken may result in cracking of the windshield or loss of the enclosure. We strongly urge, therefore, that you install a reinforcing plate as shown on the attached sketch.

In order to make this installation, it is necessary to loosen the sheet metal cover over the front spar in the cockpit and also the upper section of the enclosure. Six holes (No. 28 drill) are then drilled through the three channels as shown and the reinforcing plate of 1/16" steel is then bolted in place with No. 6-32 machine screws, 3/4" long. Lockwasher should be used to prevent loosening of the nuts.
