SERVICE

BULLETIN

NUMBER 43

SUBJECT: Stabilizer Link Tube and Rear Support Bearing Bracket

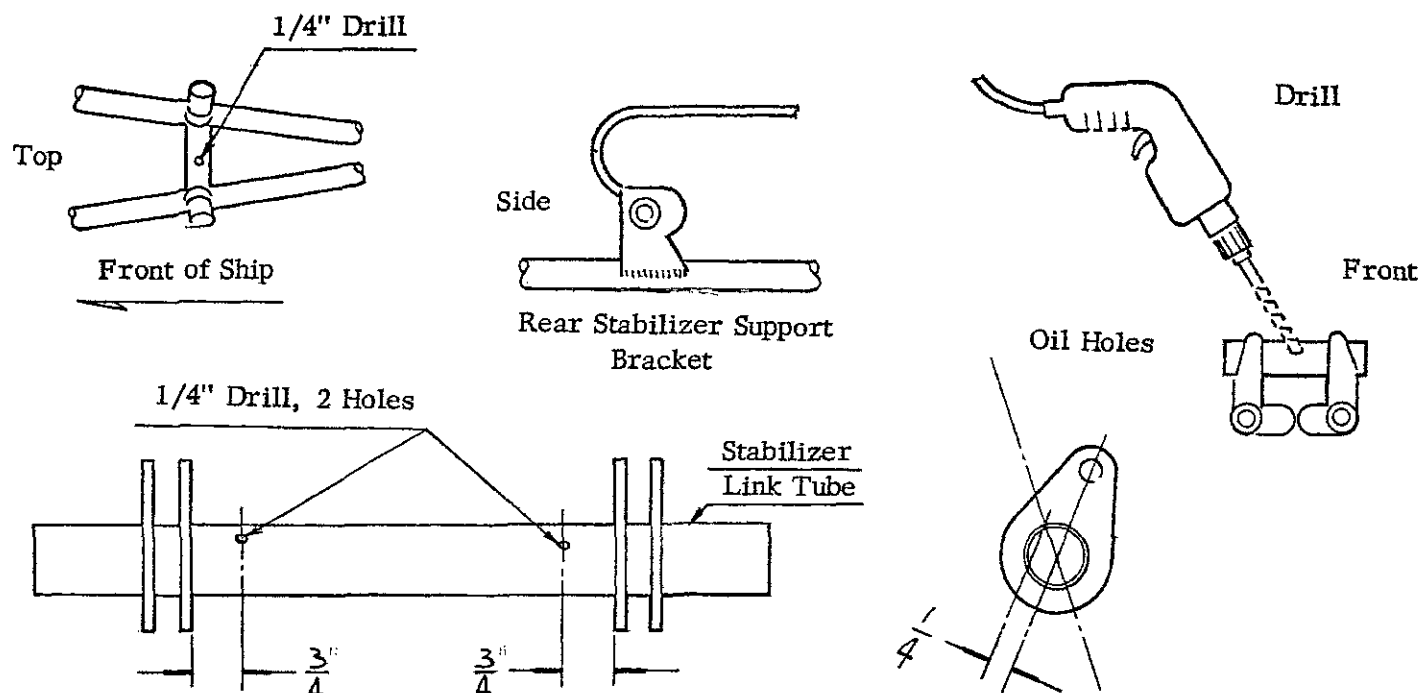
Instructions for Drilling Oil Holes

We have received a number of reports of binding in the stabilizer rear support bearing and, as the link tube at the adjustment yoke is of similar construction, there is a possibility that the same difficulty may occur there.

3. Defective parts should be replaced.
4. Before reassembling the parts, a 1/4" oil hole should be drilled in the top center of the stabilizer rear support bearing tube and also 3/4" inboard of each attachment lug on the link tube as shown on the attached sketch unless such holes are already present.

If an extension drill is not available to drill the oil hole in the stabilizer rear support bracket, a 3/16" hole may be drilled at an angle, as shown and slightly to the rear of the top center if necessary.

An extension drill may be made by brazing a 1/4" drill to a length of 1/4" cold roll steel rod.
