SERVICE

BULLETIN

NUMBER 45

SUBJECT: Control System Interference

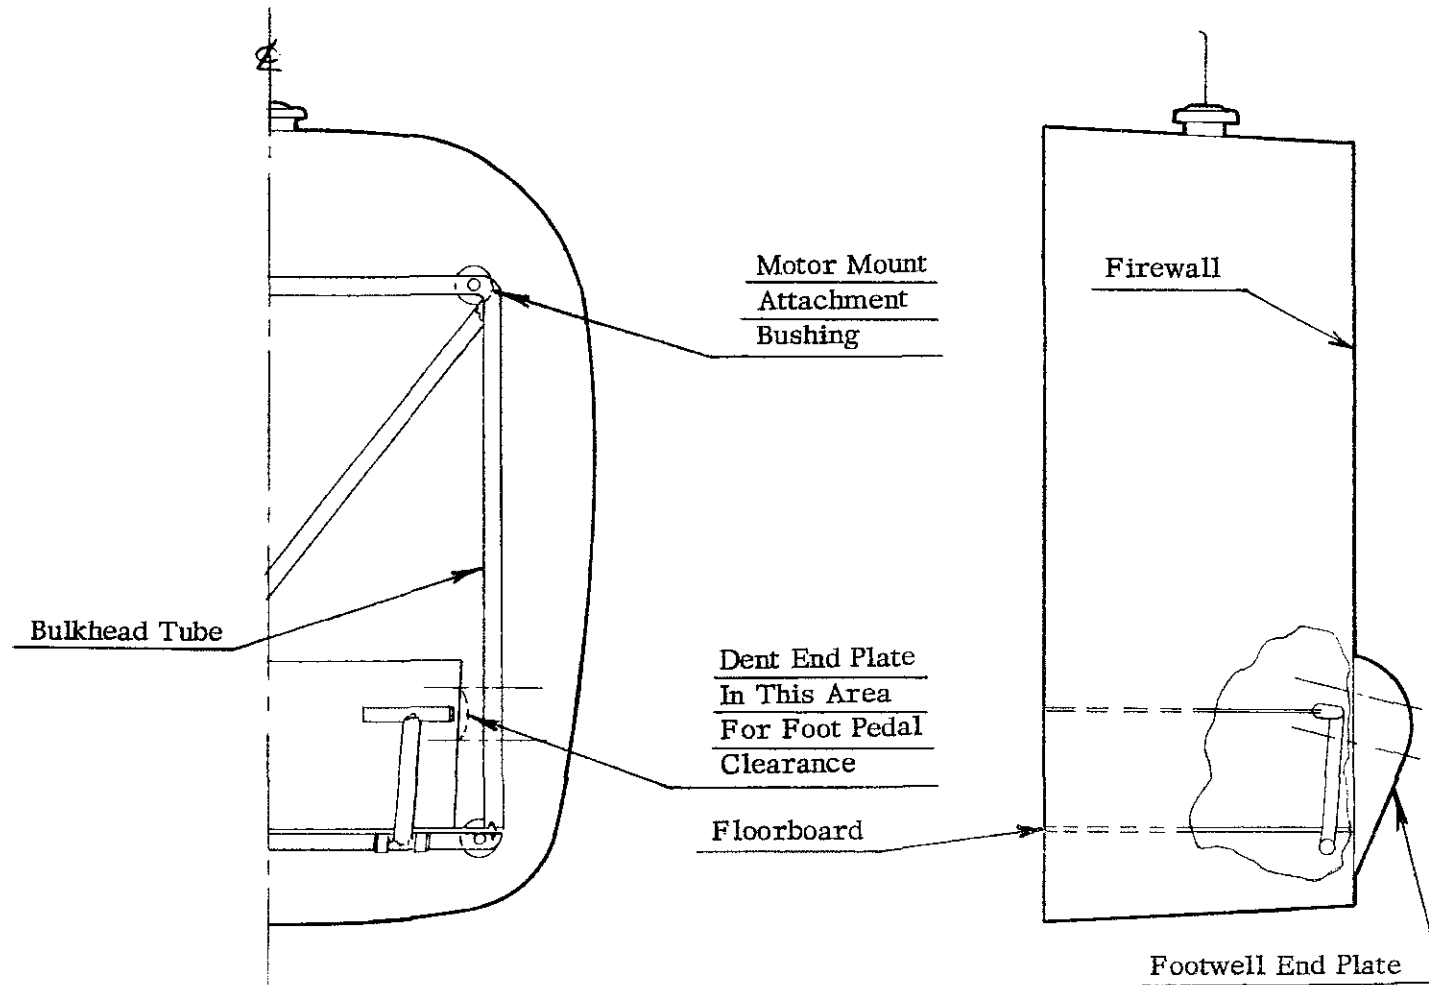
We have received reports of interference of the front rudder pedals with the fire-wall footwells. There is a possibility that the bolt attaching the cable to this pedal has been installed with the nut on the outboard side of the pedal lug. If this condition exists and if reversing the bolt position does not give a minimum of 1/4" clearance, it will be necessary to rework the footwell as shown in the attached sketch to obtain the minimum clearance.

It is requested that the clearance at this point be checked at each periodic inspection.

Note: Use Wooden or Non-Metal Mallet
Use Same Procedure On Left Side

CAUTION: DO NOT DENT BULKHEAD TUBES
