Service Bulletin #108

October 20, 1948

SUBJECT: MODEL PA-11 FRONT AND REAR SEATS

PIPER AIRCRAFT CORPORATION, LOCK HAVEN, PA., U. S. A.

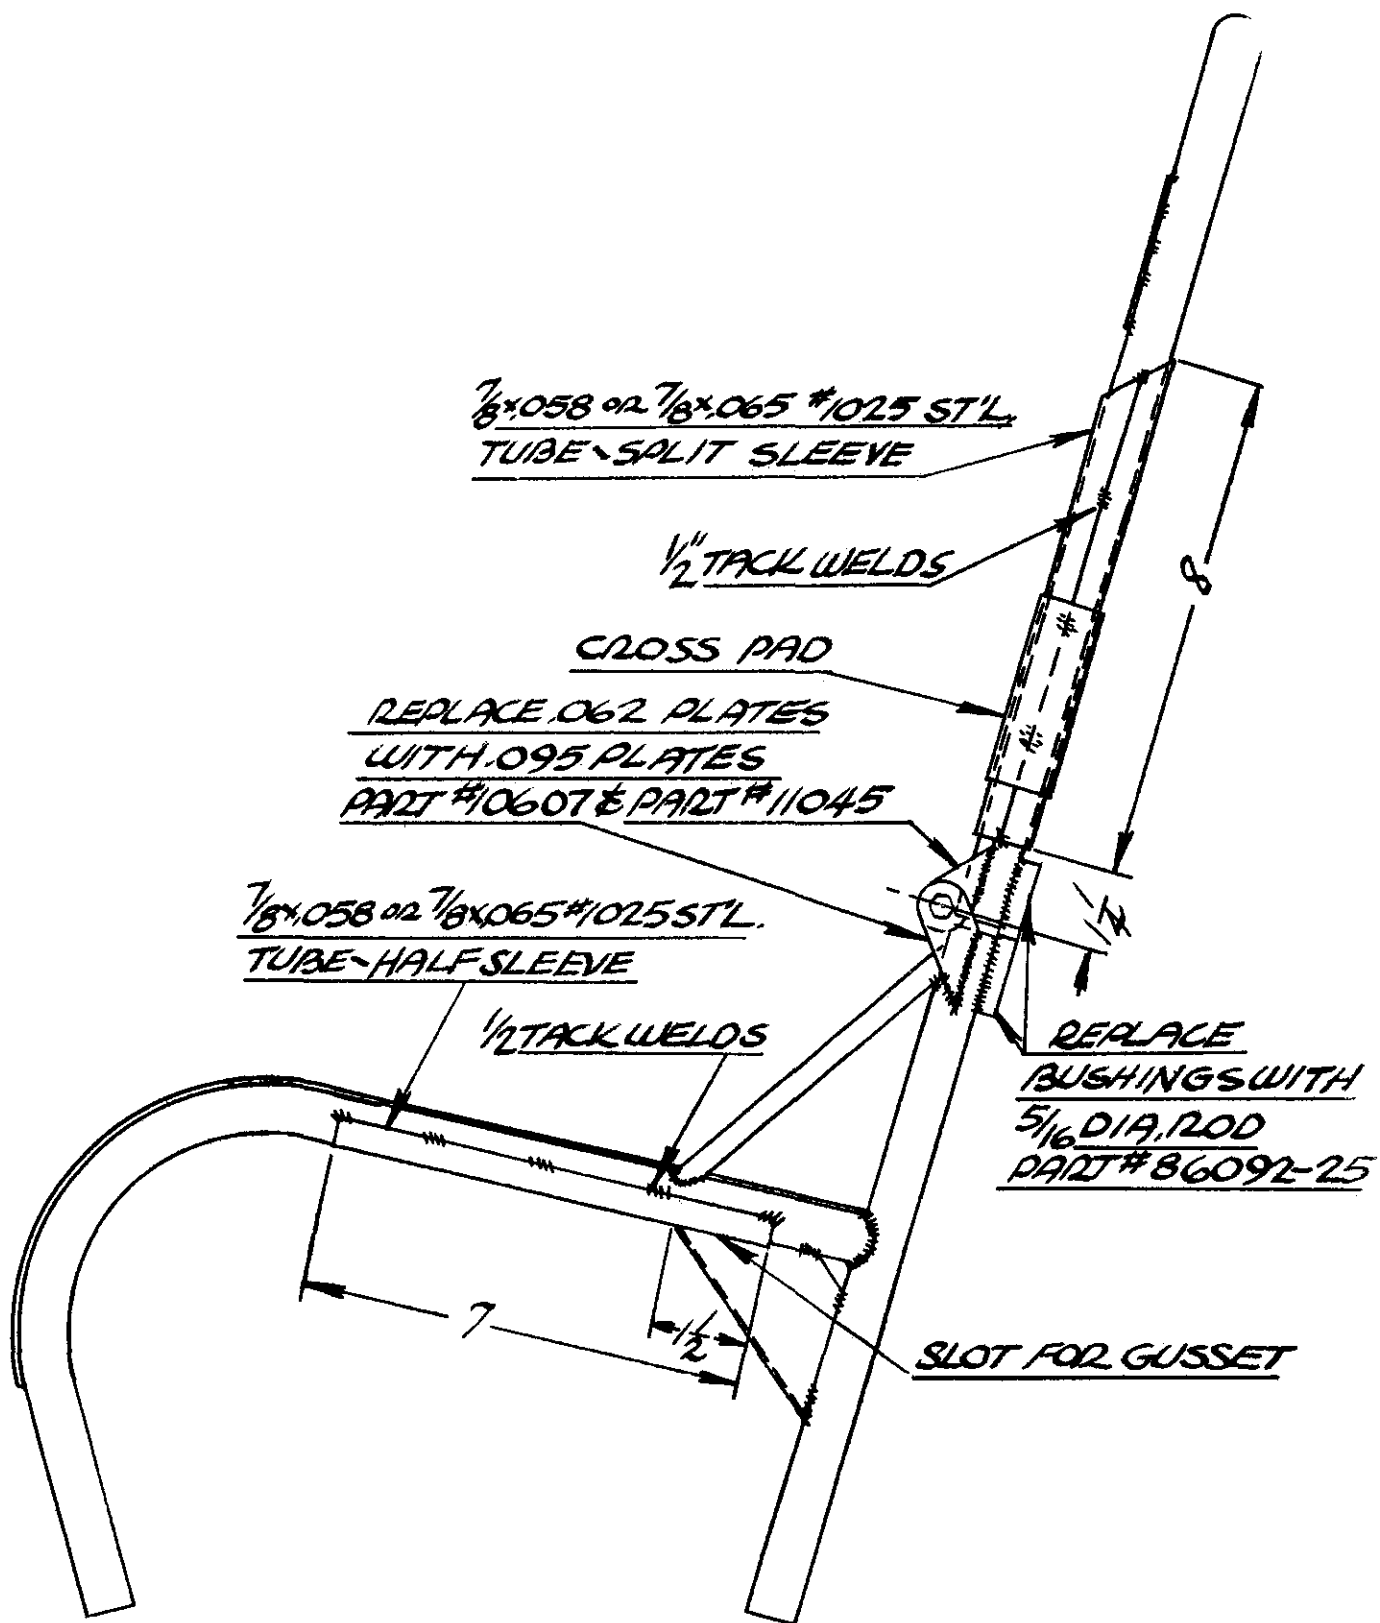
The front seat has been bent backward resulting in bending of the seat side rail and back tubes, the crushing of the stop tubes at the hinges and the stretching of the hinge plate. In order to preclude the possibility of additional failures, it is recommended that the airplane be inspected and if such deformation is found, the following repairs may be made as needed or a new seat installed.

1. Side rail tube reinforcement

Add a half sleeve to underside of tube as shown on sketch.

2. Seat back tube reinforcement

Chip off lower sheet metal cross pad. Add split sleeve as shown on sketch and replace cross pad.

3. Hinge Revision

Replace present .062 hinge plates with .095 plates.

4. Stop Revision

Replace tube with cold rolled rod.
