SERVICE BULLETIN

No. 161A

Piper Aircraft Corporation

SUBJECT: Fire Hazard

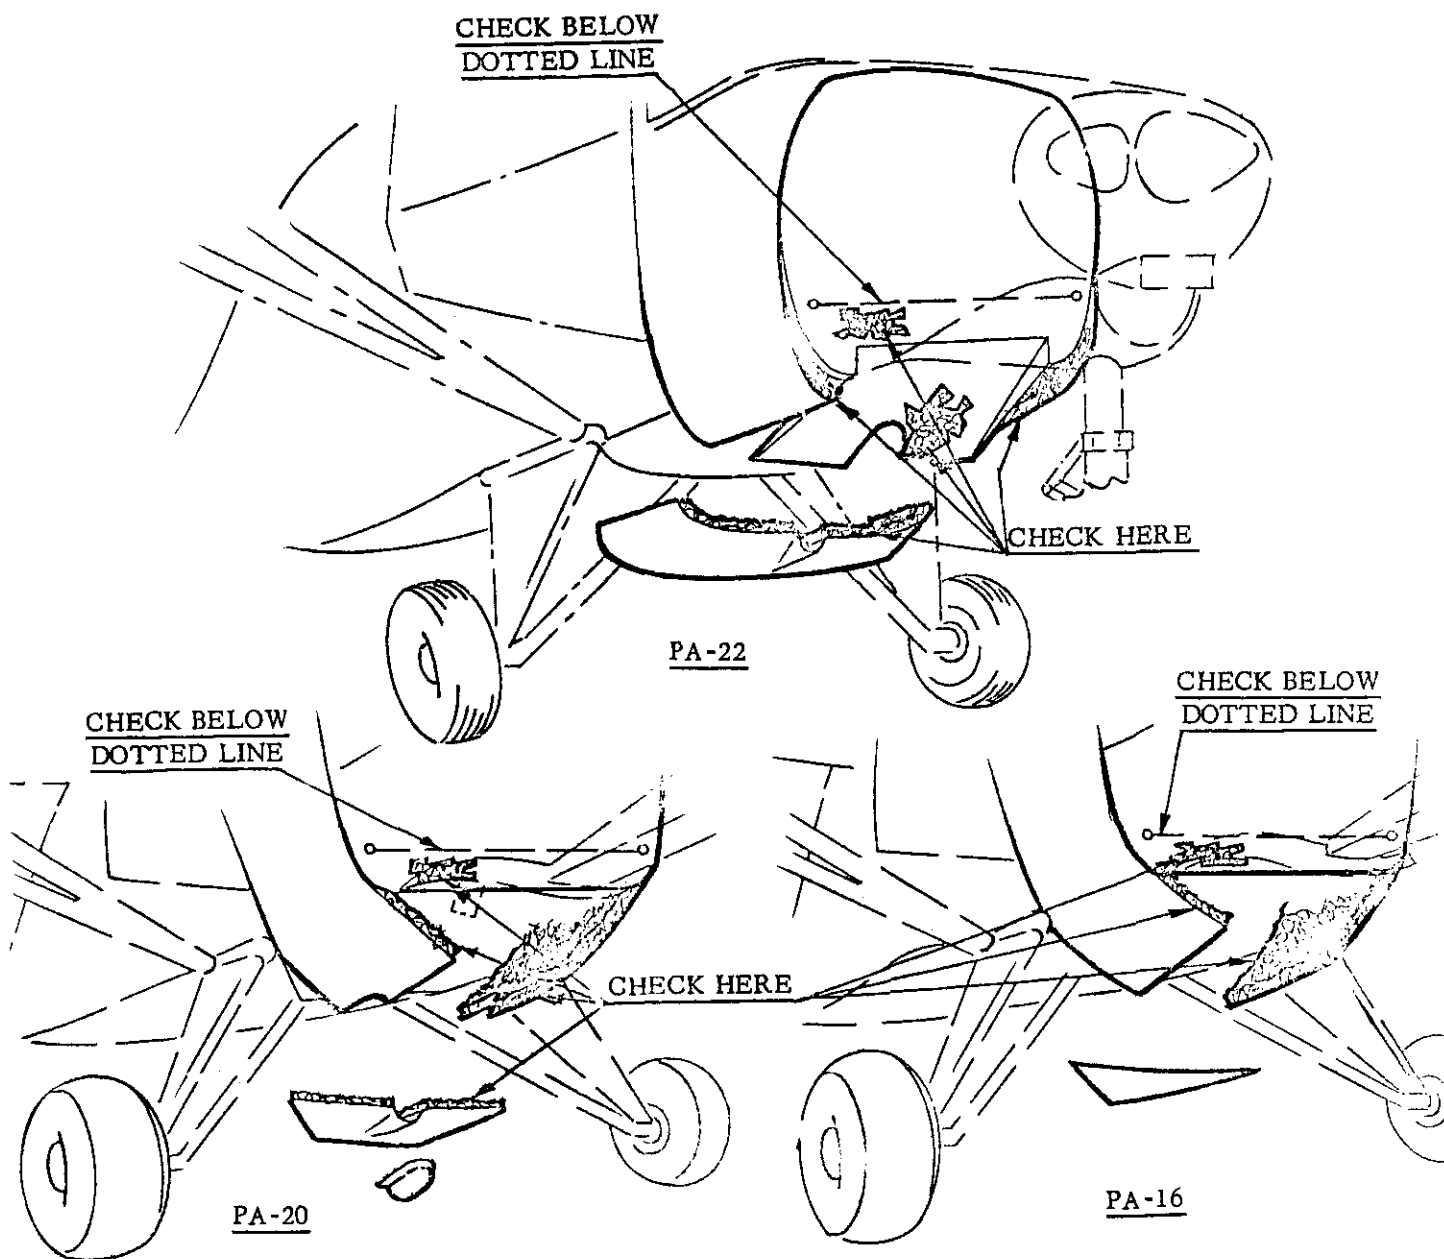
SERVICE BULLETIN NO. 161A

To preclude the possibility of in-flight fires, the following inspection and rework is necessary to eliminate combustible material and possible ignition sources from the area aft of the firewall underneath the forward cabin floor. Access to this section may be gained by removing the metal panels or opening the fuselage side cowl panels rearward of the firewall underneath the aircraft as shown in sketches on reverse side.

Remove and/or open panels as above. Remove and discard any sound-proofing material contaminated with engine or hydraulic oil or any sound-proofing which has the plastic septum separated from the fiberglass or showing signs of drying or cracking. Replacement of a discarded blanket may be made with equivalent fiberglass. Inspect for chafing of wire insulation and replace any inferior electrical wiring. Check for reasonable clearance between hydraulic lines, electrical wires, control cables and fuel lines and provide clearance if necessary.

3. Upon completion of the above, apply a sufficient quantity of B. F. Goodrich non-hardening putty No. 21 or other acceptable aircraft materials between firewall and fuselage cowl blanket to assure an airtight seal when reassembling the opened and removed panels. Non-hardening sealing material is available through your distributor or local aviation supply house.
