SERVICE BULLETIN

No. 354B

Piper Aircraft Corporation

Subject: Fuel Selector Valve Lubrication
Reason for Revision: Revise Serial Numbers, announce replacement parts.

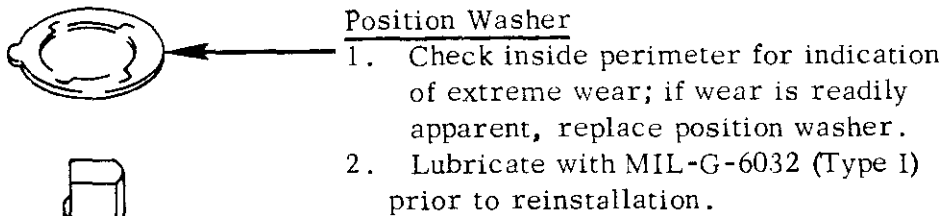
Position Washer
1. Check inside perimeter for indication of extreme wear; if wear is readily apparent, replace position washer.
2. Lubricate with MIL-G-6032 (Type I) prior to reinstallation.
