SERVICE No. 522 BULLETIN

"Modification DOA EA-1 Approved"

September 28, 1976 S

Subject: Wing Fuel Tank Cap Modification.

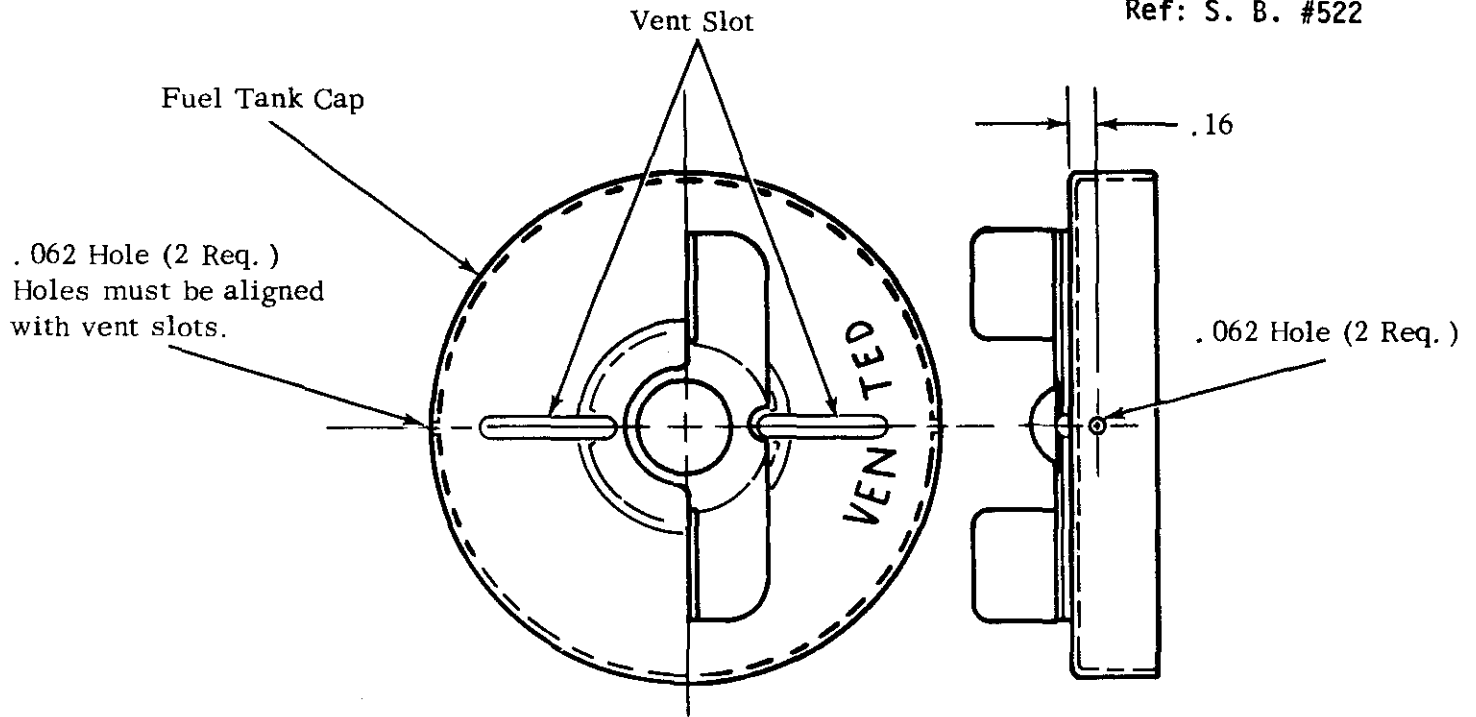
VIEW OF FUEL TANK CAP - P/N 15296-02

Two reports have been received from the field describing collapsed wing mounted fuel tanks, resulting from inadequate venting of the tank. This condition can occur when the fuel tank filler neck gasket is inverted, thus creating a seal between the filler neck and the fuel tank cap, Piper part number 15296-02.

1. Remove fuel tank caps from wings and rework caps by drilling two .062 holes .16 down from top of cap. Holes must be aligned with vent slots as shown.
2. Inspect rubber seal around fuel tank inlet to determine if seal is properly installed as shown.
 - a. If seal is not installed correctly, remove fuel tank cover from wing, reposition seal as shown and reinstall fuel tank cover.
3. Reinstall reworked fuel tank caps and make proper logbook entry of Service Bulletin 522 compliance.
