# SERVICE BULLETIN

No. 573

Subject: Wing Fuel Tank Cap Modification

Service Bulletin No. 573

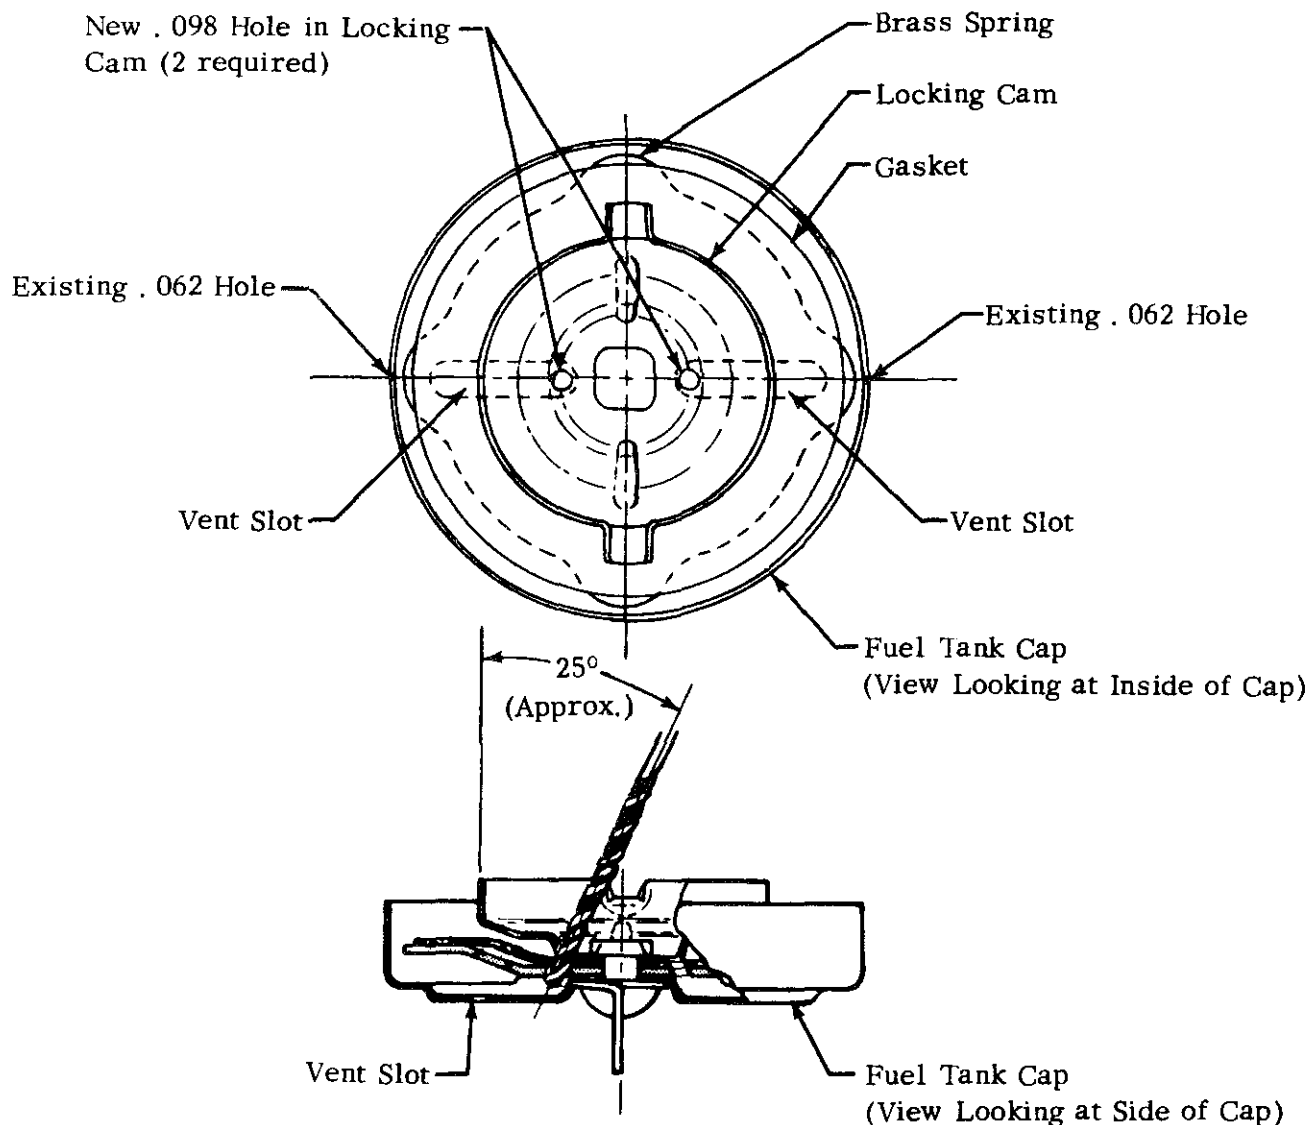
A recent fuel tank collapse was attributed to inadequate venting, caused by obstruction of the cap vent holes (installed per above referenced Service Bulletin). Accumulation of foreign material (corrosion, dirt, ice, etc.) inside the cap "sealed off" the cap internal vent slots.

This service release provides instructions to drill two additional vent holes in the cap assembly to insure adequate venting -- in the event that the present vent slots (located in the cap locking cam plate) are obstructed and recommends cleaning and inspecting present vent slots.

### INSTRUCTIONS

1. Remove fuel tank caps from wings and rework caps as follows:
  - a. Locate and mark center of two .098 holes on locking cam of cap as shown. Use existing .062 vent holes to index location of new .098 holes.
  - b. Drill two .098 holes ( $\pm 40$  drill) through locking cam. Angle drill to intersect end of vent slots as shown. CAUTION: Do not allow drill to go through top cover of cap.
  - c. Insert .032 wire in existing .062 holes. End of wire will be seen in new .098 holes if holes were correctly drilled.
  - d. With .032 wire in .062 holes, slide wire back and forth to loosen any corrosion or dirt that may be in the vent slots. Clean cap thoroughly with compressed air.
2. Reinstall reworked fuel tank caps and make proper Logbook entry of Service Bulletin 573 compliance.
