Piper Aircraft Corporation
Vero Beach, Florida, U.S.A.

SERVICE *No. 706B* BULLETIN

Date October 9, 1991

SUBJECT: Tail Brace Wire Support Installation

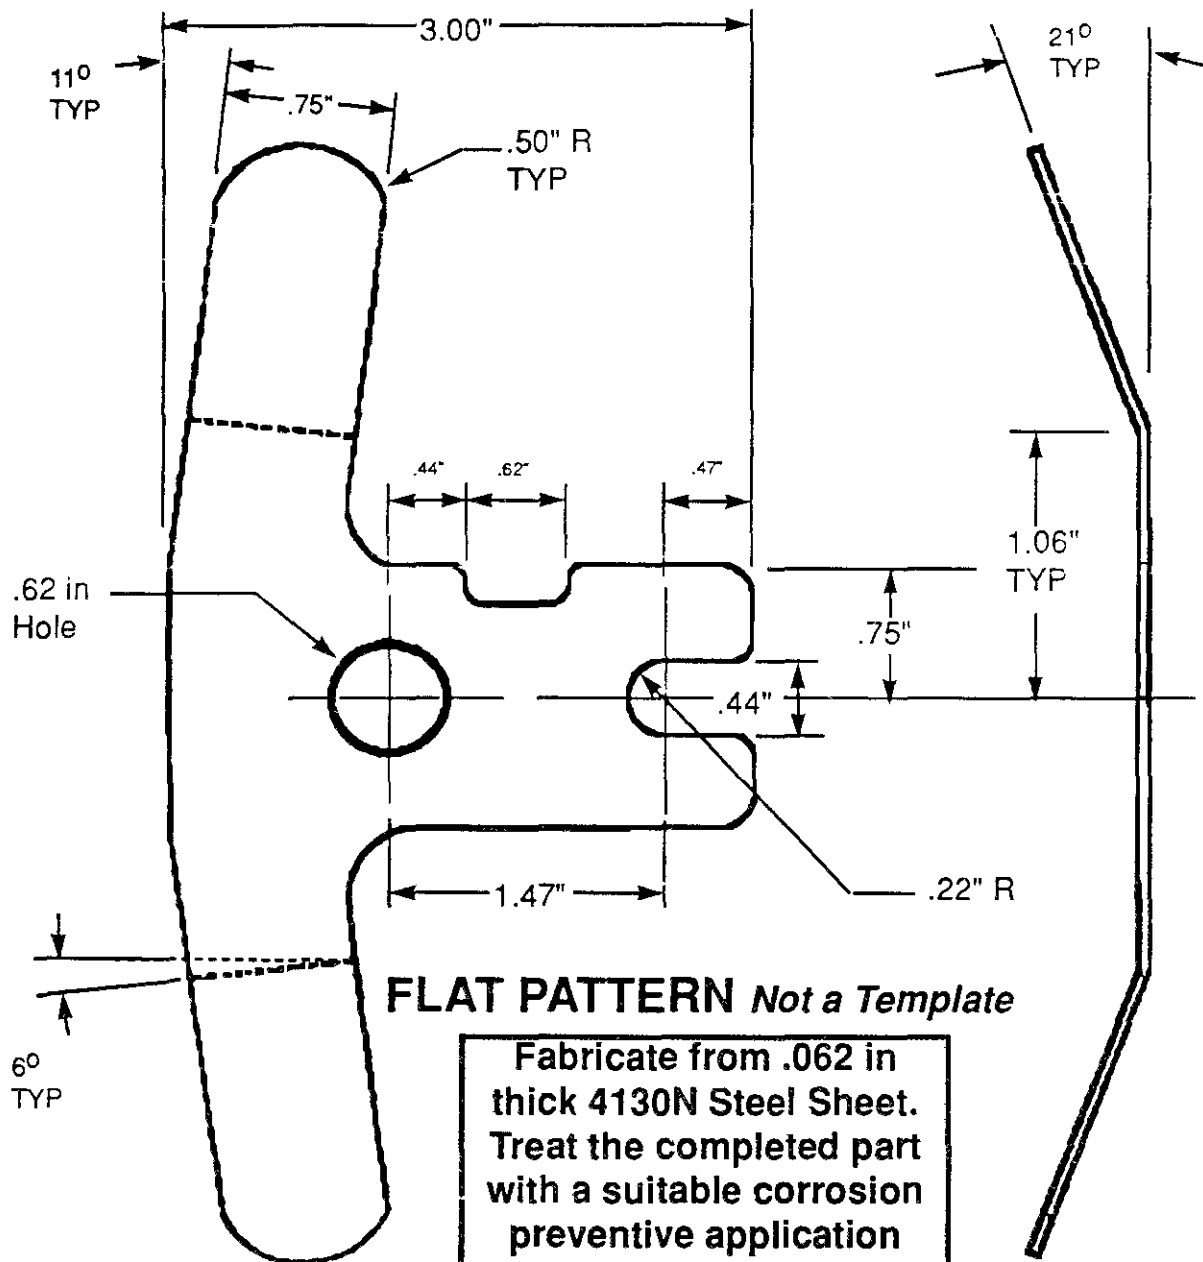
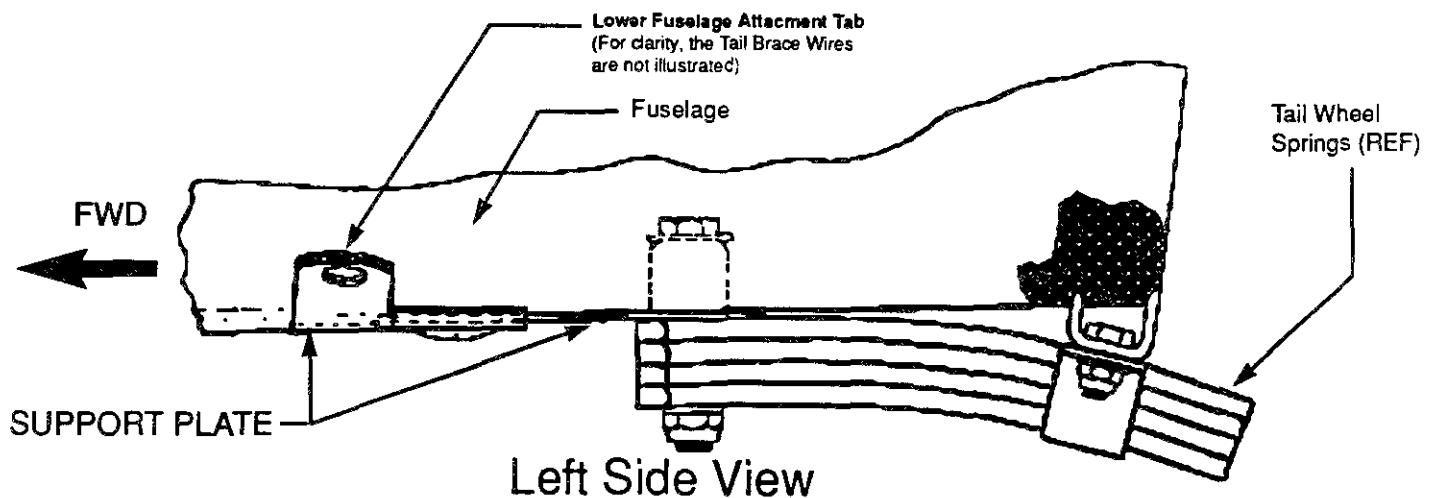
SKETCH A

Reports have been received of failure of the lower horizontal stabilizer brace wire fuselage attachment tab. This tab connects the lower horizontal stabilizer brace wire to the lower fuselage. Separation of the tab and subsequent loss of brace wire support could result in damage to the stabilizer and possible loss of control.

1. a. For PA-18-150 Super Cub aircraft, Serial Numbers 18-8602 through 18-18-8109013 only, fabricate a support plate from .062" thick 4130 N Steel sheet (6.5" x 3.0") using the template shown on sketch "A", or procure one each, Piper Part Number 60764-02 or Piper Part Number 60764-03 Support Plate.
