# SERVICE BULLETIN

No. 759

Subject: Exhaust muffler inspection and modification,  
Piper Part Number 12433-00, 12433-14,  
12232-00.

Models Affected: PA-18 Series Super Cub

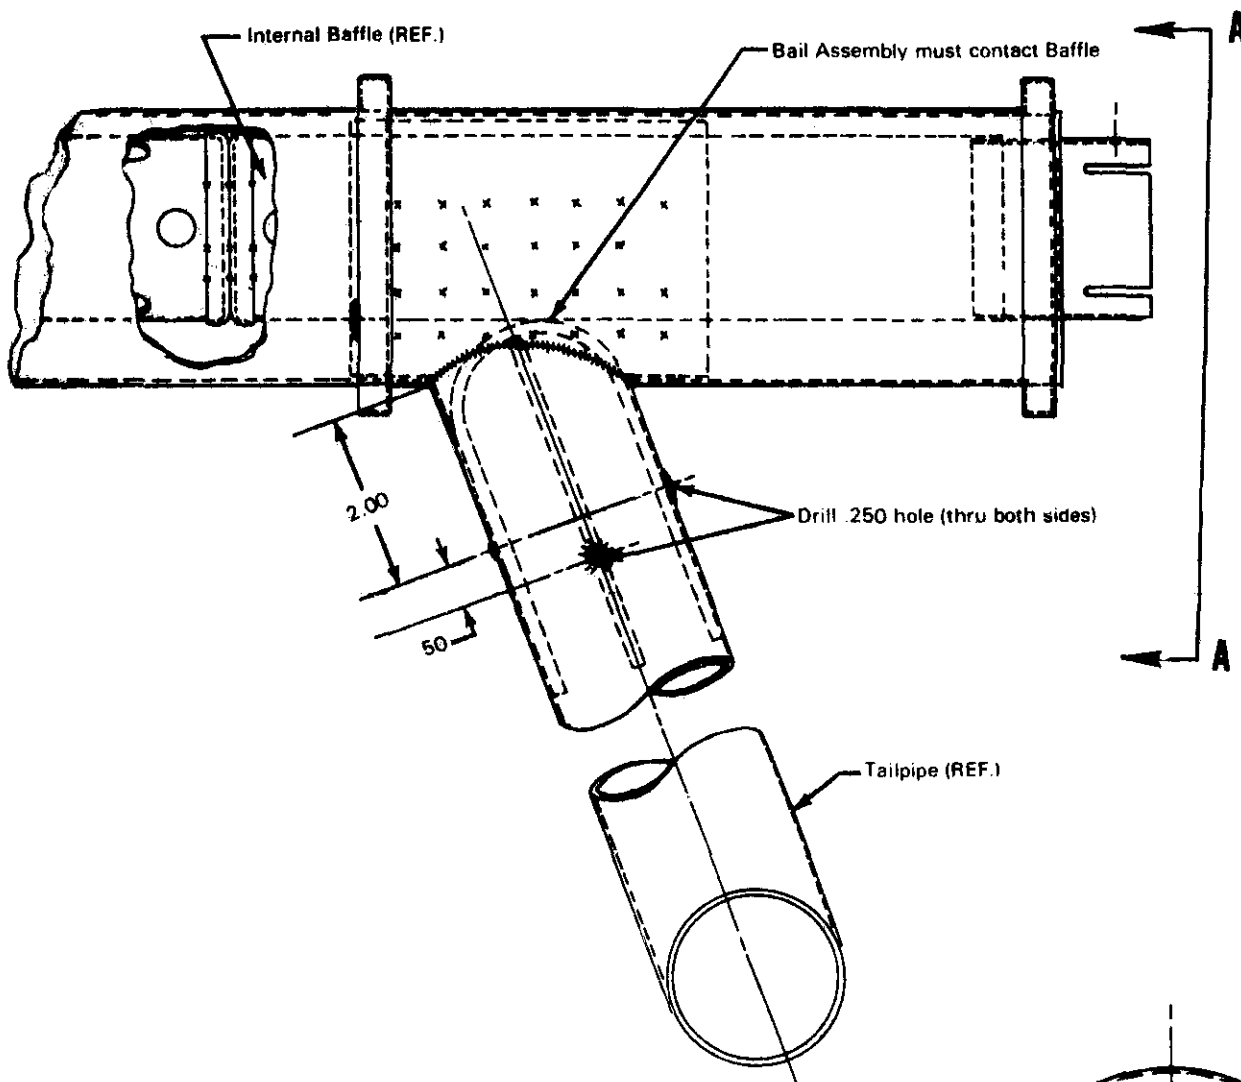
It has been determined that if the internal baffle in the mufflers of the above referenced aircraft fails, a restriction of the muffler outlet may occur. The resulting engine power loss may be enough to prevent continued flight.

7. Remove shroud from muffler assembly and comply with AD 68-05-01.
8. Drill two 1/4 inch (.250) holes through the tailpipe as shown in the following sketch.
9. Install bale assembly, Piper Part Number 452 093 into tailpipe, curved end toward the muffler until contact is made with the internal baffle. The deflector must be installed so that the opposing legs cover the four holes that have been previously drilled.

Note: A 3/4 inch square x 18 inch long stick of wood or 3/4 inch diameter x 18 inch long metal tube may be fabricated into a special tool to twist the deflector if necessary after installation to locate two of the legs directly inside the 1/8 inch holes in the tailpipe. (See sketch).

10. Rosette weld by suitable method the bale through the four 1/4 inch holes in tailpipe.
11. Reassemble muffler assembly and reinstall on aircraft. Install exhaust system components and reconnect any lines, wire, and hoses that were removed. Attach engine properly and reinstall engine cowling that was removed.
12. Make appropriate log book entry stating compliance of this Service Release.
