Piper Aircraft Corporation  
Vero Beach, Florida, U.S.A.

# SERVICE *No.* 910A BULLETIN

SUBJECT: Wing Lift Strut Assembly  
Inspection/Replacement

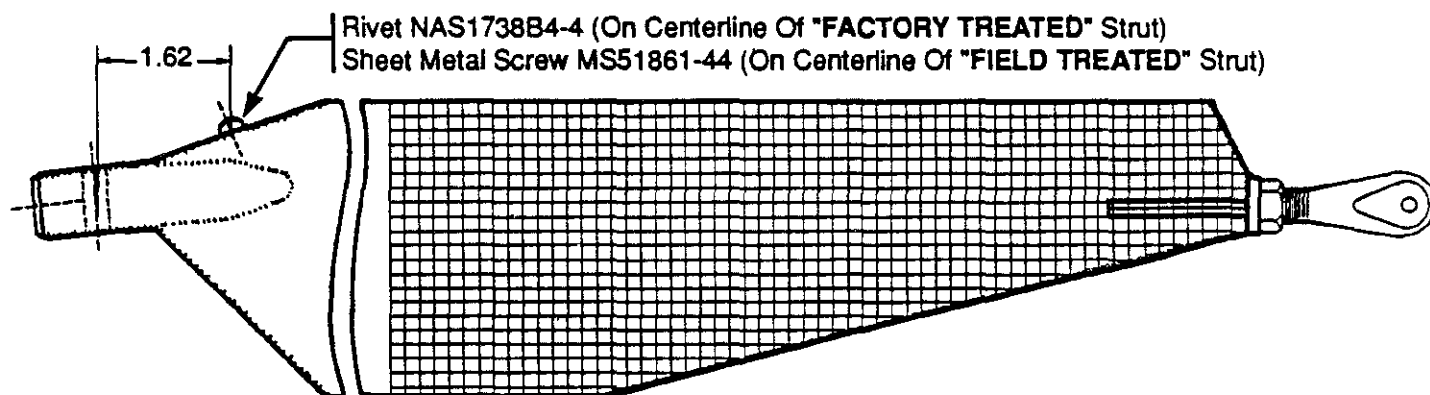
**VIEW OF MAULE FABRIC TESTER**

1. Securely tape a sheet of thin 1/4 inch graph paper to the lower 11 inches of the top and bottom surface on all wing lift struts.
2. Using a Maule "FabricTester" and holding tool normal to strut contour, apply pressure at a scale reading of 80 in in each of the grid blocks.
3. Remove the paper and inspect the lift strut tubes. A perceptible dent will appear if internal corrosion is present. If any dents are found, be certain the dent are in the metal by carefully removing the paint.
  - a. Lift strut tubes indicating the presence of any perceptible dent in the metal must be replaced with a new lift strut assembly before further flight.
  - b. If no dents appear in the metal, the lift strut may be considered airworthy.

- a. Remove lift strut from aircraft.
  - b. Inject one quart of Valoil, Lionoil Multi-Purpose L-1, Linseed Oil, Paralketone or any alternate preservative conforming to Federal Specification TT-S-176D, into the bolt hole at the top of the strut.
  - c. Plug the bolt holes and slosh oil until interior of strut is thoroughly coated.
  - d. Drain oil from strut (through bolt holes) and install MS51861-44 sheet metal screw, as shown, for future identification.
  - e. Reinstall strut to aircraft and rig.
4. Record lift strut inspection in aircraft logbook.
