# SERVICE *No. 924* BULLETIN

\*\*\*\*\*  
\* PIPER CONSIDERS \*  
\* COMPLIANCE MANDATORY \*  
\*\*\*\*\*  
Date September 13, 1989 S

SUBJECT: Shimmy Dampener Replacement

PA-22-125/135/150/160 Tri-Pacer 22-1 through 22-7642  
PA-22-108 Colt 22-8000 through 22-9848

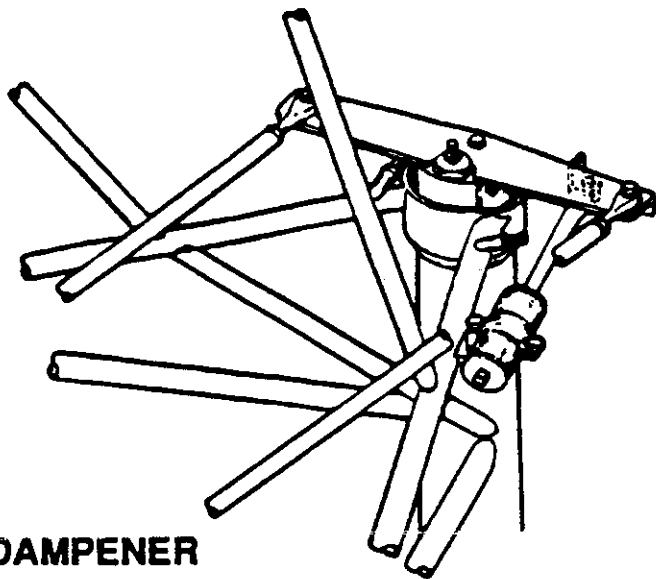
**SKETCH "A"**

PURPOSE: It is possible that through improper installation or by the lack of maintenance and lubrication that the shimmy dampener may bind or become unserviceable. Should this occur, especially on aircraft equipped with the early model shimmy dampeners, the possibility exists that during a maximum left turn the shimmy dampener shaft may jam or bend, causing loss of nose wheel steering. This condition could possibly lead to partial or total loss of rudder control.

**SHIMMY DAMPENER  
(EARLY MODEL)  
TRI-PACER - PART NO. 13086-00  
(IDENTIFICATION)**

1. Remove cowlings as necessary to gain access to nose wheel shimmy dampener. Refer to applicable Owners Manual or Parts Catalog.
2. Shimmy Dampeners with Piper Part Number 13086-00, as identified on Sketch A (attached), should be removed, discarded and replaced by Piper Part Number 21701-06.

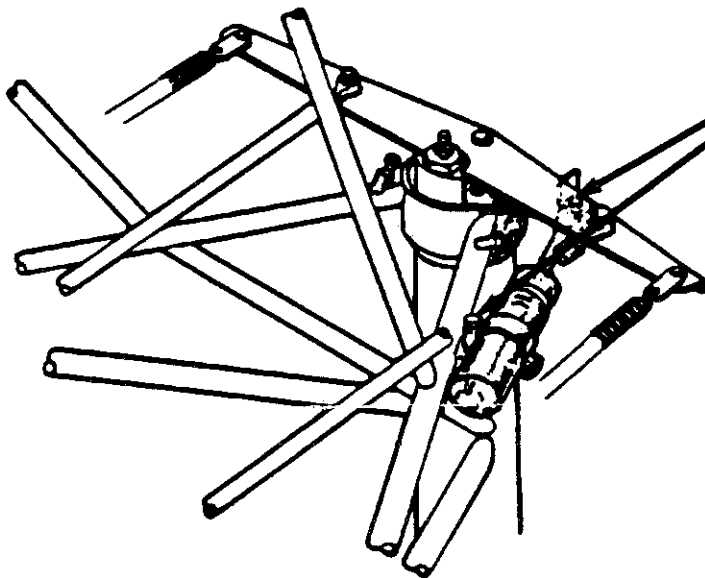
**SKETCH "B"**

**CHECK FOR  
FREEDOM OF  
ANGULAR TRAVEL**

**SHIMMY DAMPENER  
(LATER MODEL)  
TRI-PACER - PART NO. 21701-02  
COLT - PART NO. 21701-04  
(IDENTIFICATION)**

3. If the shimmy dampeners with Piper Part Numbers 21701-02 and 21701-04, Sketch B (attached), are inspected and determined to be serviceable and airworthy and the instructions below are complied with, those shimmy dampeners may be returned to service.

4. Determine that nose wheel travel is 20 degrees left and right of center.
5. Determine that the shimmy dampener rotates freely on the axis of its attachment bolt throughout its full travel, especially as it approaches the limits of nose wheel travel.

6. Determine that the attachment of the shimmy dampener rod end to the nose wheel steering arm is free to accept angular travel in either direction.
7. Should any stiffness, restrictions, or other maladies be noticed, correct by replacing parts and adjusting as necessary until proper fit and function is obtained.

8. A regular maintenance routine of inspection, cleaning, and lubrication should be performed at each one hundred (100) hours of operation or at any inspection event. Lubricate shimmy dampener rod end and pivot point using general purpose low temperature oil (MIL-L-7870 or equivalent). Wipe shimmy dampener shaft using a clean cloth saturated with MIL-H-5606 hydraulic fluid.
