The New Piper Aircraft, Inc.
2926 Piper Drive
Vero Beach, Florida, U.S.A. 32960

SERVICE No. 1020 BULLETIN

DATE: July 10, 1998

**Inspection of the ARTEX 110-4 ELT and
ELT Attachment Bracket**

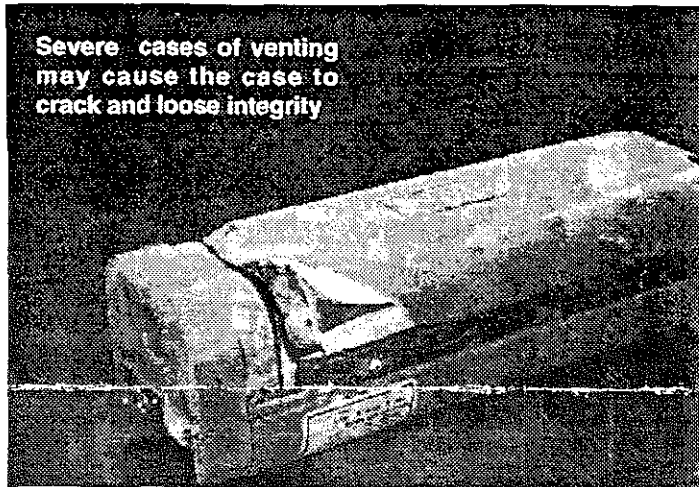
Recent reports indicate that the ARTEX 110-4 ELT battery packs may vent and leak acid into the battery case. This condition combined with humidity, may cause the plastic material of the ELT battery case to break down, which could result in severe cracking of the ELT battery case. ARTEX has released Product Advisory Notice No. 2 regarding this condition, which is included with this publication. In addition, should the ELT battery case crack and leak acid, the ELT attachment bracket may corrode and require replacement. Left uncorrected, the possibility exists that the ELT function may become impaired and that the ELT attachment bracket may fail due to corrosion.

**ELT Battery Pack
(Severe Damage from Battery Venting)
REPLACE UNIT**

3. If the ELT battery pack does not pass the criteria as set forth in the ARTEX publication, the ELT battery pack must be replaced with a new ELT Battery Pack, Piper Part Number 758-696. *(See the data tag and corrosion photographs on page 3.)*

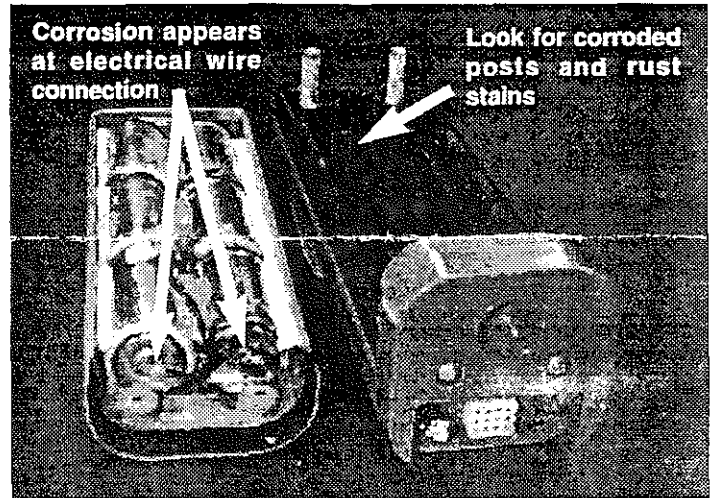
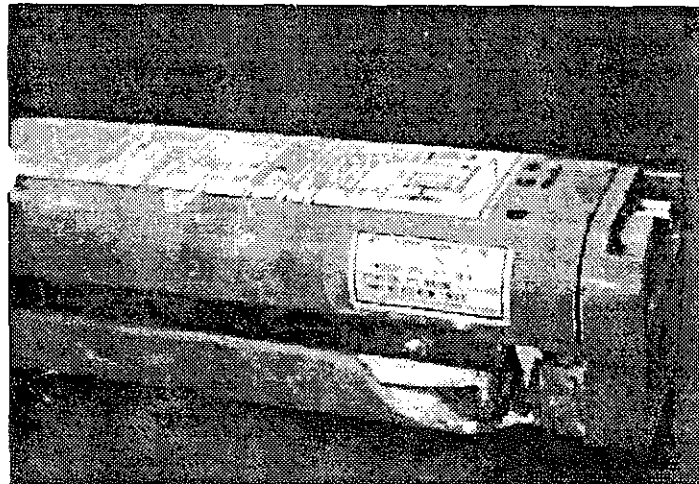
**ELT Battery Pack
(Light Damage from Battery Venting)
REPLACE UNIT**

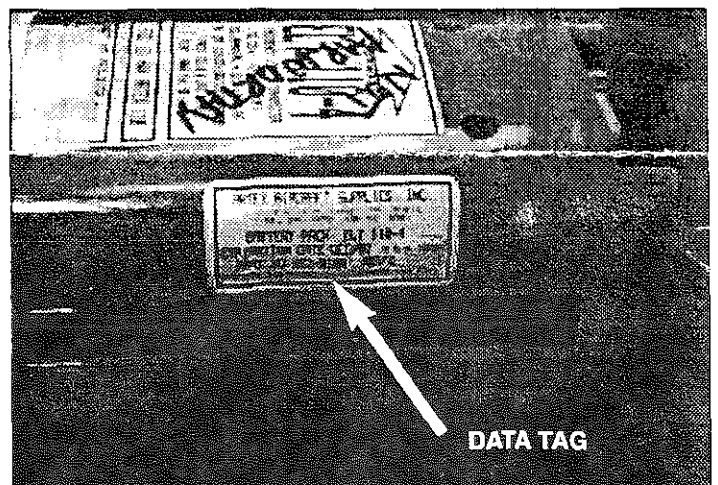
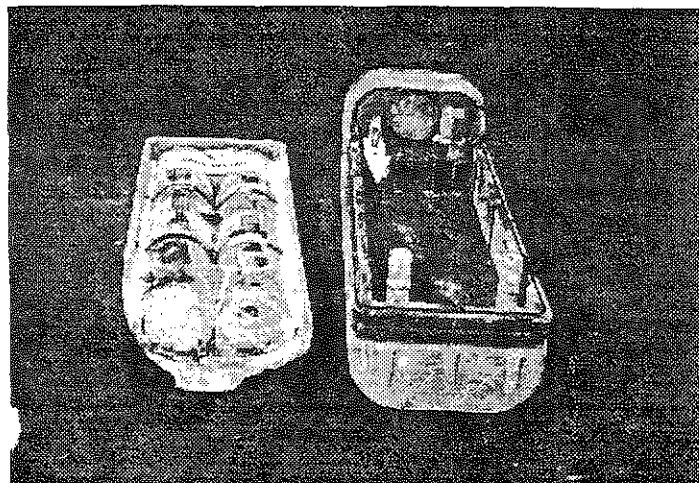
**ELT Battery Pack with Data Tag
(Identifies Unit and shows Expiration Date)
If Beyond Expiration Date REPLACE UNIT**

4. If the ELT battery pack is not defective, return it to service for use until the expiration date listed on the data tag. *See the data tag photograph on page 3.*
