# SERVICE No. 1026 BULLETIN

**Distribution of Parker Hannifin Airborne  
Service Letter 48, "Inspection/Replacement  
of dry air pump flexible couplings".**

Service Letter Number: 48

Subject: Inspection/Replacement of dry air pump flexible couplings.

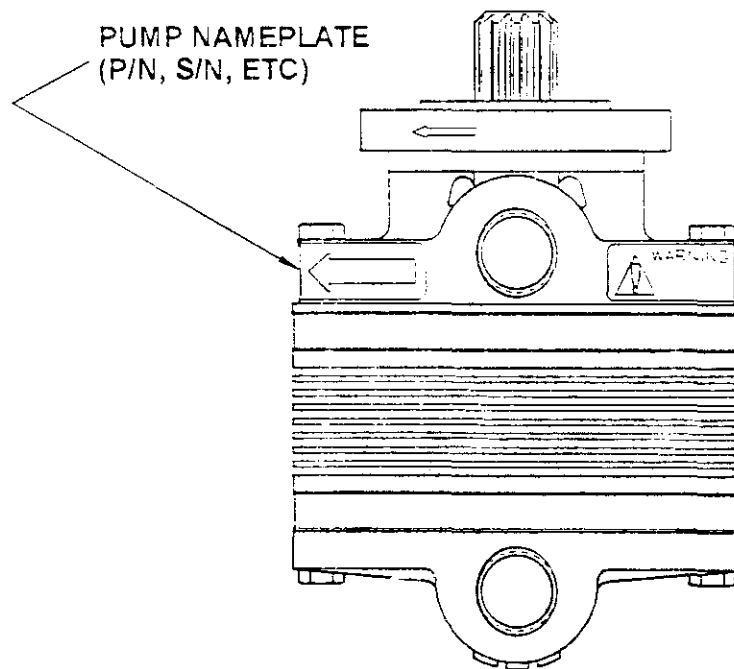
**FIGURE 1**

Applicability: Airborne dry air pumps, conversion kits and flexible coupling kits with the following part numbers/serial numbers which have not been inspected per this service letter as identified in step number seven of the procedure listed below. These components were shipped from Airborne between 1/1/98 and 10/13/98. Refer to Figure 1 for location of part number/serial number nameplate.
