Service Letter No. 109

October 15, 1947

SUBJECT: J3, PA-11 and PA-12 Winter Operation Recommendations

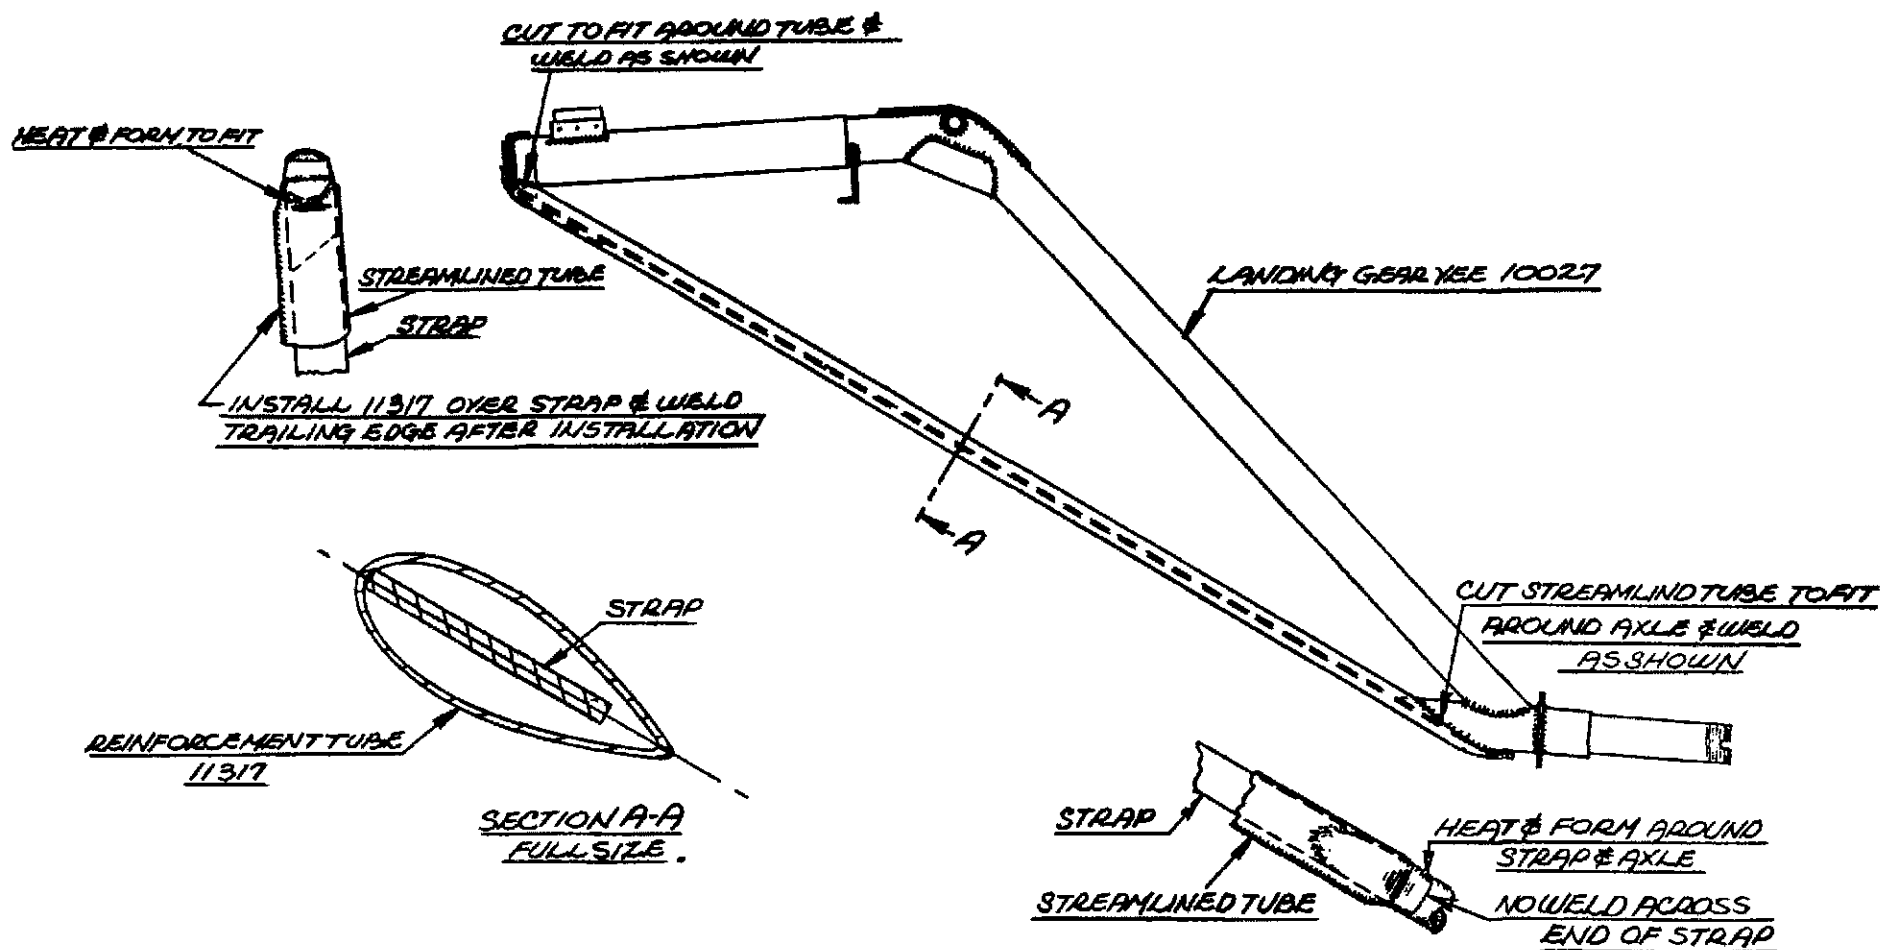
FIGURE 1
LANDING GEAR STRAP REINFORCEMENT

This added reinforcement to the strap is an additional brace for the purpose of carrying any extreme compression loads which may be induced in the plane of the strap, due to inertia, or side loads, which are apparently being encountered in landings while operating on skis, or on severely rutted and rolling fields.

Due to additional stress loads being applied on the landing gear, encountered during ski operation on PA-12 Aircraft, it is recommended that a streamline tube, Piper part number 11317 (two (2) required), be installed over the landing gear strap, as shown on the sketch on opposite side of this letter, which is taken from Piper drawing SK-198.

Installation of the streamline tube reinforcement strap, as mentioned above, is not only recommended for ski operation, but also for operation on rough and rolling fields, particularly at high altitudes where aircraft landing speeds are considerably higher than those encountered at near sea-level operations.
