Service Letter No. 188

April 11, 1952

SUBJECT: Flap Cable Installation

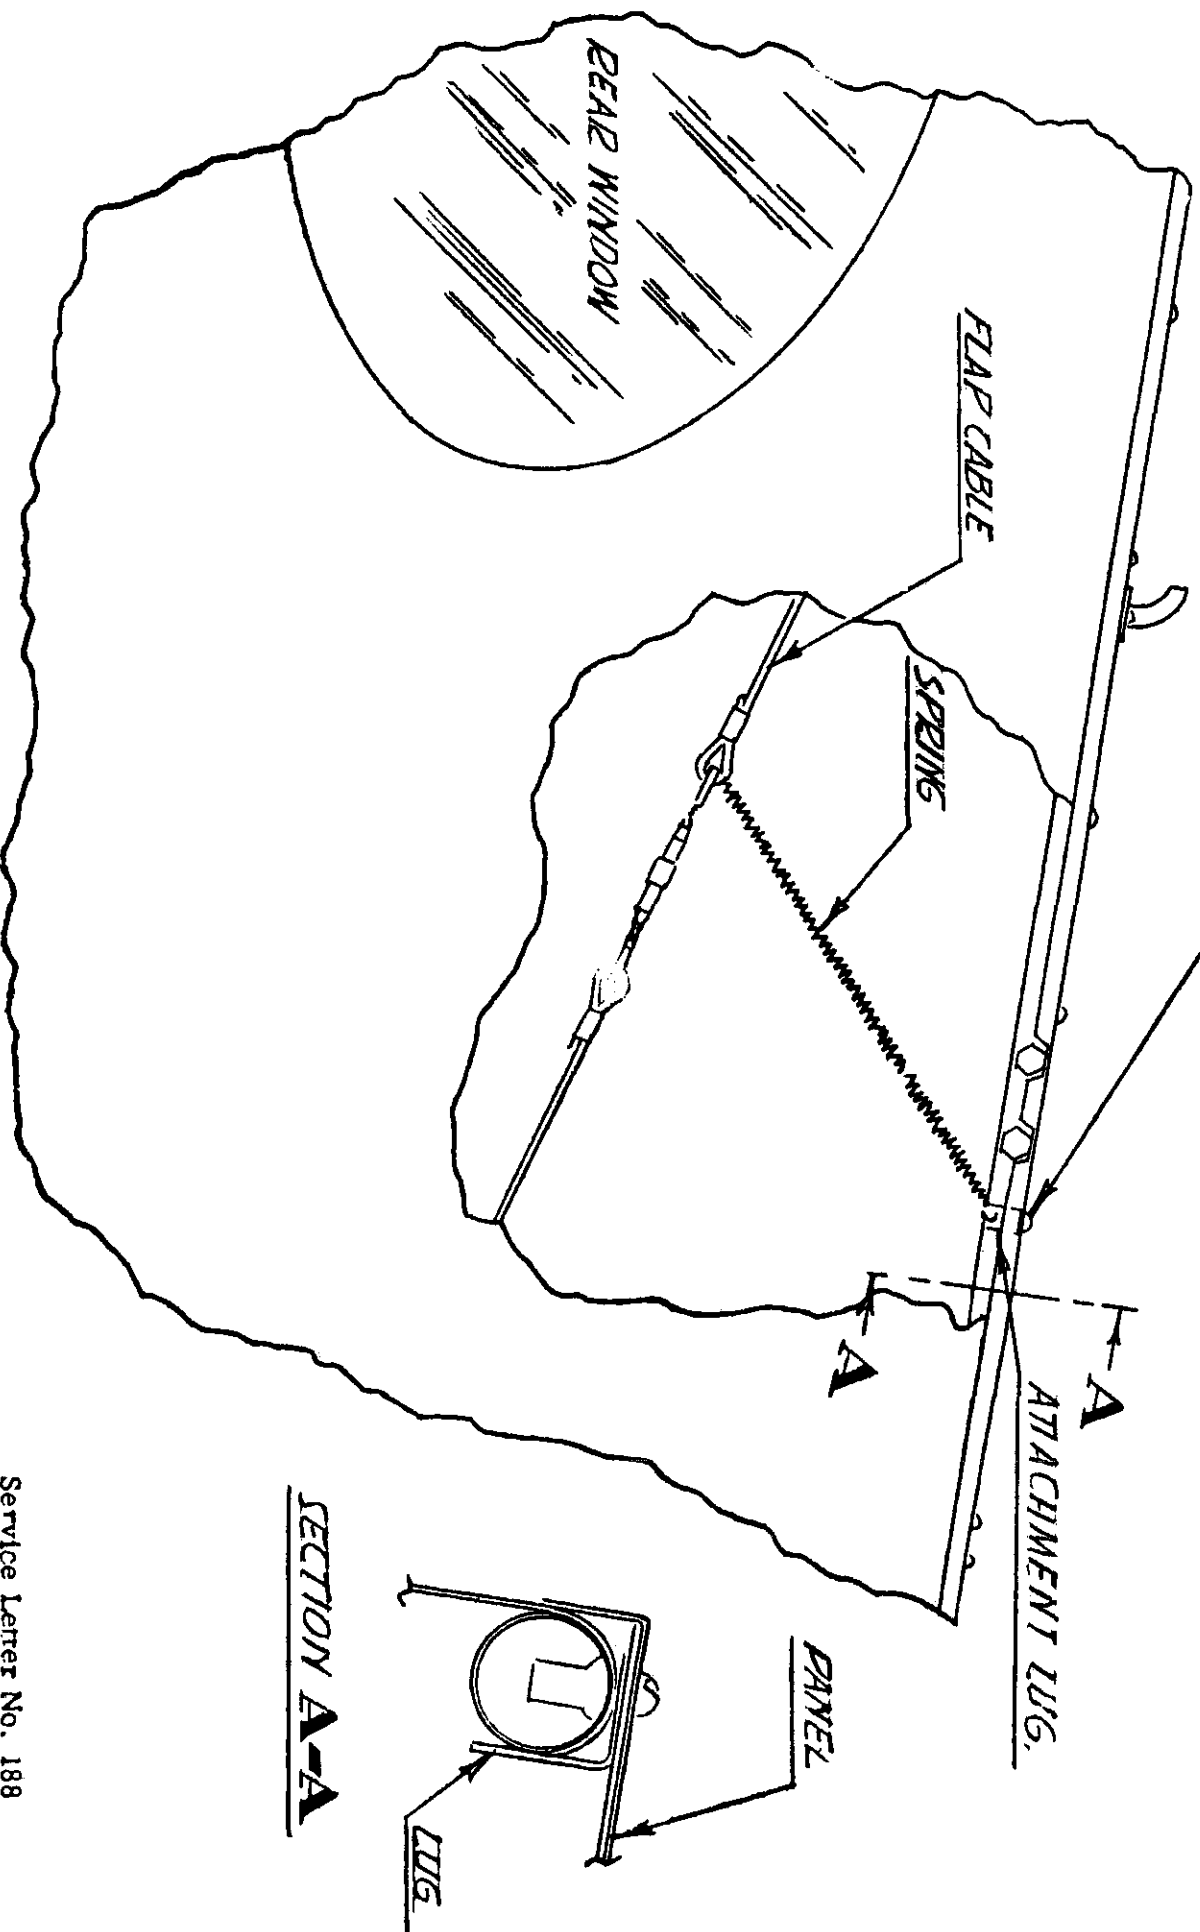
It has been brought to our attention that there is a possibility of the flap cables on the PA-18A becoming fouled between the hopper and the diagonal fuselage tube.

The probability of fouling is very slight, however, and can only happen when either or both flaps are forced down without the use of the flap handle in the cockpit. When the flap is forced down it allows the cable to sag and slide down between the hopper and the fuselage tube.

REMOVE THIS RD. HD. MACH
SCREW & INSERT LUG.

We have a service fix for this particular problem and will make available to any PA-18 airplane owner, whose airplane bears one of the above listed serial numbers, our kit number 752 236 at No Charge. The time required to install this kit is approximately 15 to 20 minutes.

1. Remove the two (2) round head machine screws as indicated in the sketch.
2. Using the baggage compartment door as an access hole, insert the lug which is attached to the spring between the longerons and the hopper cover support panel so that the hole in the lug lines up with the hole from which you removed the machine screw.
3. Reinsert the machine screws and tighten. (The assistance of a second person will be necessary to accomplish this.)
4. Attach the other end of the spring to the flap cable by inserting the end coil on the spring through the flap cable thimble hole at the front end of the turnbuckle.
