# SERVICE LETTER

No. 207

Piper Aircraft Corporation

SUBJECT: Oil Quick Drain Valve Assembly, Part Number 12956-04

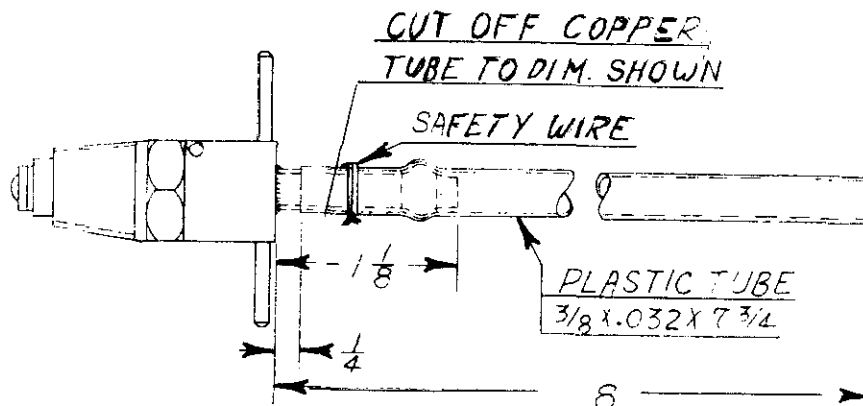
It has been brought to our attention that vibration has caused the quick oil drain valve to break at the rubber washer seal and also at the point where the copper drain tube is soldered.

To eliminate this condition it is recommended that the valve be modified in accordance with the sketch shown below. The plastic tube may be obtained from the Service Department of the Piper Aircraft Corporation on a No Charge basis. This plastic tube will be furnished on a No Charge basis until June 1, 1954.
