# SERVICE LETTER

No. 718

Bendix Magneto Bulletin No. 566 -- reference attached Avco Lycoming Service Bulletin No. 373, dated March 22, 1974.

**SUBJECT:** S-1200 Distributor Block and Gear Change

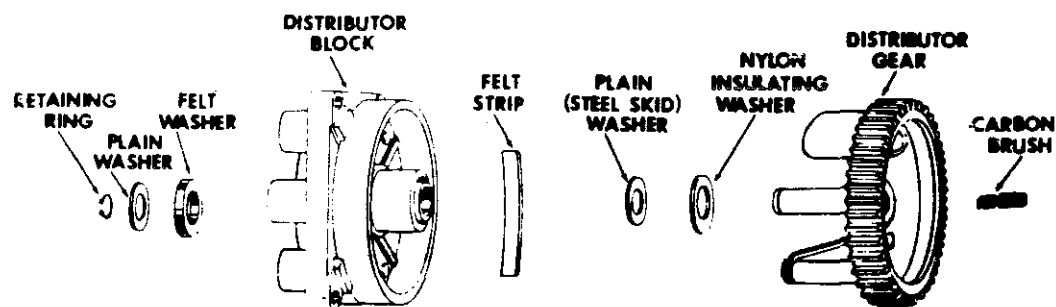
Figure 1.

It has been found that the addition of a nylon insulating washer and steel skid washer between the distributor gear electrode and the block bushing, as shown in figure 1, reduces the possibility of deterioration of the lubricant and possible seizure of the parts.

Assemble large distributor gear, nylon and steel washers to new or reworked block as follows using figure 1 as a guide.

Once modified, the distributor block can be used only with a gear having the nylon and steel washer installed over the shaft as shown in figure 1.

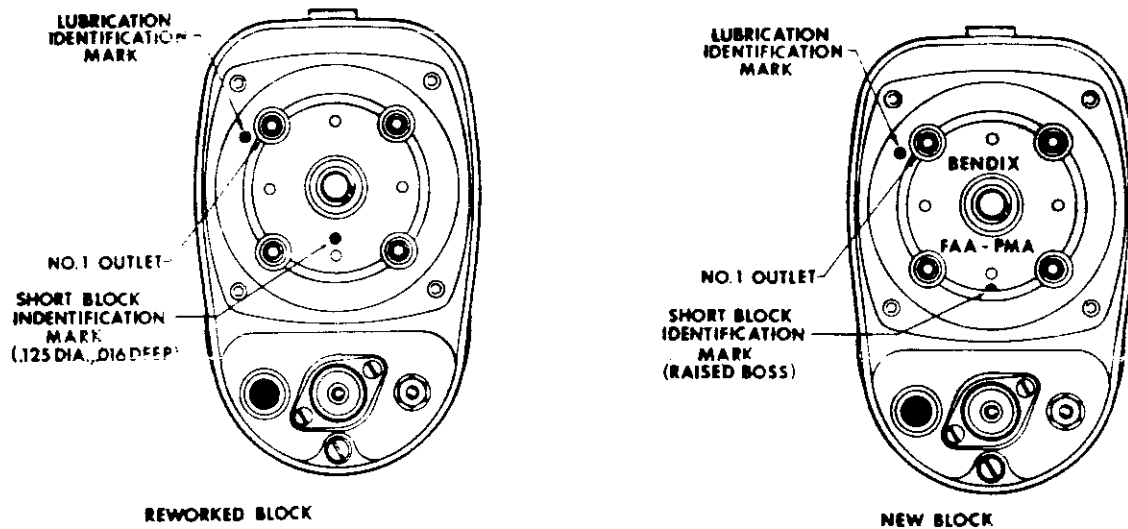
Figure 2

The addition of the washers make it necessary to shorten the gear end of the bushing and block. New production blocks incorporating the change are identified by a raised

boss between the high tension towers at the six o'clock position and molded in letters as shown in figure 2. Reworked blocks are identified by a drill point indentation in the same location. New and reworked blocks both have different part numbers from the current (old) block. See Table 1.

7. Identify reworked blocks by drilling a flat bottomed hole .125" diameter and .016" deep in the six o'clock position as shown in figure 2.

(3) Identify distributor block by drilling flat bottomed indentation 0.125 inch diameter and 0.016 inch deep located as shown in figure 2.
