VSP-30
May 20, 1981

VENDOR SERVICE PUBLICATION

Subject: Bendix Service Bulletins 599A, 609A, 610,
613, 614

SERVICE BULLETIN NO. 599A
(Supersedes Service Bulletin No. 599)
**Engineering Aspects are
FAA Approved**

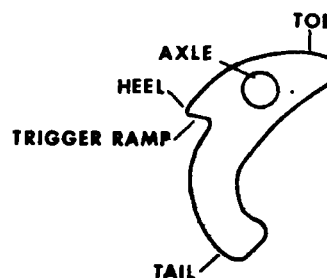
Figure 1. Terminology

- a. Bend the end of a stiff wire into a right angle 1/8 inch long, maximum.
- b. Position impulse coupling so that heel of flyweight (see figure 1) is adjacent to stop pin. Reach

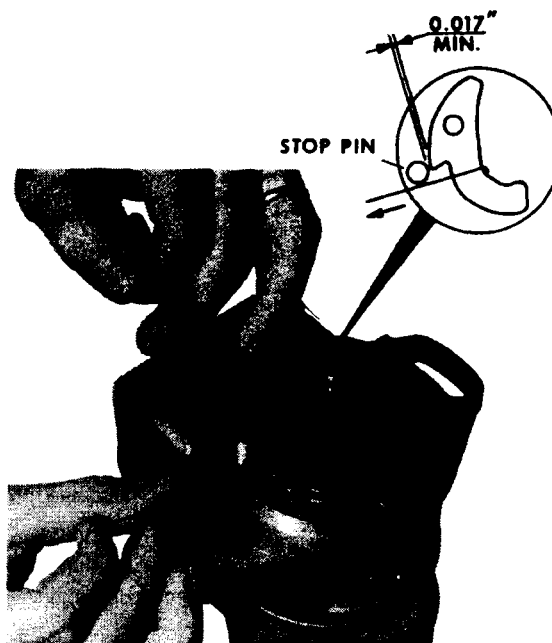
Figure 2. Checking Flyweight to Stop Pin Clearance

c. While pulling flyweight outward, insert feeler gages to measure the clearance between the heel of the flyweight and the stop pin, assuring a minimum of 0.017 inch exists.

d. If less than 0.017 inch clearance exists, this is cause for immediate rejection of the impulse coupling cam assembly, or possibly the entire impulse coupling. Refer to the applicable Magneto Overhaul Instructions for inspection procedures to determine if other impulse coupling parts are still serviceable.

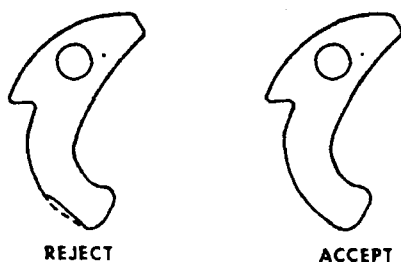
Figure 6. Flyweight Tail Condition Check

4. Flyweight tail condition must be given a visual examination to determine if flyweight is still serviceable. The surface at the apex of the beveled edge must blend smoothly with the outer contour of the flyweight. No flattening, denting or chipping is permissible. Any irregularity of this surface is cause for immediate rejection of the cam assembly. (See figure 6)

6. If the impulse coupling is found to be unacceptable as a result of any of the preceding checks described, replace the entire impulse coupling assembly or worn parts according to instructions of applicable Bendix publications.
7. When inspection of the impulse coupling assembly is being performed, the stop pins in the magneto flange or housing must also be examined. Visible damage or wear in the area where the flyweight contacts the stop pin is cause for repair or replacement of the magneto, stop pin, housing or flange depending on magneto. (Reference latest revision of Bendix Overhaul Manuals Publication Forms L-205, L-645, L-945 and L-1019.)
8. When inspection procedures outlined in this bulletin have been completed, an appropriate notation must be made in the Engine Log Book referencing magneto serial number.

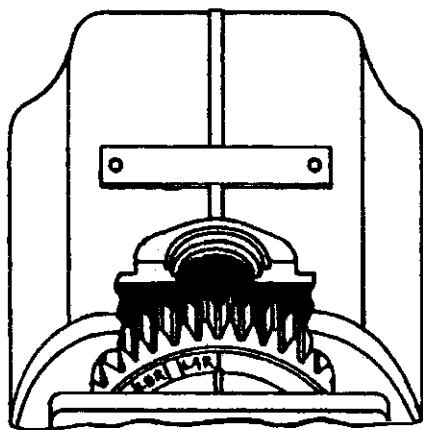
Figure 2. Alignment of Timing Marks on Distributor Gear — 4 Cylinder, Right Hand Rotation

- a. Turn engine in direction of normal rotation past TDC firing position until impulse coupling "clicks."
 - b. Turn engine in opposite direction slightly past the TDC firing position.
 - c. Turn engine slowly back toward number one cylinder firing position until proper timing mark on magnet is in center of the viewing hole (See figure 1).
4. Check at top timing hole in magneto to determine if proper mark on distributor gear aligns with timing rib on distributor block. Alignment tolerances are as follows:
- a. "4" and "8" Cylinder, all types — The timing rib on the distributor block MUST align within 1/2 tooth either side of the "L" or "R" mark on the gear, depending on magneto rotation. (See figure 2)

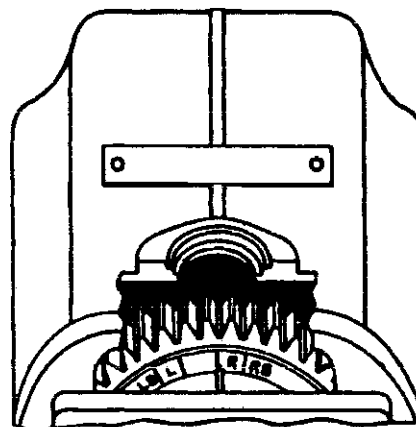
Figure 3. Alignment of Timing Marks on Distributor Gear — 6 Cylinder, Single Breaker, Right Hand Rotation

- b. "6" Cylinder, single breaker types — The timing rib on the distributor block MUST lie between the "L" and "LB" or the "R" and "RB" marks on the gear, and should be nearer to the "L" or "R" mark, depending on magneto rotation. (See figure 3)

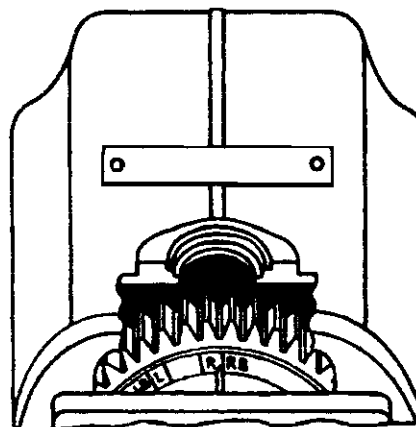
Figure 4. Alignment of Timing Mark on Distributor Gear — 6 Cylinder, Retard Breaker, Right Hand Rotation

- c. "6" Cylinder, retard breaker types — The timing rib on distributor block MUST lie between the "L" and "LB" or the "R" and "RB" marks on the gear, and should be nearer to the "LB" or "RB" mark, depending on magneto rotation. (See figure 4)

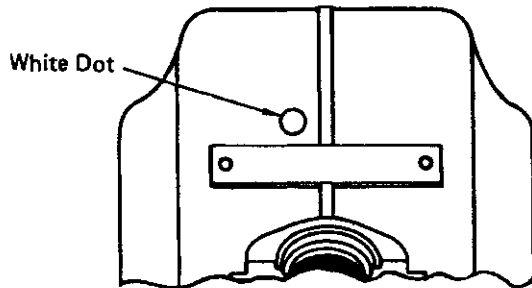
Figure 5. Typical identification mark location.

- a. An appropriate Engine Log Book entry must be made.
- b. The magneto must be identified by painting a white dot approximately 1/4 inch in diameter on the magneto housing at the location indicated in figure 5.

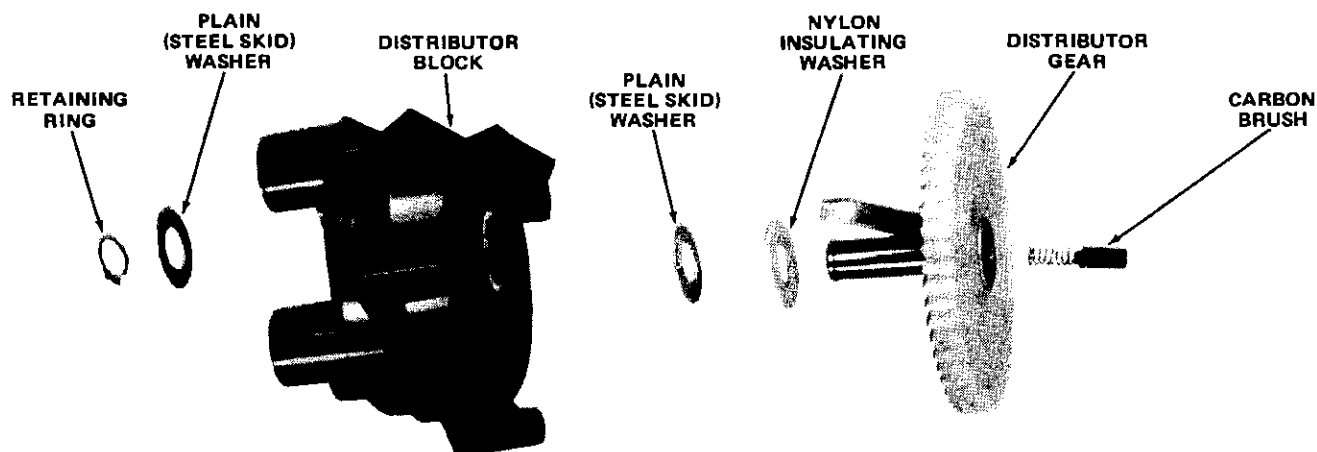
This bulletin announces availability of an improved, insulated distributor gear in kit form which is interchangeable between the D-2000/D-2200 & D-3000/D-3200 series magnetos. The kit includes all parts (except distributor block) as identified in figure 1.

Assembly sequence of the gear kit to distributor block is shown in Figure 1.

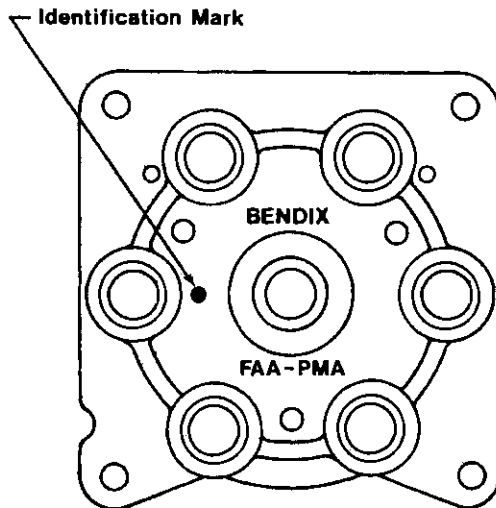
Figure 1. Location of Identification Mark

The new "Gripper Bushing" will eliminate the possibility of the bushing becoming loose. The "Gripper Bushing" block can be identified by a circular shaped mark 0.188 inch \pm 0.031 inch in diameter raised 0.010 inch to 0.030 inch above the surface of the block. This mark is located on the tower side of the block, as indicated in figure 1.

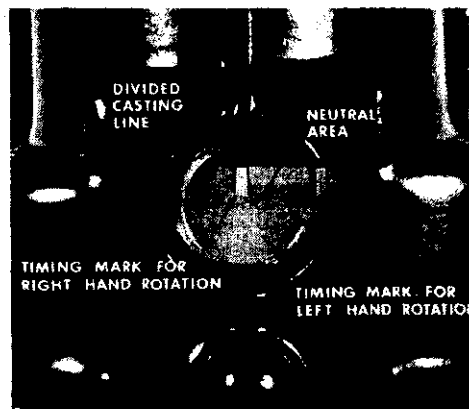
Figure 2. Alignment of Magnet Marks —
Right Hand Rotation

- b. Continue turning the engine slowly, still in the direction of normal rotation, until the proper timing mark on the rotating magnet is centered in the viewing hole. Figure 2 illustrates the timing mark centered for a right hand rotation magneto. A left hand rotation magneto would have the left hand mark centered. (See figure 2.) Eight cylinder magnetos will show an "R" line or an "L" line on the rotating magnet.

one cylinder firing position until proper timing mark on rotating magnet is in the center of the viewing hole. (See figure 2.)

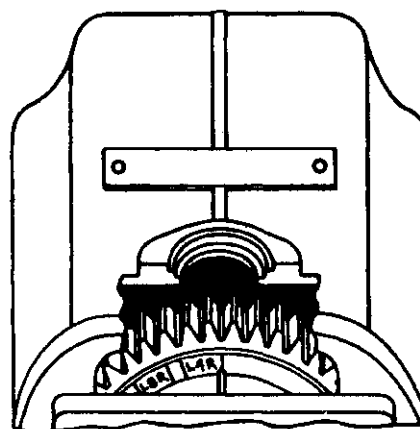
Figure 3. Alignment of Timing Marks on Distributor
Gear — 4 Cylinder, Right Hand Rotation

6. Check at top timing hole in magneto to determine if the proper mark on the distributor gear aligns with the timing rib on the distributor block. Alignment tolerances are as follows:
 - a. Four and eight cylinder, all types — The timing rib on the distributor block **MUST** align within 1/2 tooth either side of the "L" or "R" mark on the gear, depending on magneto rotation. (See figure 3.)

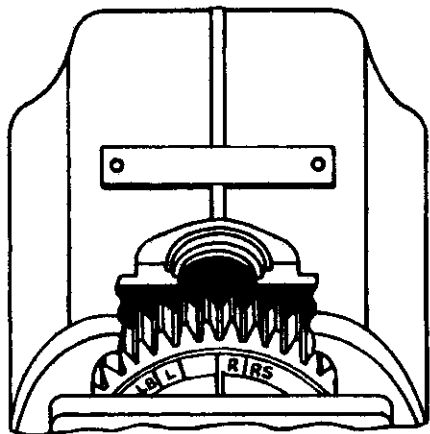
Figure 4. Alignment of Timing Marks on Distributor Gear —
6 Cylinder, Single Breaker, Right Hand Rotation

b. Six cylinder, single breaker types — The timing rib on the distributor block MUST lie between the "L" and "LB" or the "R" and "RB" marks on the gear, and should be nearer to the "L" or "R" mark, depending on magneto rotation. See figure 4.

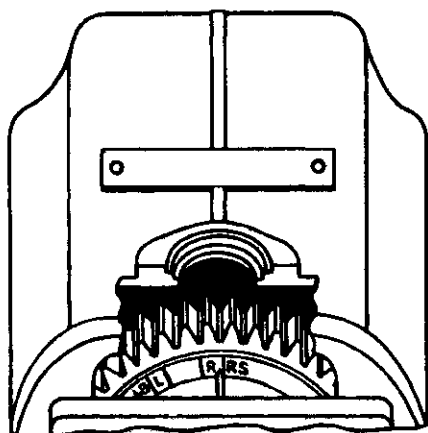
Figure 5. Alignment of Timing Marks on Distributor Gear —
6 Cylinder, Retard Breaker, Right Hand Rotation

c. Six cylinder, retard breaker types — The timing rib on the distributor block MUST lie between the "L" and "LB" or the "R" and "RB" marks on the gear, and should be nearer to the "LB" or "RB" mark, depending on magneto rotation. (See figure 5.)

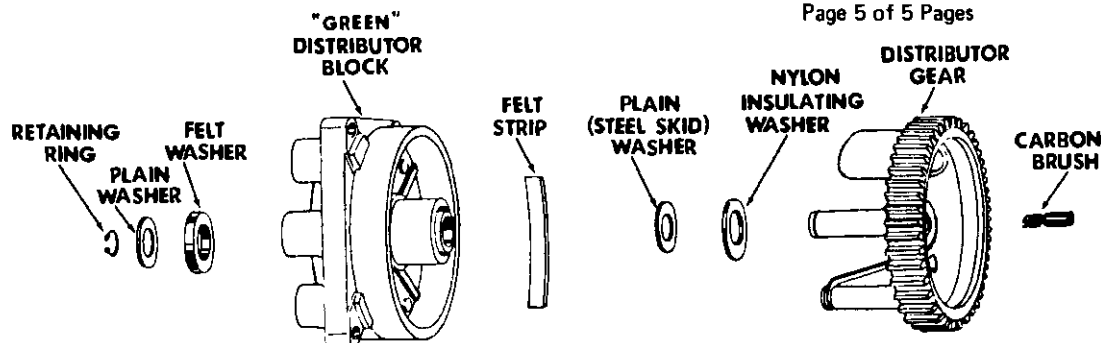
Figure 6. Distributor Gear/Block Exploded View

B. For reassembly, reference figure 6 and proceed as follows:
