SUBJECT: AVCO Lycoming Service Bulletin No. 464A

Service Bulletin No. 464A
(Supersedes Service Bulletin No. 464)
Engineering Aspects are
FAA Approved

Bendix Engine Products Division Jacksonville, Fl. 32245-7880
SERVICE BULLETIN	JP- 00278
Engineering Aspects are FAA Approved	Bulletin No. 623A Date 9/1982 Revised 8/1984

Inspection of impulse coupling cam assemblies.

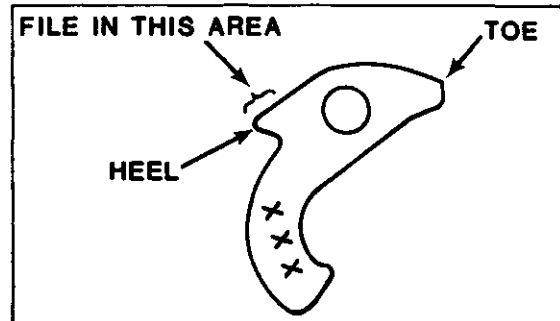
Figure 1.

Some improperly heat treated (soft) flyweights have been reported on impulse couplings currently in service. If this condition exists and is not detected, impulse coupling failure could occur. The flyweights must be inspected in accordance with the instructions in this Service Bulletin and if defective (soft) the impulse coupling or cam assembly must be replaced immediately.

3. Use finger pressure to push inward on the toe (see figure 1) of each flyweight so that the flyweight heel protrudes outward.
4. Using a fine #1, double cut, 1/2 inch wide file, at least 3/32 inch thick, pass the file across the heel of the flyweight attempting to remove material. (See figure 1.) If the flyweight has been properly heat treated the file will "glide" smoothly over the heel of the flyweight, removing no material. If the flyweight is not properly heat treated (soft), the file will not "glide" easily across the surface of the flyweight heel, and material will be removed.

XXX indicates heat treated flyweight by lot number

5. If an improperly heat treated (soft) flyweight is found, immediately remove and replace the cam assembly and/or the impulse coupling assembly following procedures in the magneto overhaul instructions, and paying strict attention to notes and cautions.

11. Any cam assembly with an improperly heat treated (soft) flyweight should be returned to the manufacturer through a currently Authorized Bendix Engine Products Division Distributor.
12. A new method of marking is being implemented to permanently identify heat treated cam assembly flyweights. See figure "1" for location. Pending consumption of current inventory, there will be a mixture of assemblies identified by the following methods.
 1. Original method ---- Yellow paint (Dykern or Lacquer) on the heel of each flyweight.
 2. New method ---- Stamped numbers as indicated in figure "1" on each flyweight.
