VSP 98
October 18, 1989

SUBJECT: Textron Lycoming Service Bulletin Number 486

Service Bulletin No. 486
Engineering Aspects are
FAA Approved

Inspection of **Single Belt** Driven Ring Gear Support Assemblies

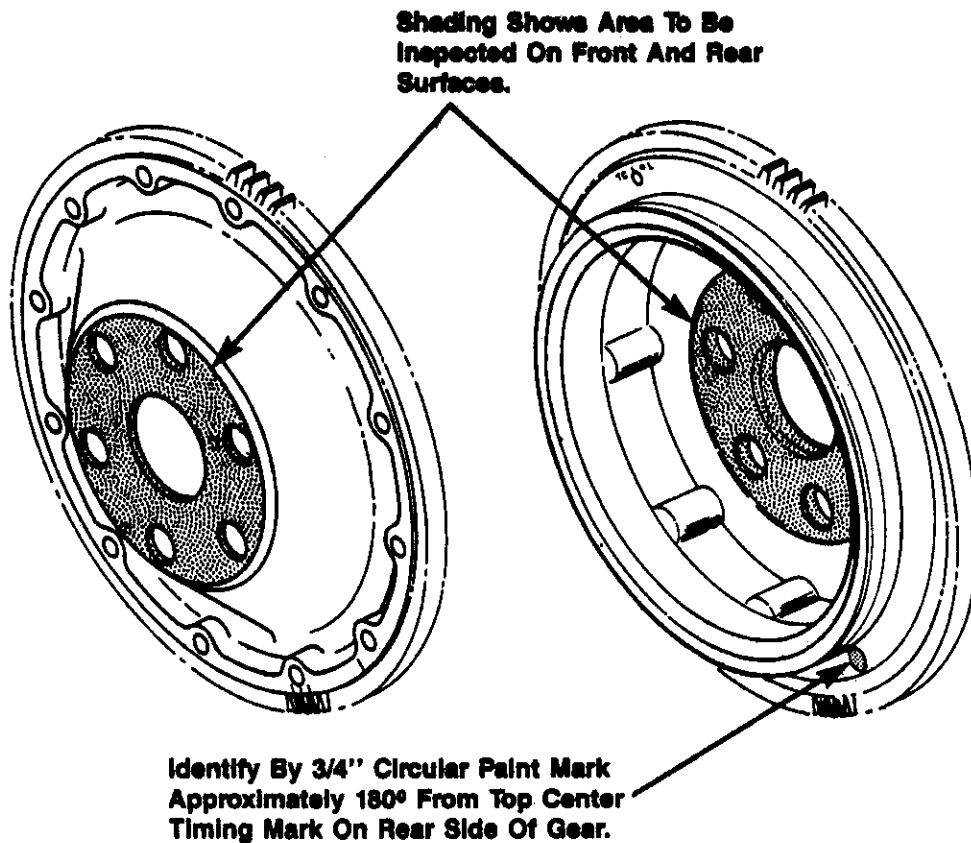
Figure 1. Starter Ring Gear Inspection Areas

It has been discovered that a small quantity of Starter Ring Gear Support Assemblies installed on engines and shipped as spares between January 1, 1988 and June 12, 1989 may exhibit one or more cracks on the front and/or rear machined surfaces. The crack or cracks may appear at any point on the surfaces mating with the crankshaft/propeller flange. See Figure 1, Page 5.

After removal of the starter ring gear support, inspect the support assembly in the areas shown in Figure 1, Page 5, using a dye penetrant to insure no cracks are evident. Follow the penetrant manufacturer's instructions to perform the inspection.

If a crack is evident, the starter ring gear support assembly must be returned to Textron Lycoming through an authorized Textron Lycoming distributor for warranty consideration.

If no cracks are found, the starter ring gear support assembly must be identified with a yellow circular paint mark approximately 3/4 inch in diameter located 180 degrees from top dead center mark on the rear side of the support assembly. See Figure 1, Page 5.
