Stinson Service Bulletin #266

February 1, 1950

Subject: Stinson Rudder Cables Model 108; 108-1; 108-2; and 108-3

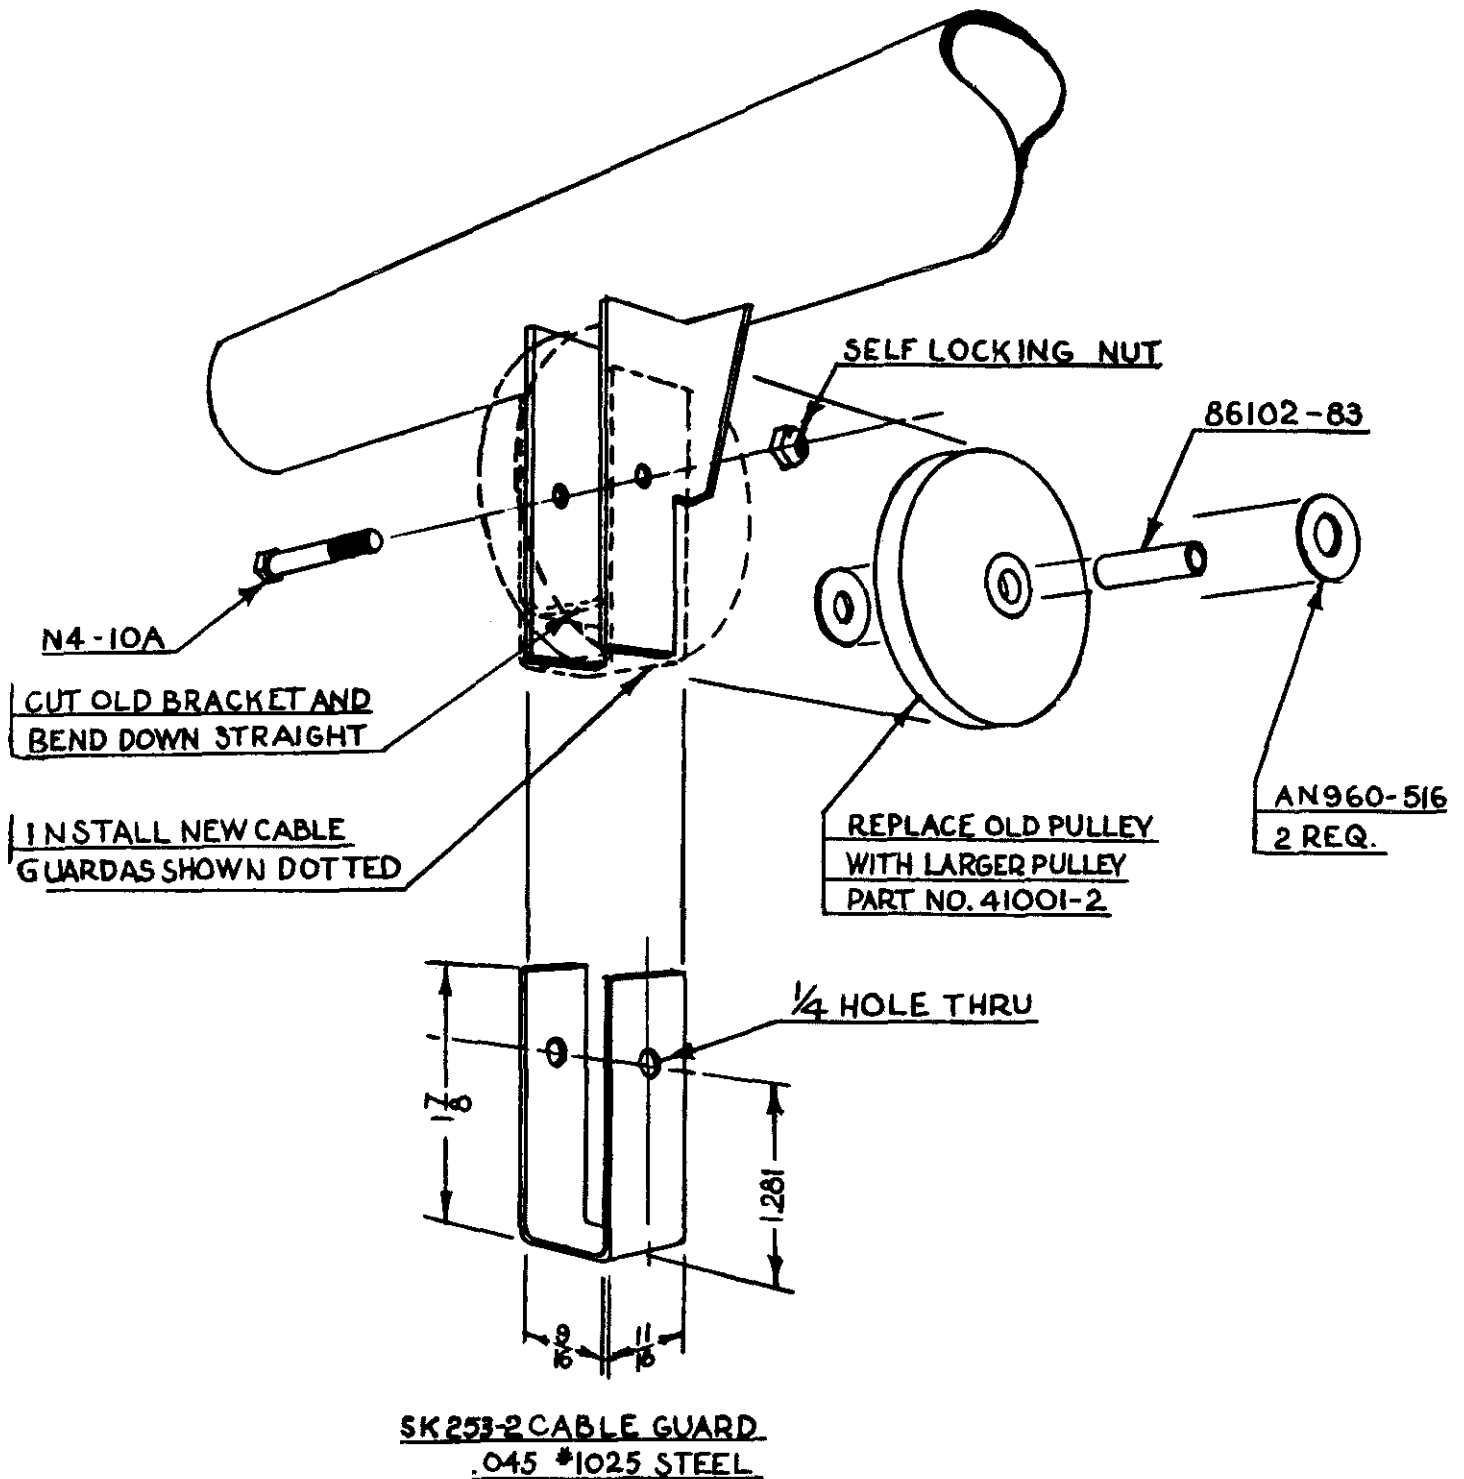
PULLEY BRACKET MODIFICATION
STINSON 108

We have received several reports from the field that the core strands of the rudder cables were found to be broken at a point where the cable passes over the AN210-3A pulley at fuselage station 18.75, (immediately under rudder pedals.)

The cable strand breakage was caused by too great a degree of bend around the pulley. It is recommended that the pulley modification, as indicated on the accompanying sketch, be accomplished on all subject aircraft. The listed instructions should be followed in performing the modifications:

1. Remove the forward belly access door.
2. Remove the right and left hand landing gear fairing.
3. Peel back the forward edge of the landing gear dust cover strips, which are doped to the metal fuselage cowl, far enough to uncover the pulleys on both sides of the airplane.
4. Remove the AN210-3A Pulley.
5. Cut the pulley brackets, as indicated on sketch.
6. Install two Part Number 41001-2 pulleys and two Part Number SK253-2 Cable Guards.
7. If rudder cables show signs of breakage, they must be replaced.
8. Redope the landing gear dust cover strips to the fuselage cowl.
9. Replace the right and left landing gear fairings.
10. Replace the forward belly access door.
