SPECIAL AIRWORTHINESS INFORMATION BULLETIN SAIB CE-14-03

Inspection of Ercoupe Main Wing Spar for Inappropriate Modifications and/or Unapproved Holes

SAIB: CE-14-03

SUBJ: Wing Spar Damage

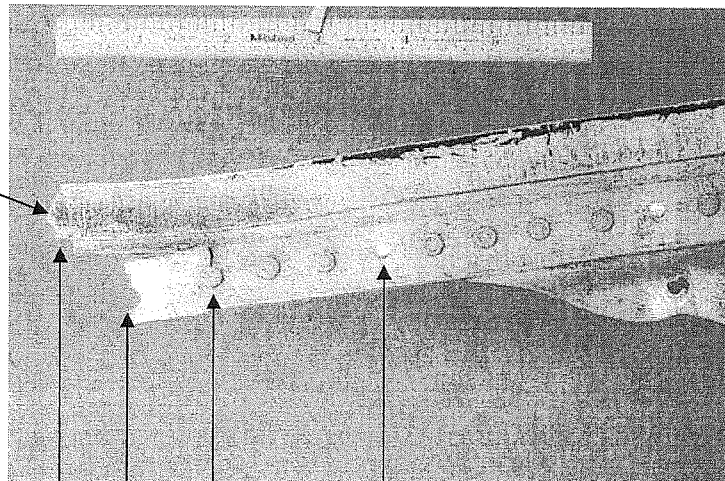
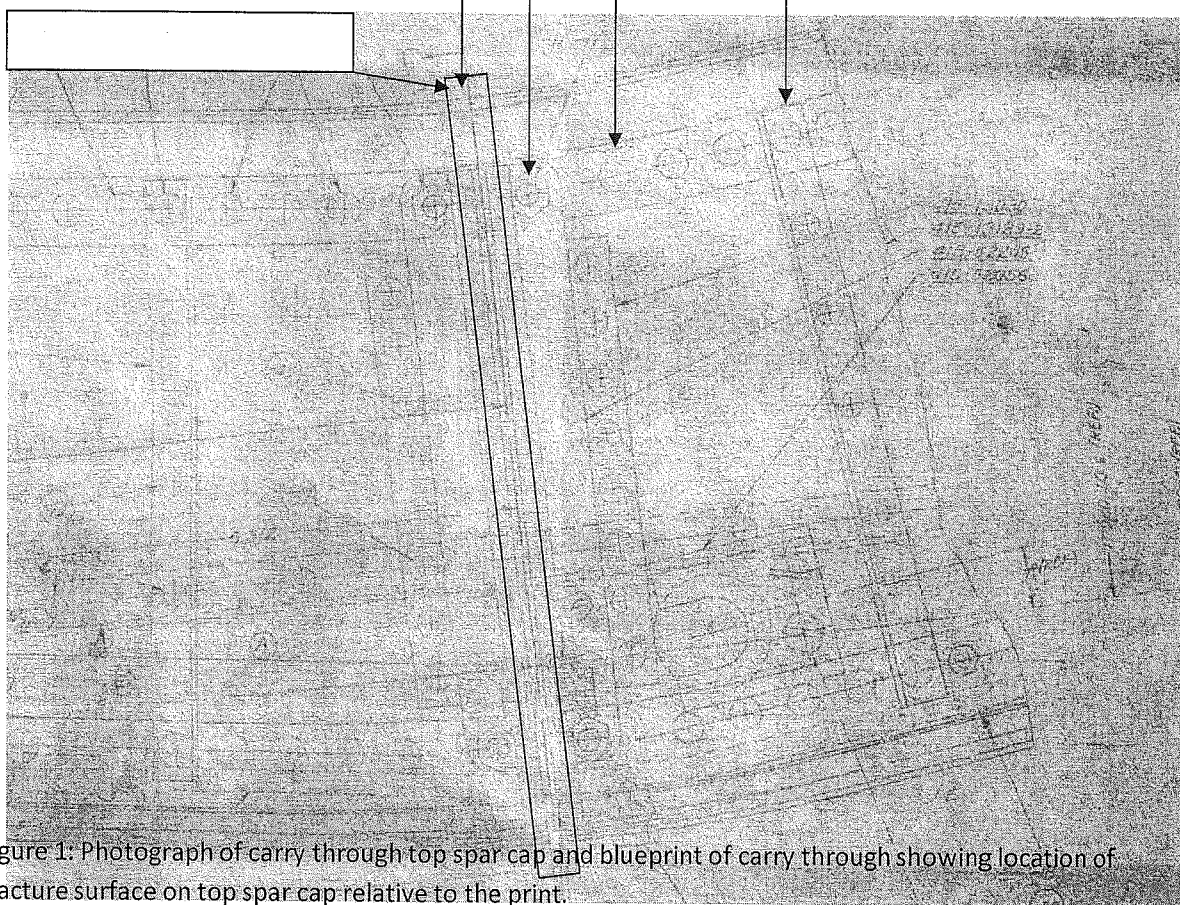
Note: See Figures 1 and 2 below for information of an example of an inappropriate modification performed on a spar cap. This particular spar cap most probably failed due to the pilot exceeding the design stress limitation of the airplane. A self-tapping fastener had broken off in one threaded hole and another had been threaded right into the radius of the flanged member of the spar cap (the "T" junction). The location of the hole in the spar cap T junction can lead to a reduction in structural strength of the affected structure.

Centerline of carry through. The three threaded screw holes are on this fracture surface.

Centerline of carry through.

Figure 1: Photograph of carry through top spar cap and blueprint of carry through showing location of fracture surface on top spar cap relative to the print.

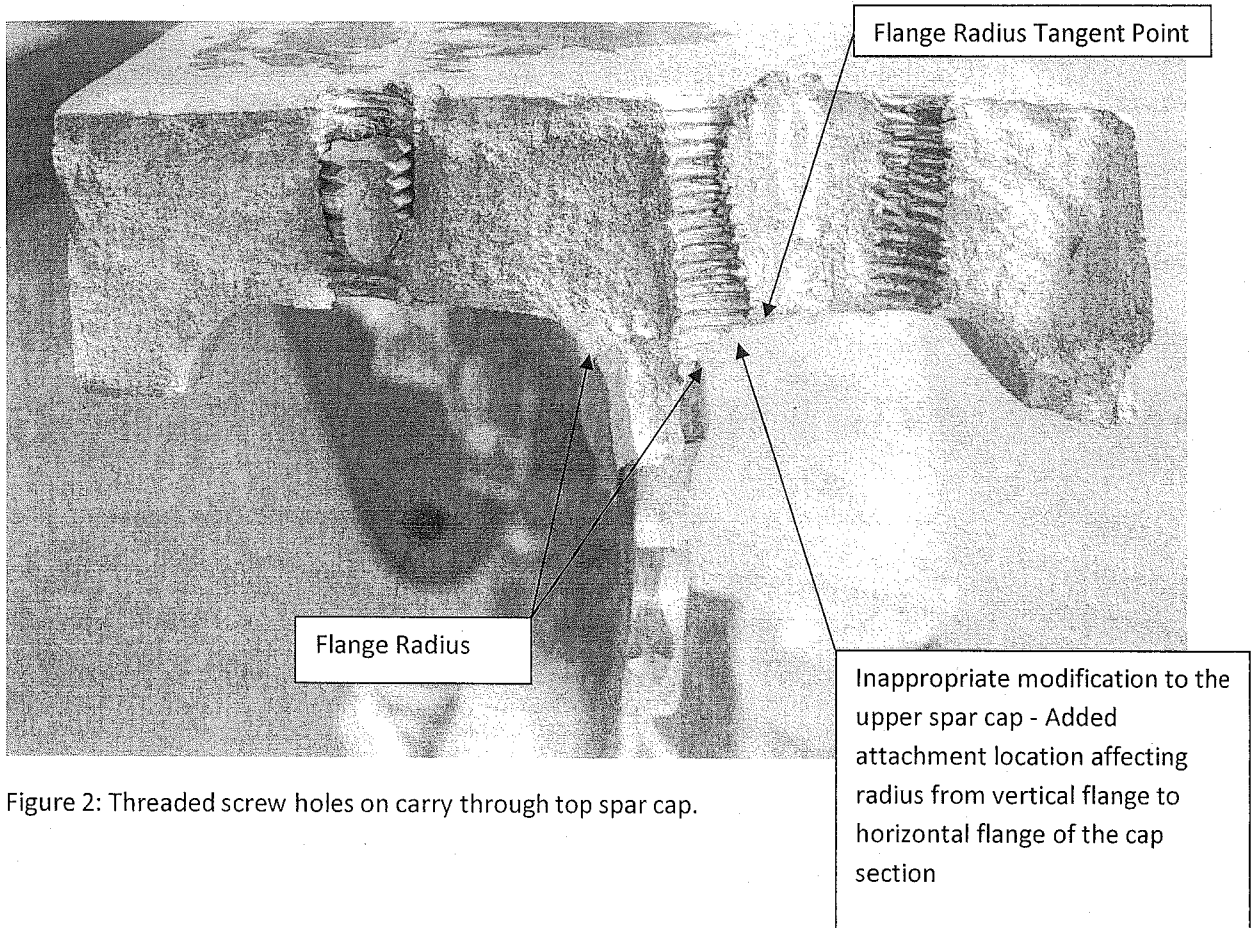
Figure 2: Threaded screw holes on carry through top spar cap.

- If during any inspection open holes are found to exist in the spar cap structure as shown in Figure 2, or in the spar web areas; fill the open hole locations using the following guidance documents: Advisory Circular (AC) 43.13-1B Section 4-57, Advisory Circular 43.13-2B, Chapter 1, Paragraphs 106-110, and Metallic Materials Properties Development and Standardization (MMPDS-04) April 2008, Chapter 8, Page 8-13. Monitor this repair under standard aircraft inspection intervals. If it is necessary to drill an open hole location to obtain a clean hole for rivet installation, the final hole diameter should not intersect the tangent point to the flange radius as shown in Figure 2. Avoid drilling holes larger than 10-percent of the existing cross sectional area; or otherwise decreasing the effective tensile strength areas and/or edge distance of wing spar cap strips, web areas, or highly stressed tensile areas. If these criteria cannot be satisfied, further repair as noted above will be necessary.
