UNIVAIR PIPER STAMPED ALUMINUM RIB Service Letter No. 100 Field Repair Process

Service Letter No. 100

Field Repair Process

SUBJECT: Stamped Rib Repair

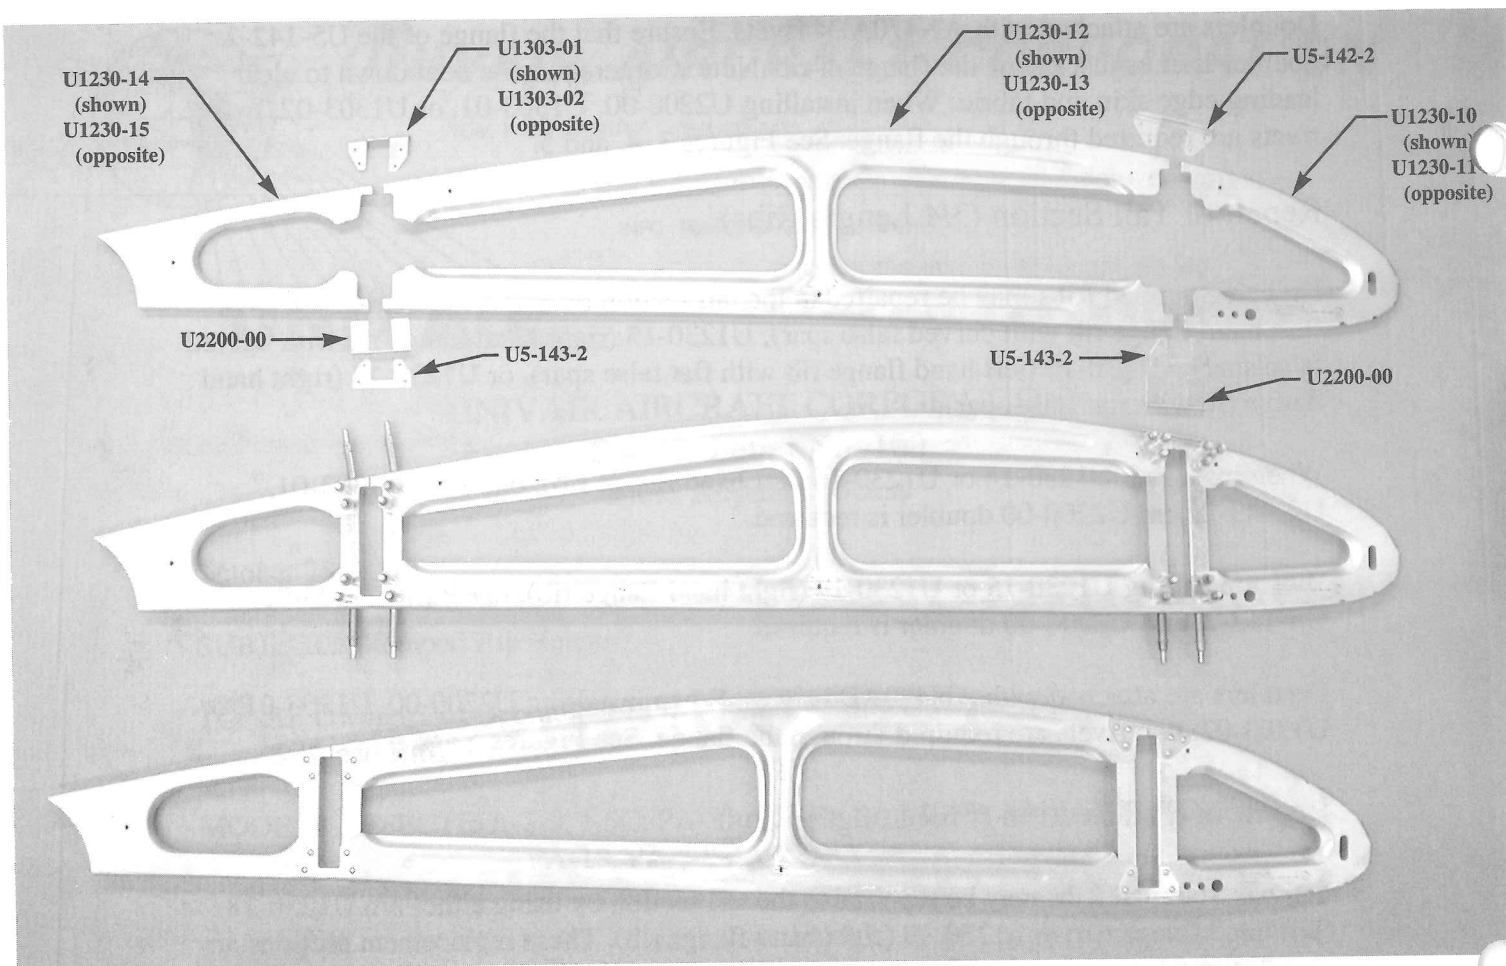
Figure 1

This letter outlines the repair of Univair STC'ed Stamped Ribs in accordance with the original STC and FAA Advisory Circular AC 43.13-1B. Repairable ribs include all full length ribs and 3/4 length ribs excluding tip ribs and nose ribs. See Figures 1 and 2.
