SERVICE

BULLETIN

NUMBER 40

SUBJECT: Outlet Reinforcement on 12 Gallon Fuel Tanks

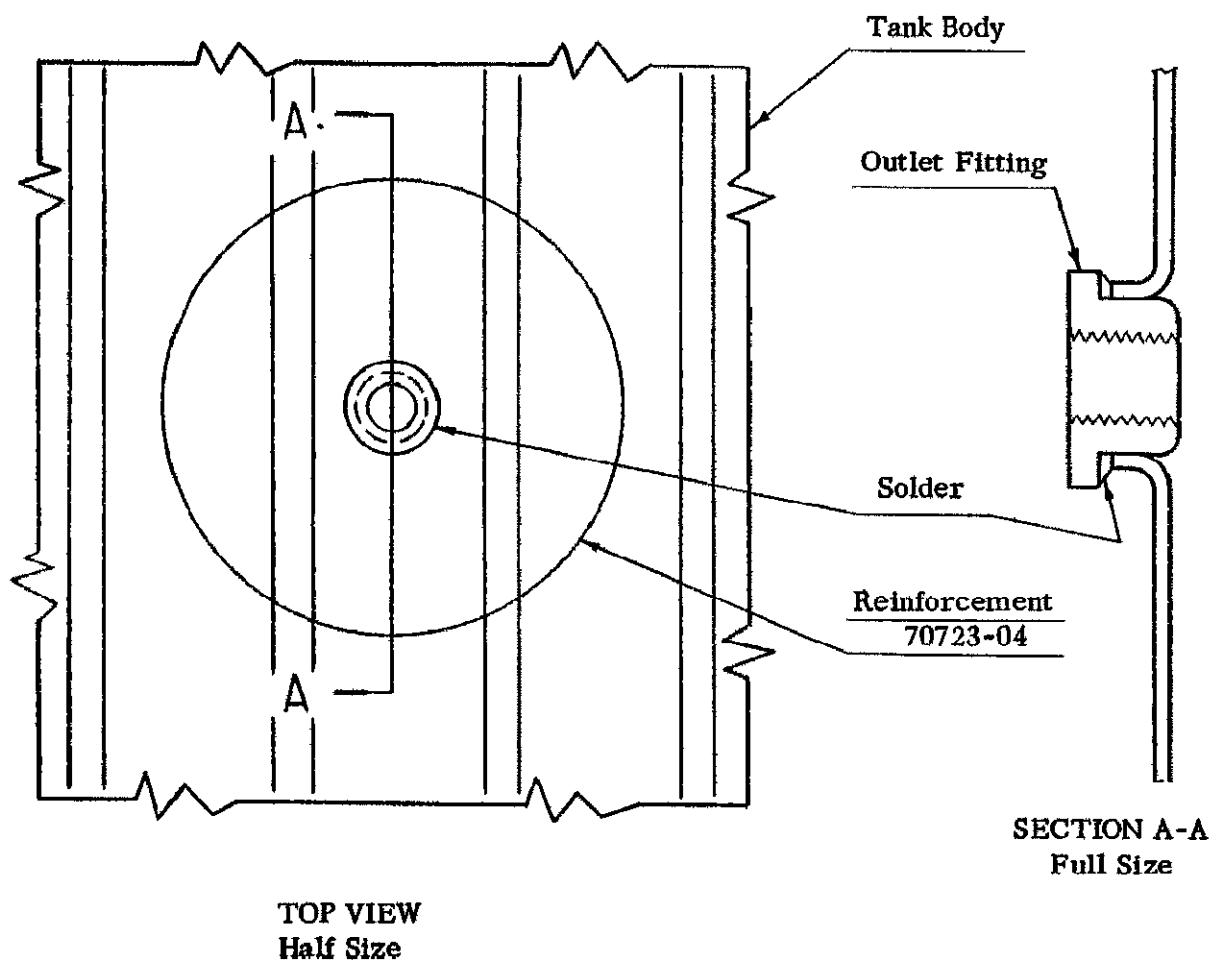
If it is found that this patch was not installed, we suggest that this be done, as we have received a number of reports of cracking occurring near the outlet fitting on tanks without this reinforcement.

This part (No. 7662) may be obtained, without charge, from your local dealer or distributor and should be installed according to the attached sketch.

After the reinforcement has been installed, an appropriate entry should be made in the aircraft log book.

Before installing this patch, the fuel tank should be drained, removed from the ship and either blown out with live steam or flushed with carbon tetrachloride (fire extinguisher) or both; otherwise a serious explosion may occur due to the presence of gasoline fumes.
