SERVICE BULLETIN

NO. SB-1

Model: A2

Subject: C-90-16F Continental Engine Breather Fitting

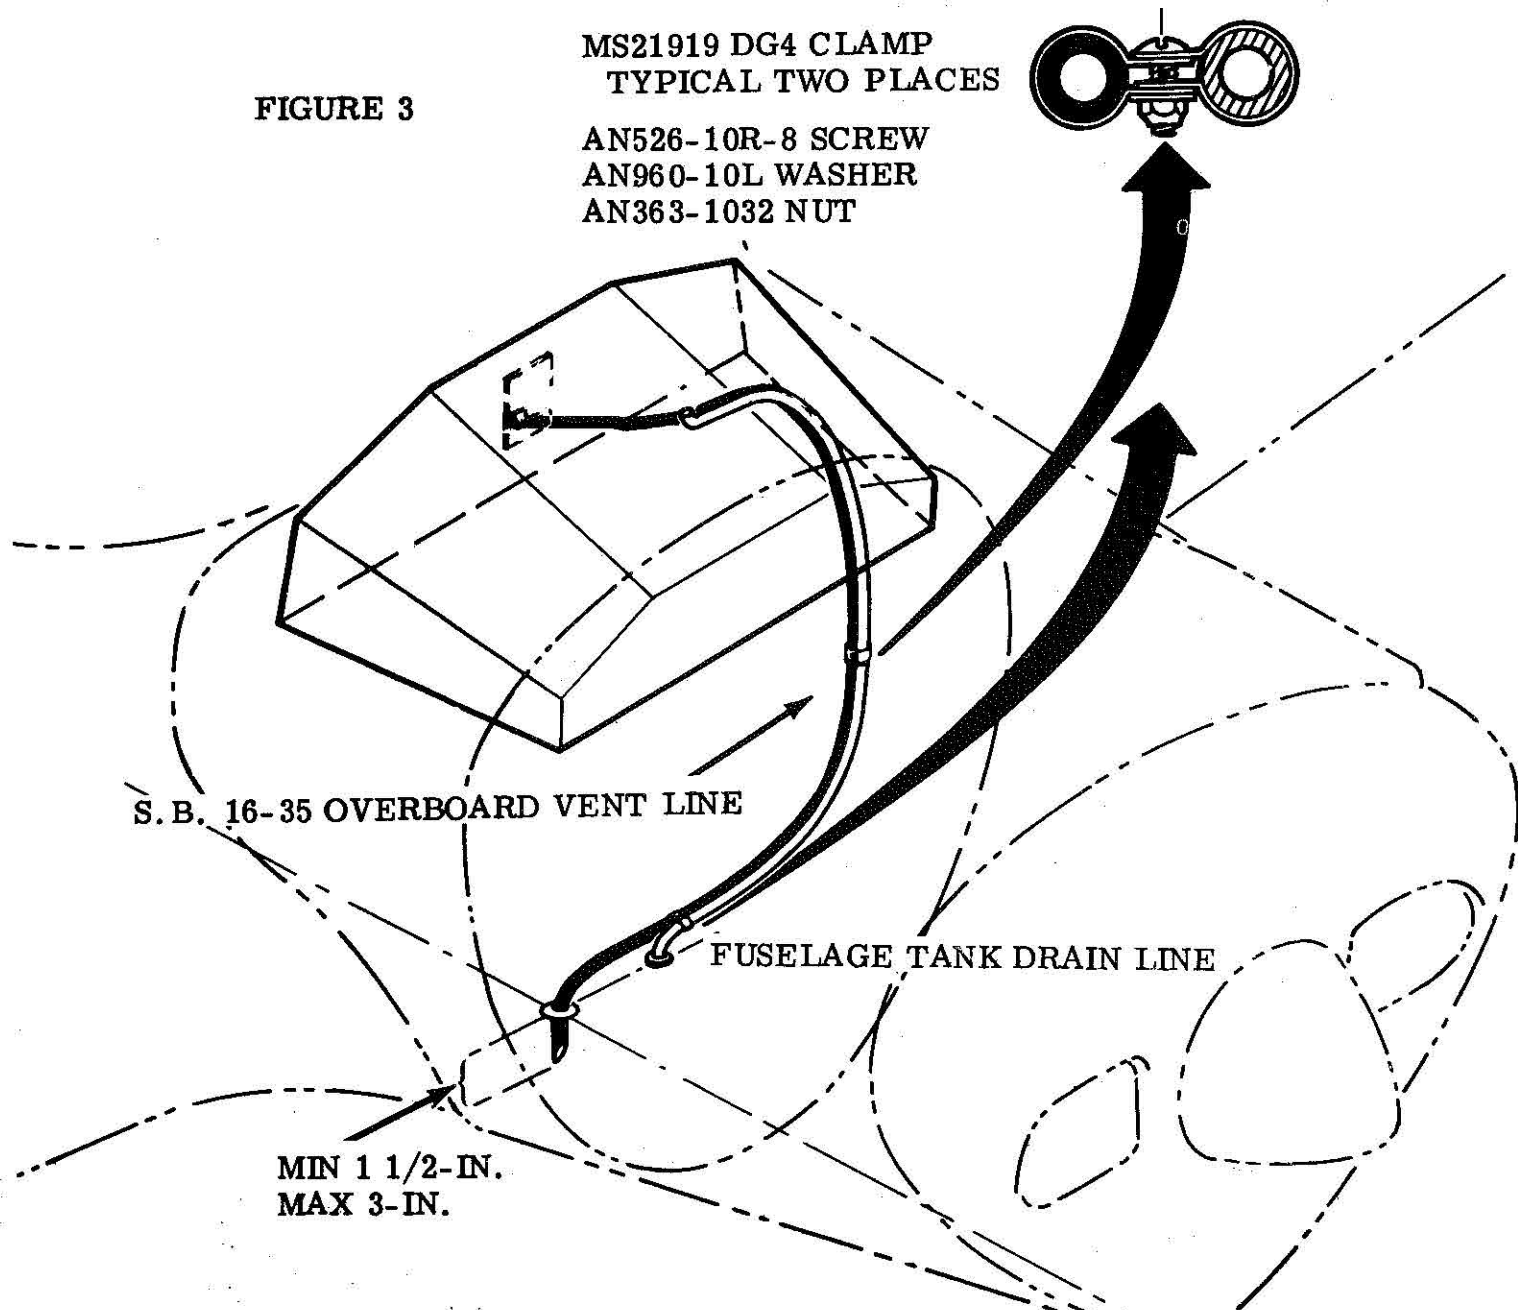
FUSELAGE TANK DRAIN LINE

MIN 1 1/2-IN.
MAX 3-IN.

- a. Install AN913-2 plug in overflow return line fitting from which T-fitting has been removed.
- b. Locate template on center line of aft side of fuselage tank using top of tank as locating reference (See Figure 1).
