ERCOUPE SERVICE MEMORANDUM

^{No.} 38

SUBJECT: Trim Tab Control Installation

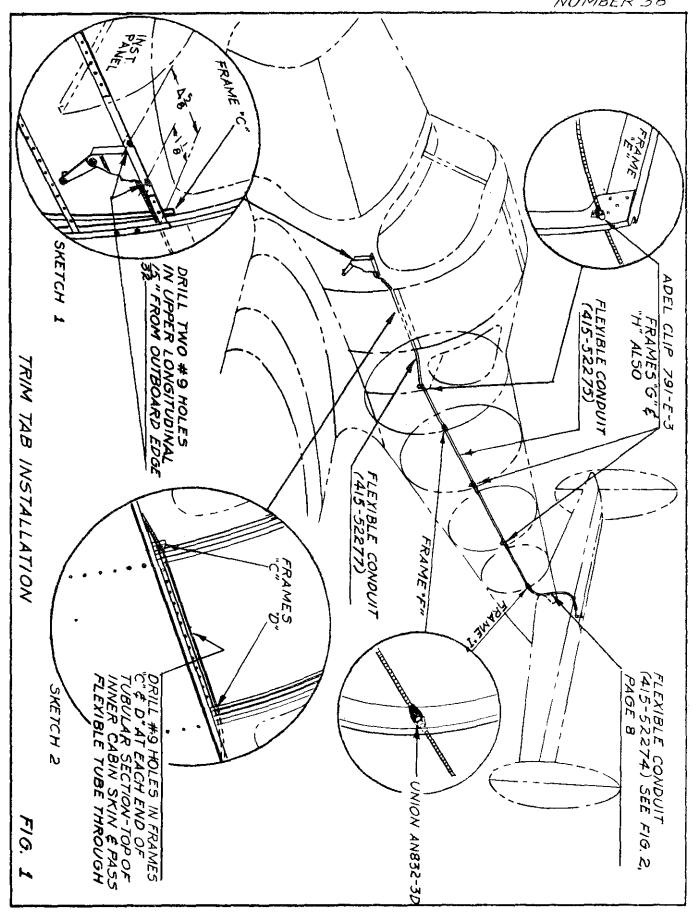
- B. Installation of New Trim Assembly.
 - Handle Assembly Installation. (See sketch No. 1.)
 - a. Drill two holes No. 9 (.196) in upper longitudinal at the left side of the cabin. These holes are located 1½" and 4¾" forward of rear end of horizontal flange 15/32" from outboard edge of longitudinal.

- b. Install bracket with two AN3-3A bolts and AN365-1032 elastic stop nuts.
 - c. Drill through the outer skin with a No. 9 drill, using bottom hole in bracket as template. Install an AN526-C-10-C screw and an AN365-1032 elastic stop nut.

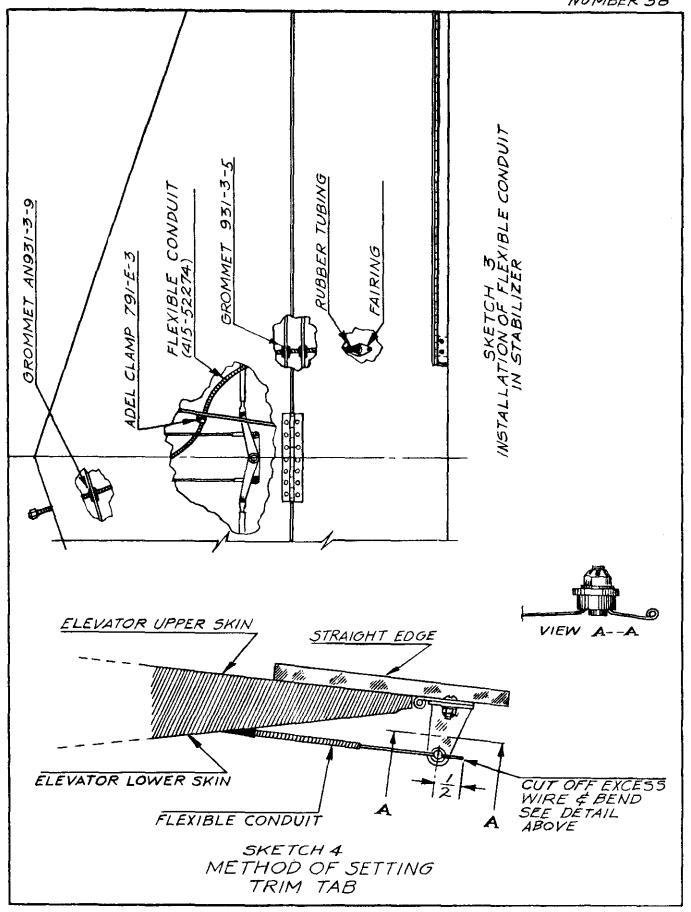
- 4. Installation of Flexible Conduit (415-52277) (See sketch No. 2).
 - a. Drill a No. 9 hole in frame "C" and "D" in line with and at each end of the tubular section at the top of the left inner cabin skin. (415-31035)

- 7. Installation of Conduit (415-52274) in stabilizer. (See sketch No. 2.)
 - α. Drill α 5/16" hole 8-23/32" to the right of the center line of the rear spar of the stabilizer and 27/32" above horizontal center line of the spar. Insert rubber grommet (AN931-3-5).
