SERVICE BULLETIN

NUMBER 181

SUBJECT: Replacement of 1/8 - 7 x 19 Flexible Stainless Steel Control Cables

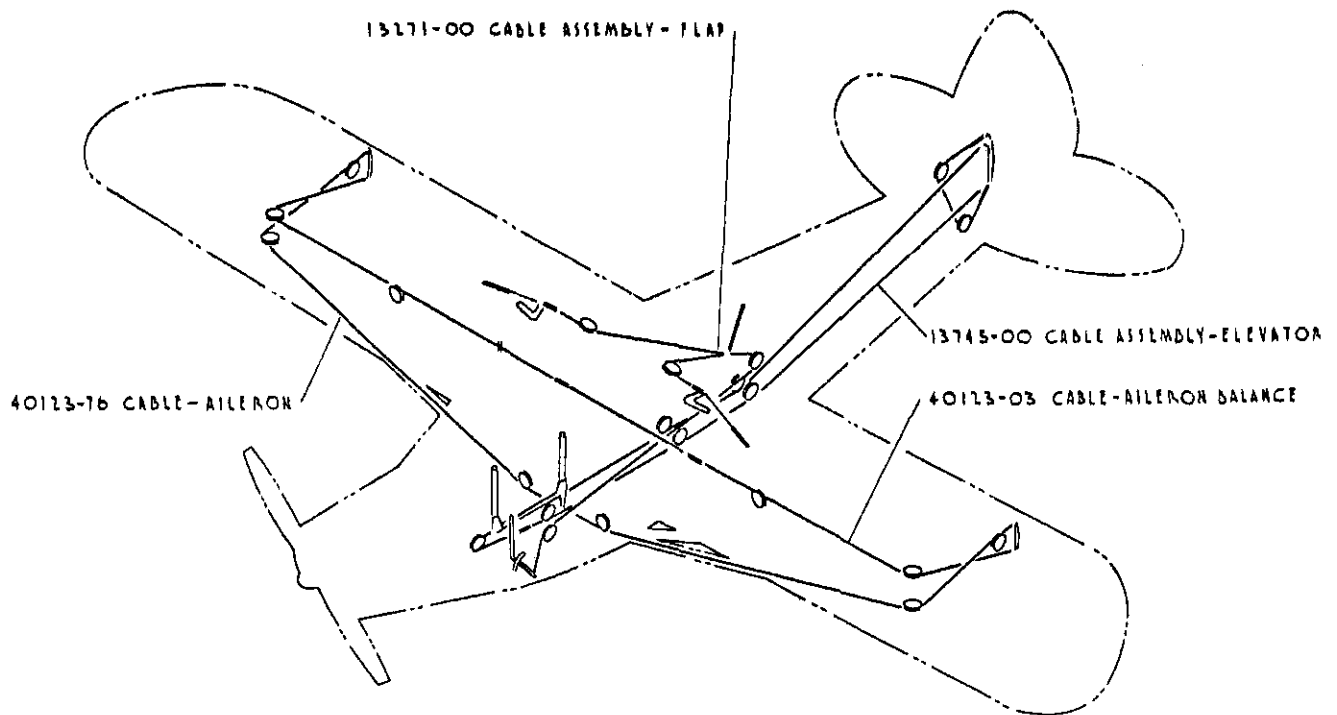
PA-18A

The following is a list of the affected control cables and their respective replacement parts which apply to the aircraft serial numbers listed after "MODELS AFFECTED", exclusive of the aircraft listed under Note "A". See sketches A, B and C for identification.
